Technical Expert Review Report No 297-07-17/T
Examination of the technical condition of the basement under the building B (02) and
under the adjacent pools on the cadastral unit No 0100213011 in Chisinau Municipality,
23 Gh. Asachi Street, in order to assess the possibility of conducting the planned
refurbishment

Technical expert review conducted at the request of: UNDP Moldova
filed with the ‘Societatea de Cercetari Stiintifice si Prospectiuni in Constructii’ S.A. [Society of Scientific Research and
Prospecting in Constructions JSC]

Chisinau 2017

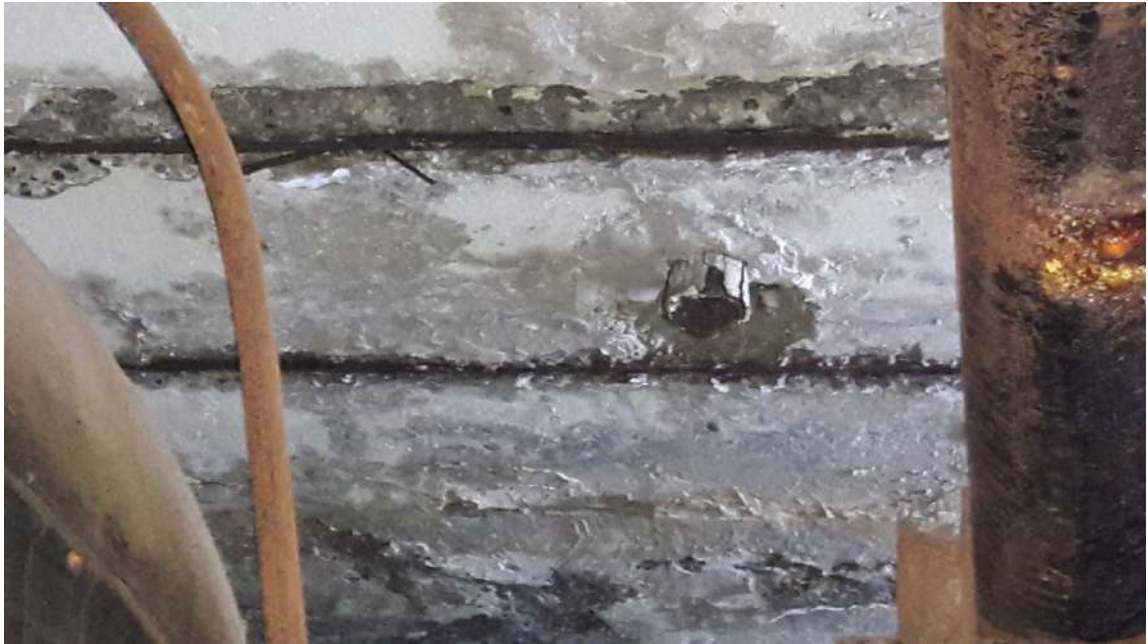
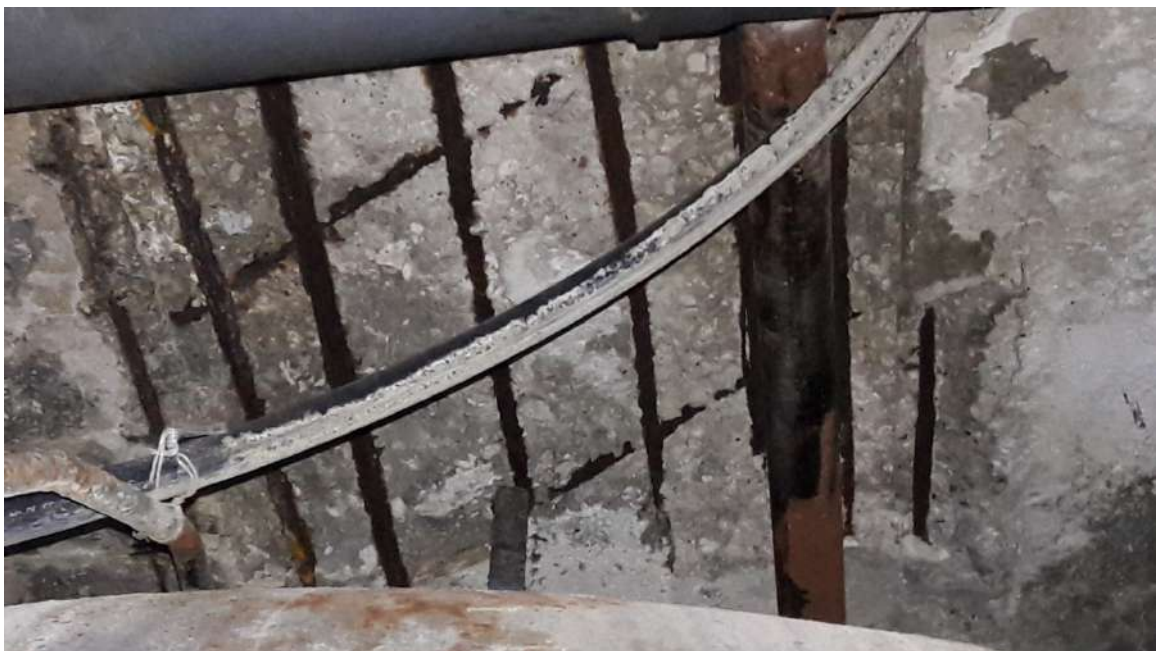
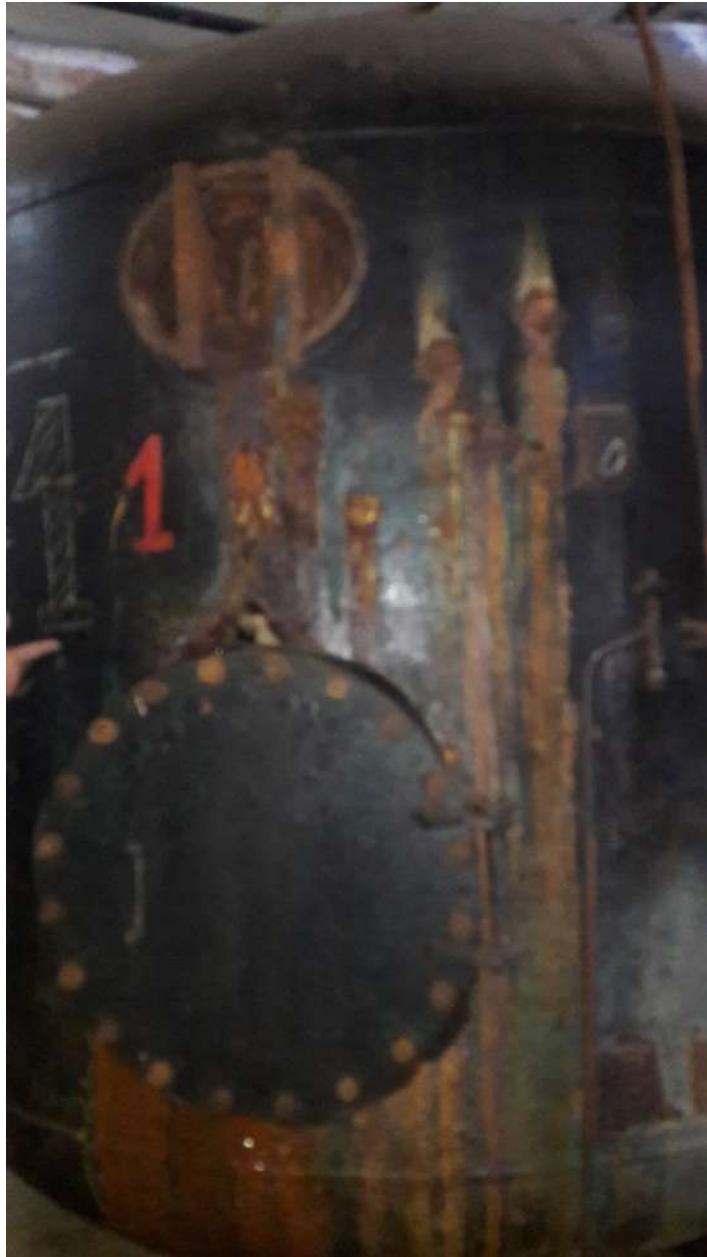
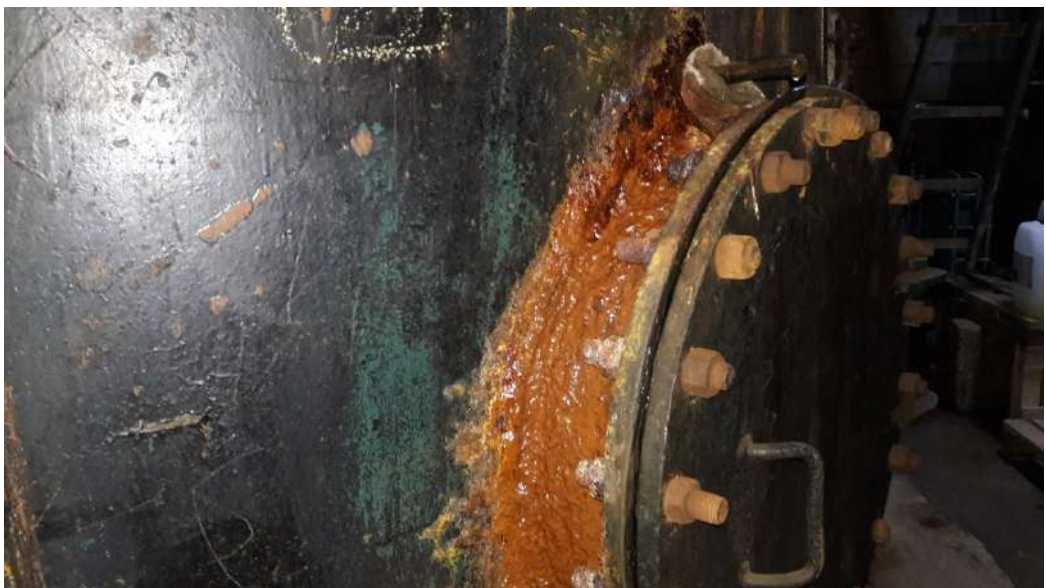
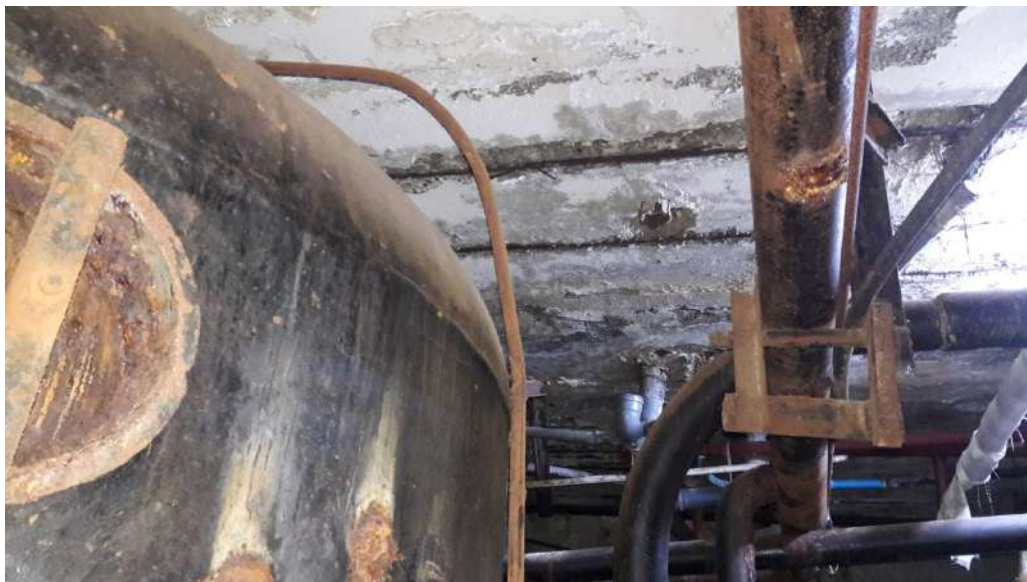
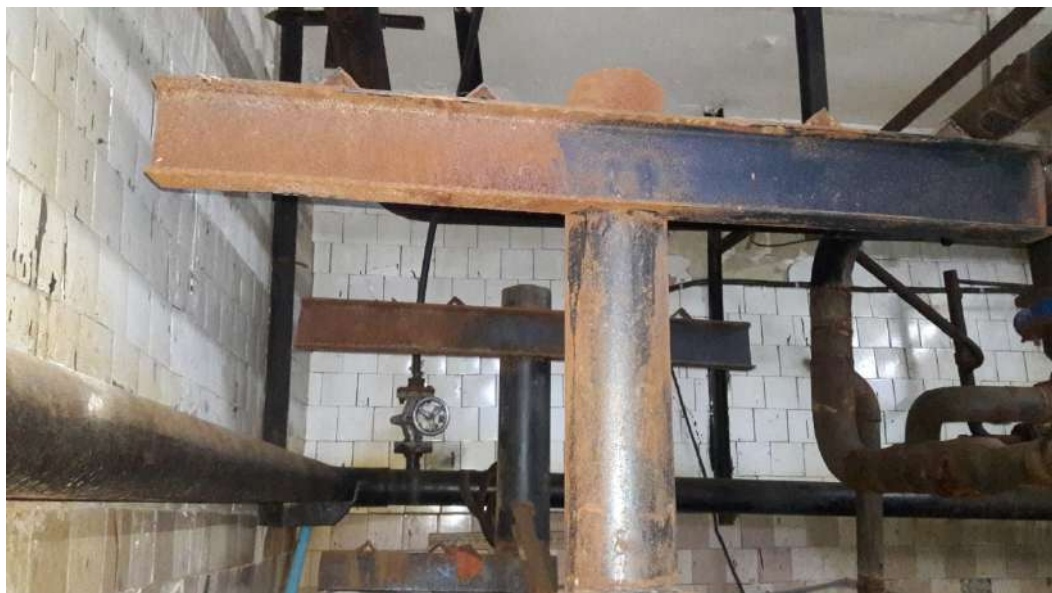
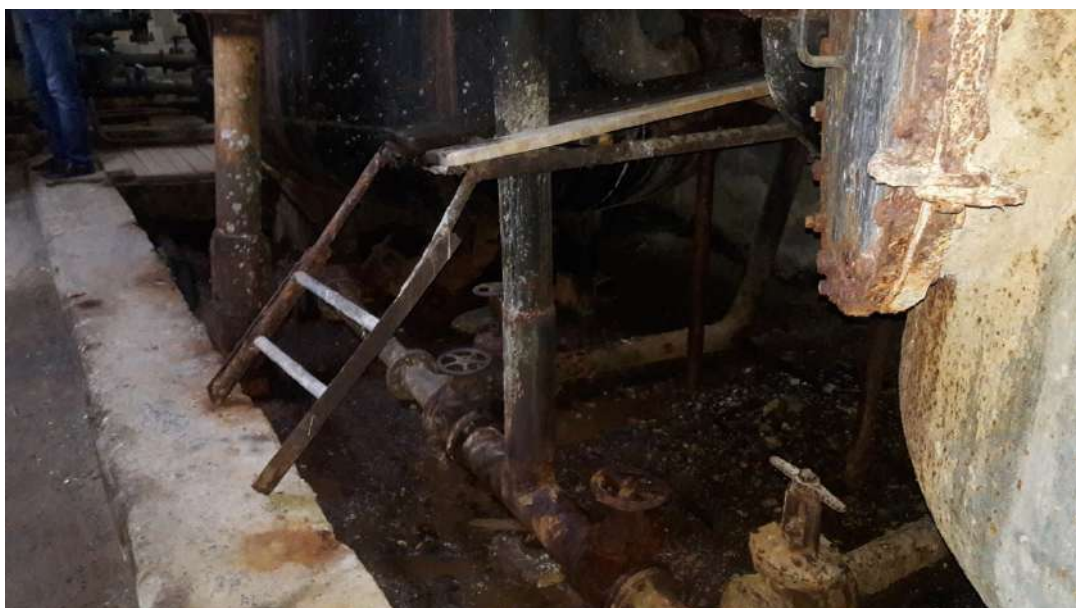
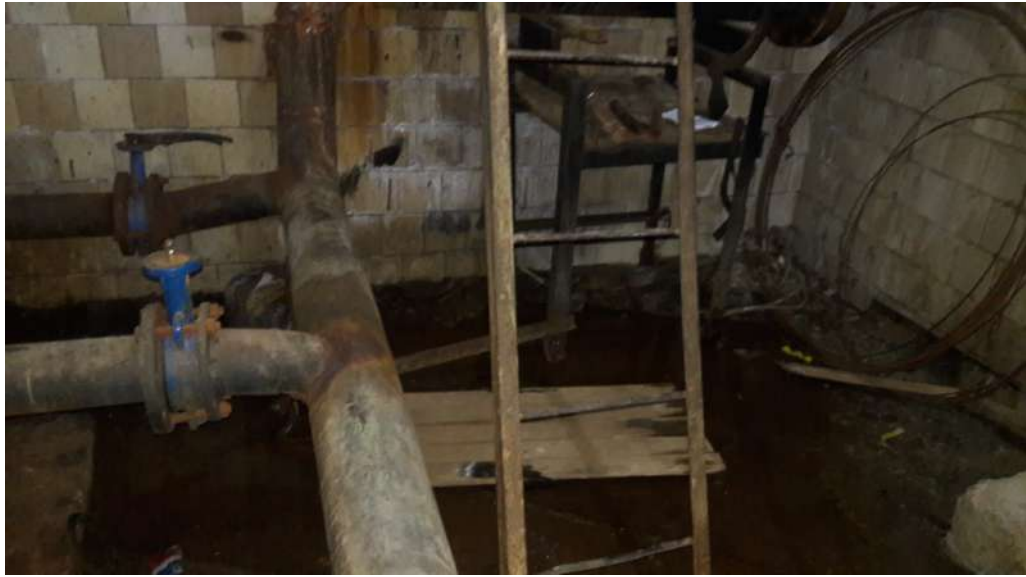
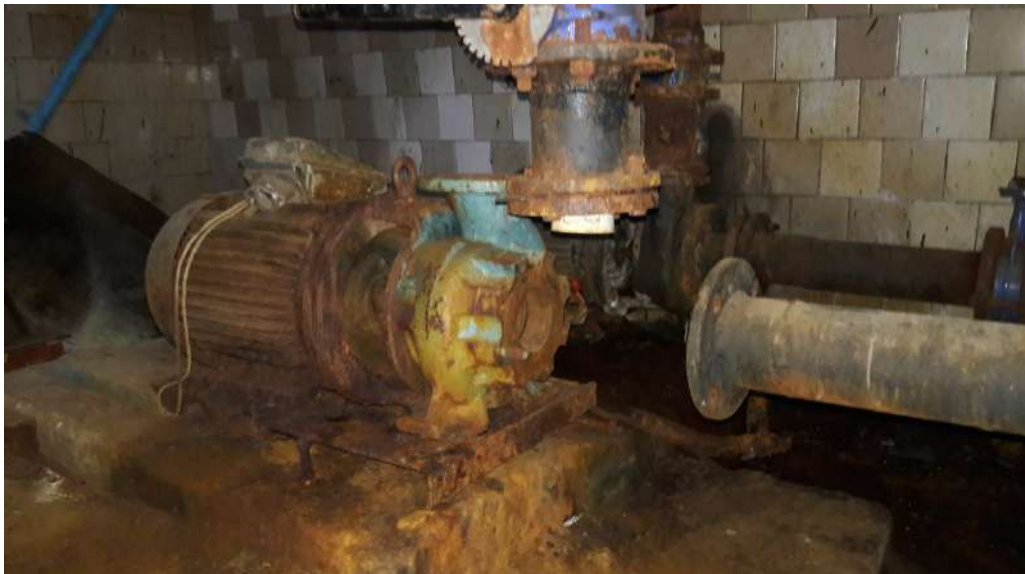
The visual examination of the technical condition of the load-bearing constructions of the basement and facilities inside it revealed that the concrete and armature of the roof slabs were deteriorated and eroded on their lower parts. The water treatment equipment (tanks, pipes, support facilities etc.), that are exposed to continuous corrosion, was deteriorated. There was water on the floor, which affects the water treatment equipment.

6. The load-bearing constructions in the basement under the building B (02), examined as part of this expert review, where the pool water treatment equipment is located, are in a **partially satisfactory** technical condition.

- a) the reinforced concrete constructions (floor panels), where the armature of the casings is exposed and corroded, needs to be rehabilitated by cleaning the rust and restoring the protection layer of the armature in order to stop the degradation process and it is necessary to take measures to strengthen the load-bearing capacity of the basement floor on its entire area, as recommended in **Annex A6**.

- b) the water treatment equipment (tanks, pipes, supporting constructions, etc.) subject, to a great extent, to continuous corrosion, will be cleaned of rust and treated with special anti-corrosion solutions after local repairs are done and highly worn-out elements are replaced (i.e. if this system will be used further on), or it will be dismantled if it is decided to replace it with a more efficient water treatment system. Removing and evacuating the existing filtering equipment and system and the water treatment equipment out of the basement is only possible by cutting to pieces their solid parts. The sizes and weight of these parts will be determined on site, taking into account the size of the entrance to the basement, the size of the staircase and whether they will be evacuated manually or by using special devices. If installing a new water
