REPORT OF EXPERT EXAMINATION No. 9839-08-23/T

**of the 'UN House Moldova' building
with cadastral no. 0100520.040.01 and 0100520.040.02
on 131, 31 August 1989 str., Chisinau municipality**

Prepared based on the request of
UNDP Moldova

Chisinau, 2023

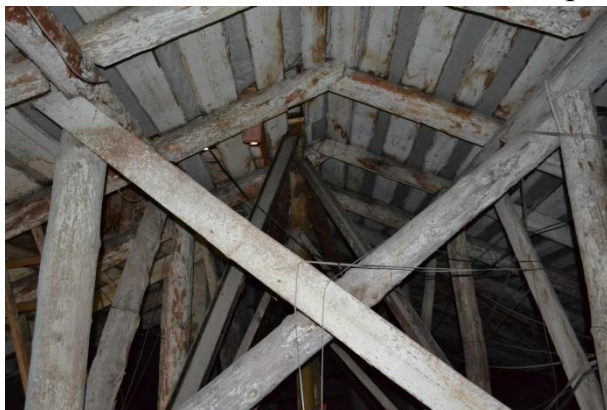
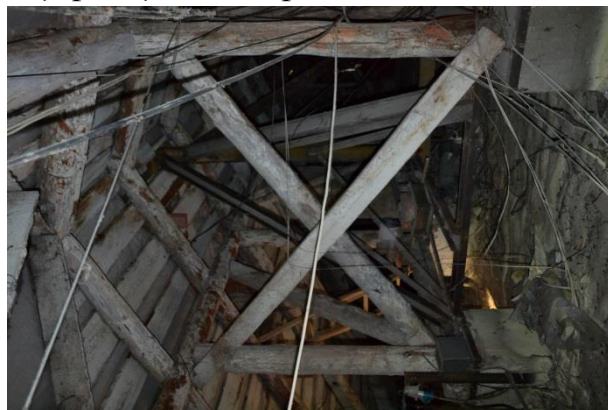
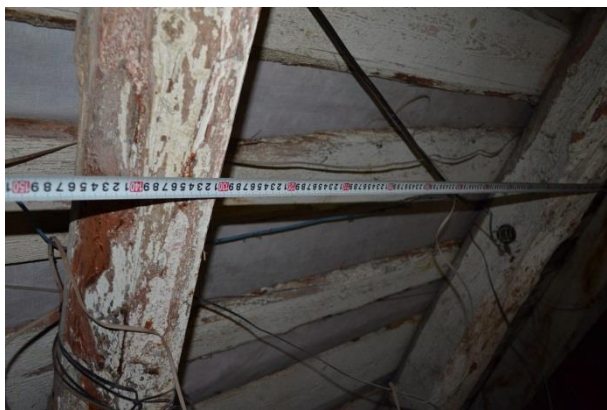
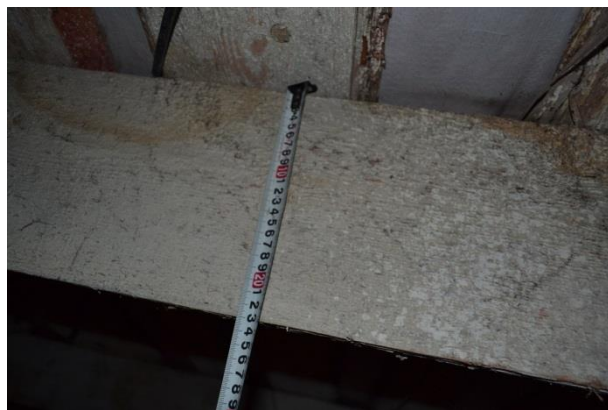
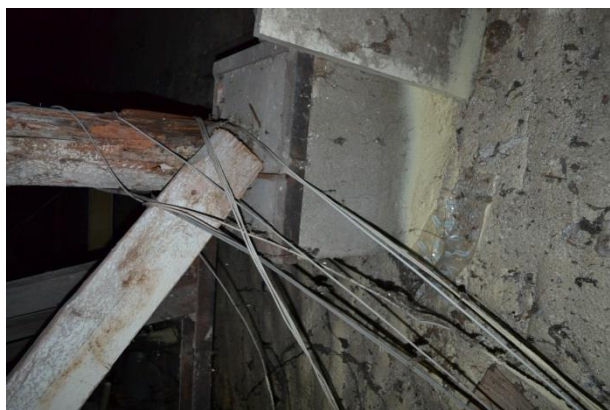
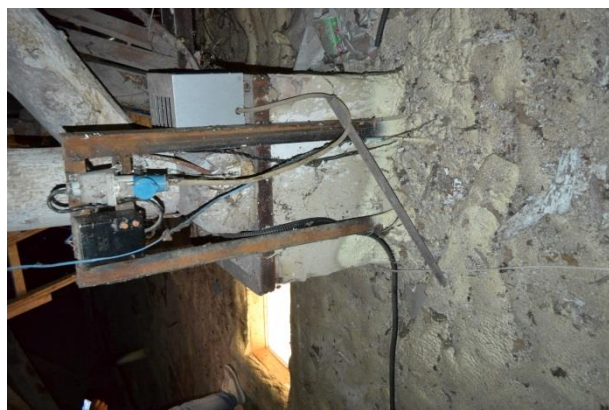
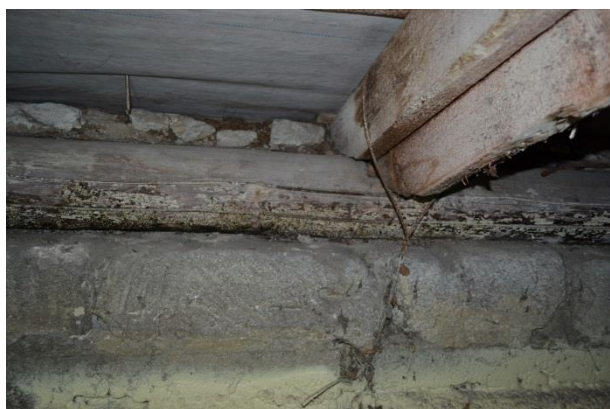
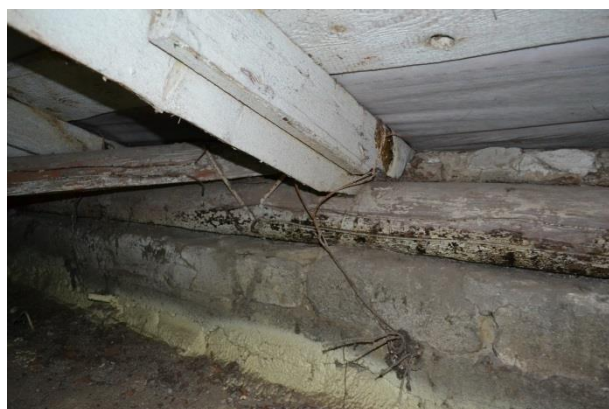
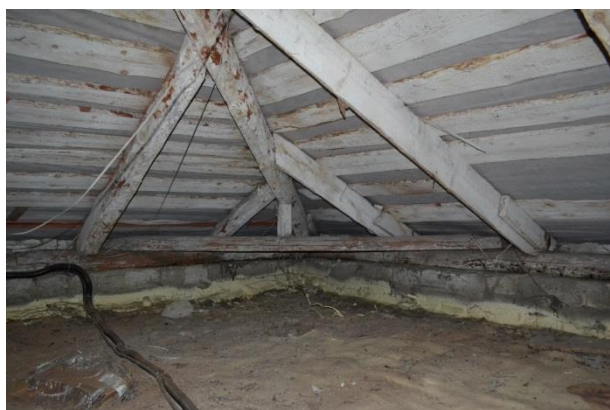
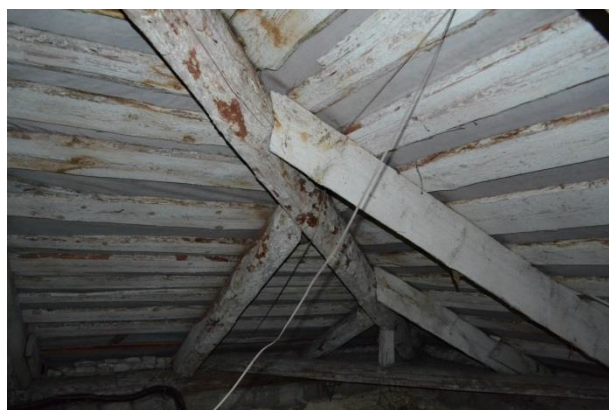
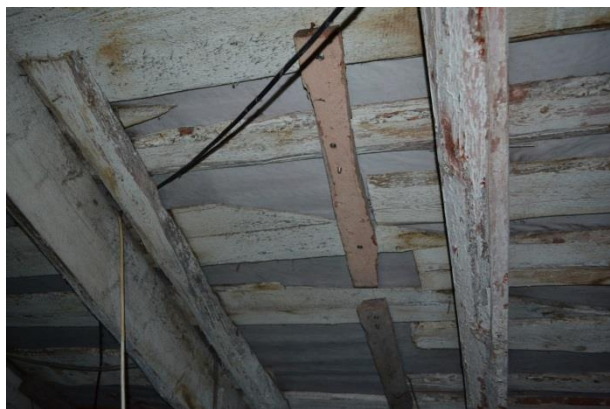
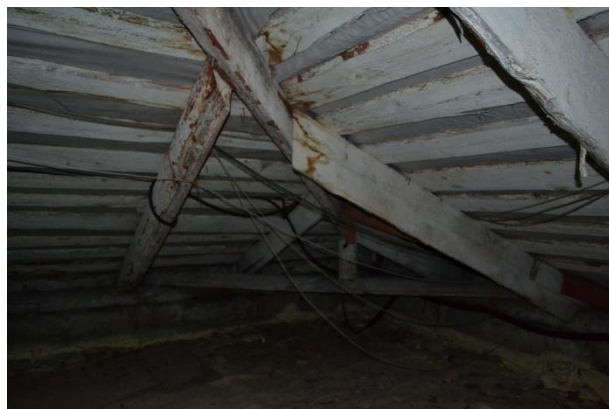
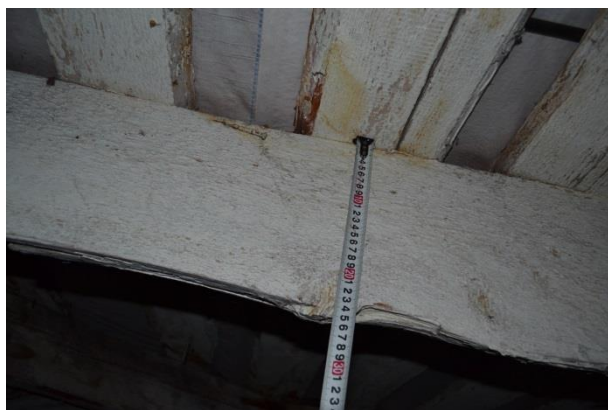
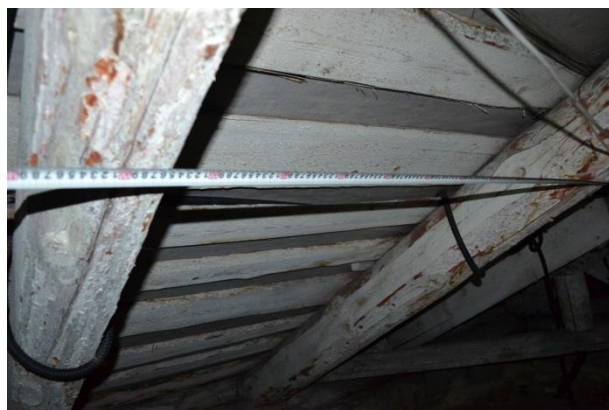
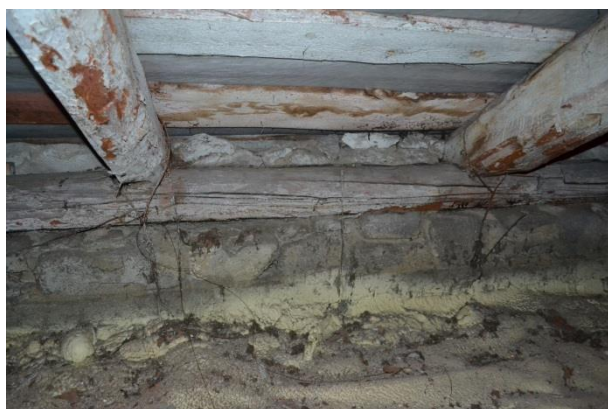
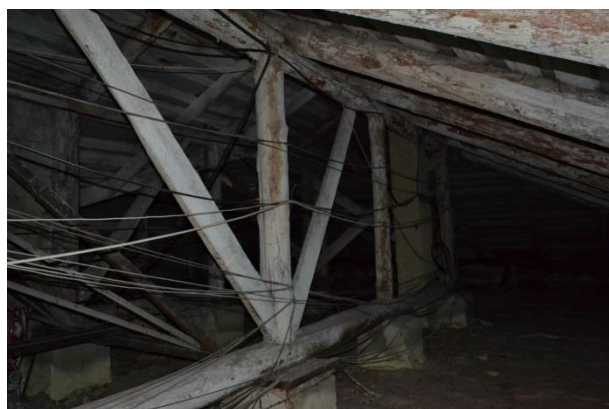
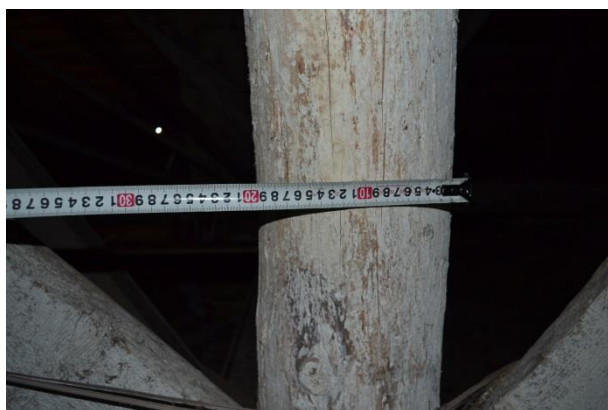
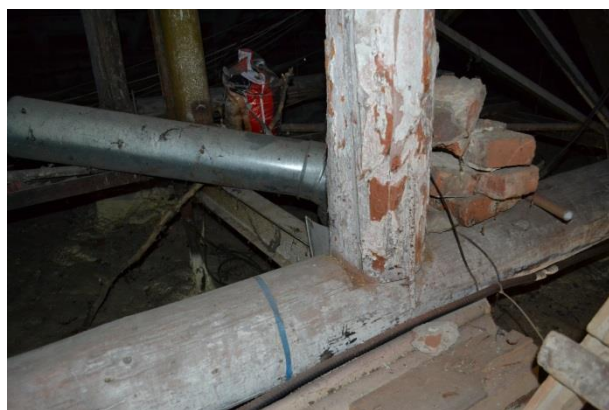
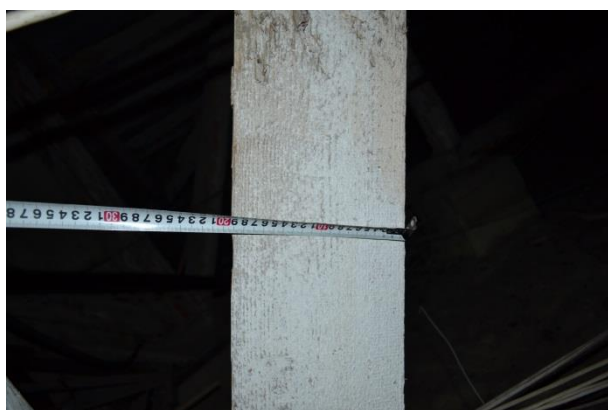
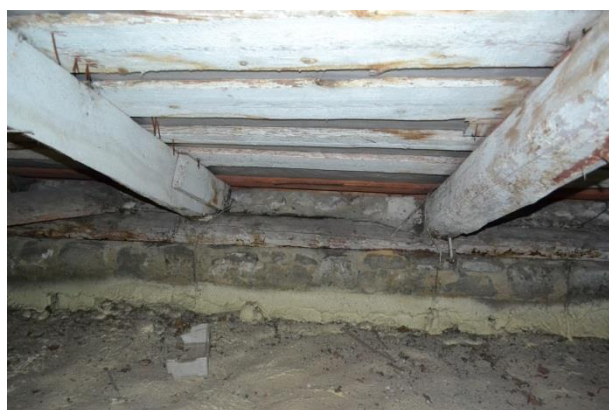
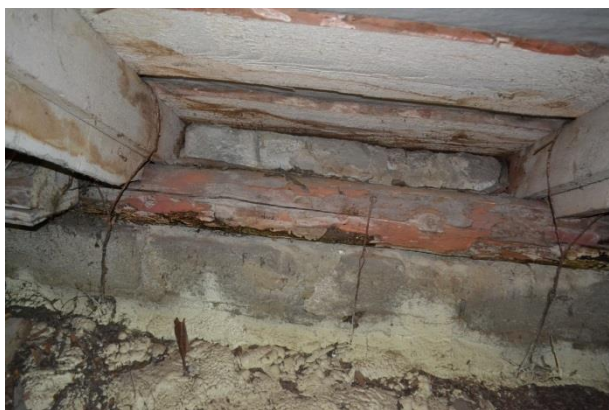
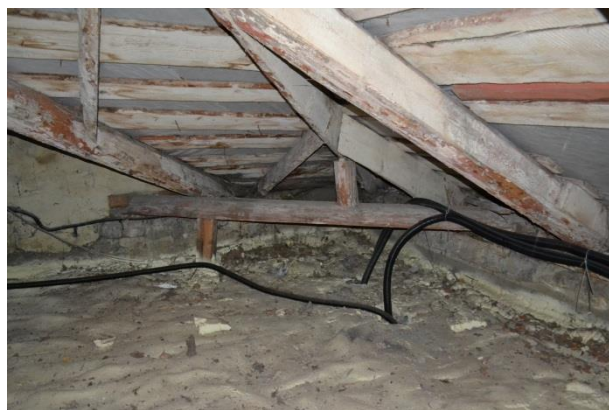
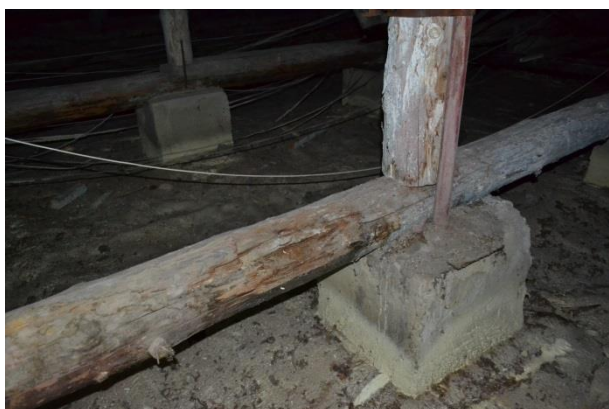
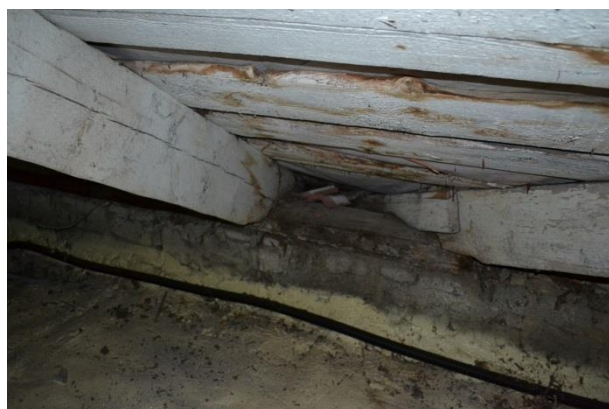
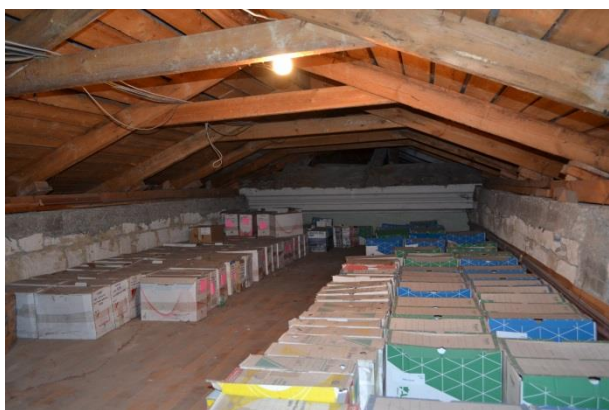
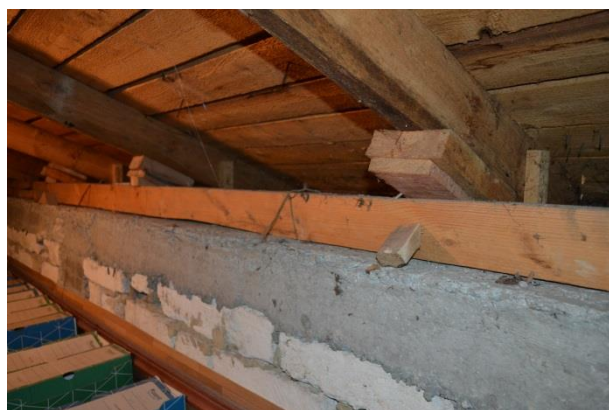
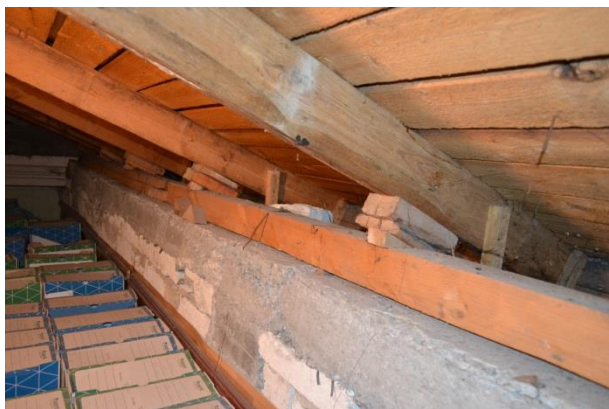
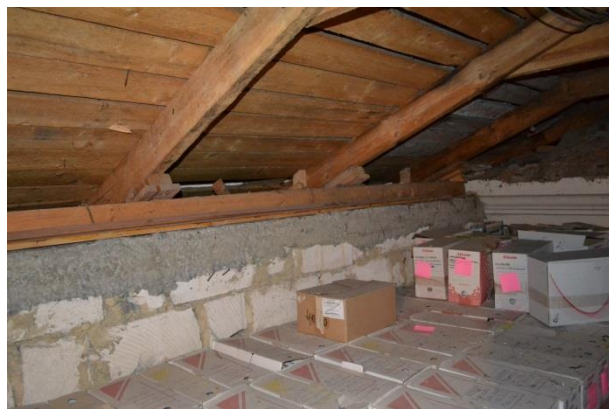
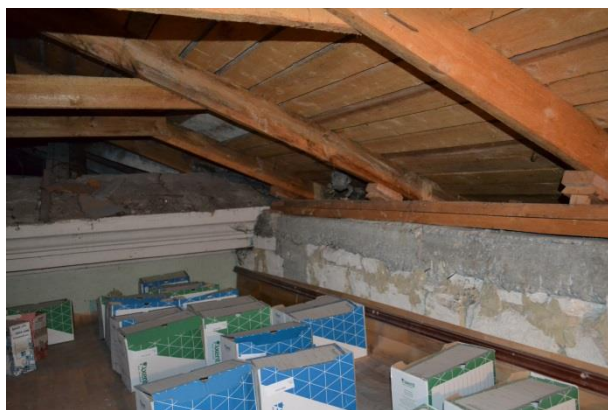
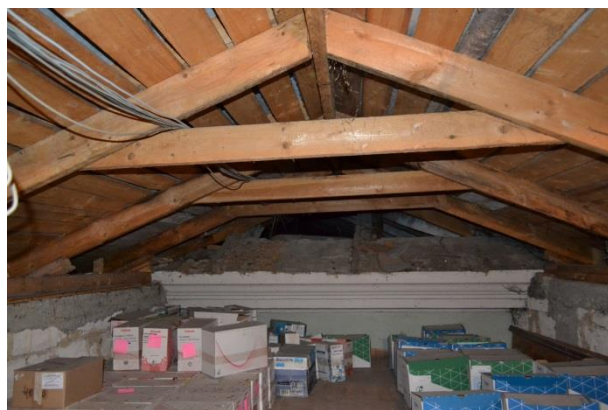
Starea tehnică a acoperișului și planșeului de pod:

We also mention that the term of operation of some structural elements (floors made of wooden elements) is exceeded, is highly worn, and the structural scheme, materials used do not meet the current normative provisions in force, as compared to the design requirements at the construction stage (lack of normative basis during the 50s of the XXth century).

Once the strengthening options is chosen, it is recommended to reconstruct the roof by dismantling the existing wooden structural elements and covering, and build a new structure in accordance with the normative requirements in force.
