No. 04-46/T

dated 21.07.2025

## REPORT OF EXPERT EXAMINATION No. 9998-06-25/T

**of the ‘UN House Moldova’ building –  
sector letter B1 located on the land plot  
with cadastral no. 0100520.040  
on 131, 31 August 1989 str., Chisinau municipality, in order to assess  
the technical condition following the collapse of a part of the floor  
above the ground floor.**

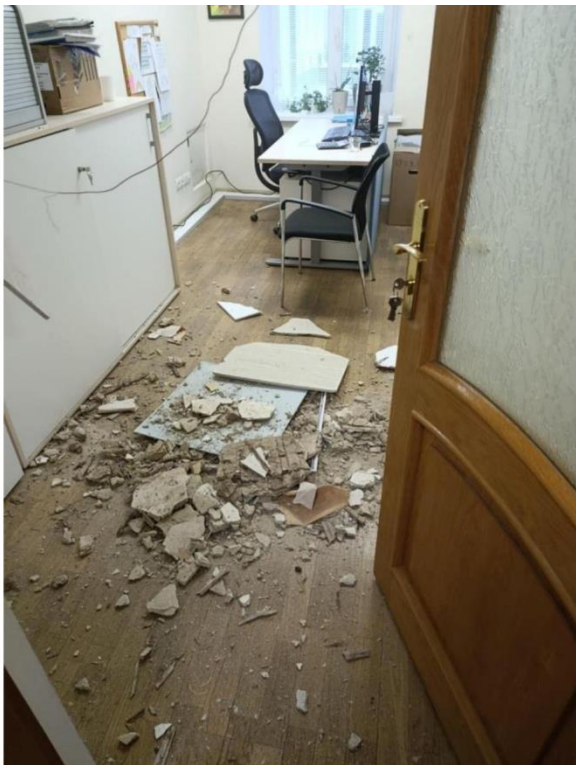
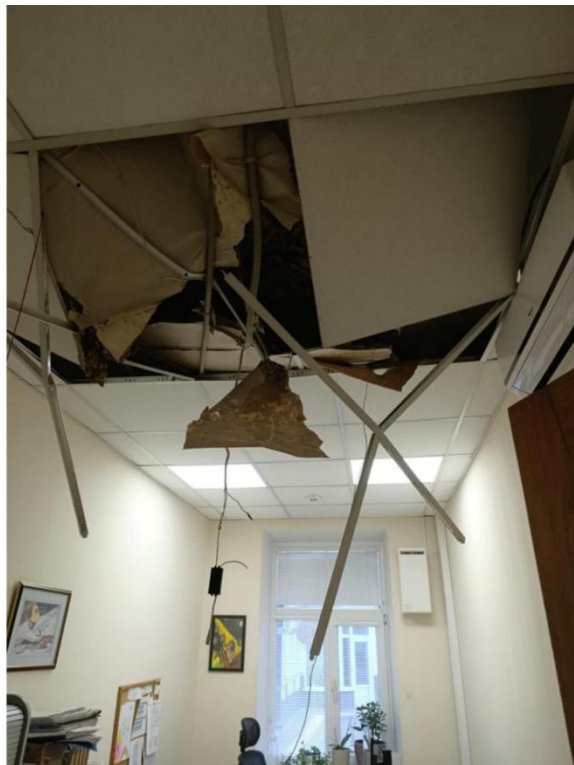
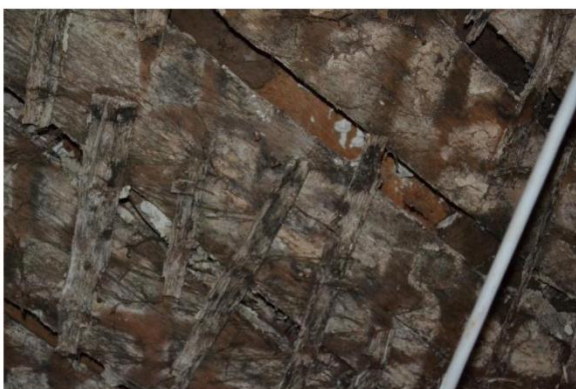
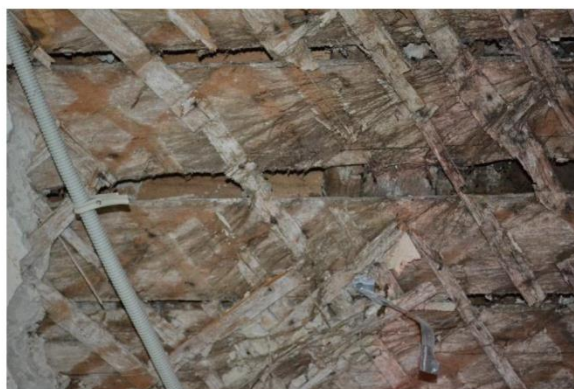
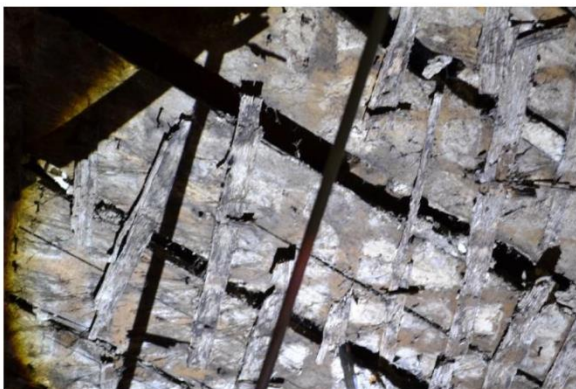
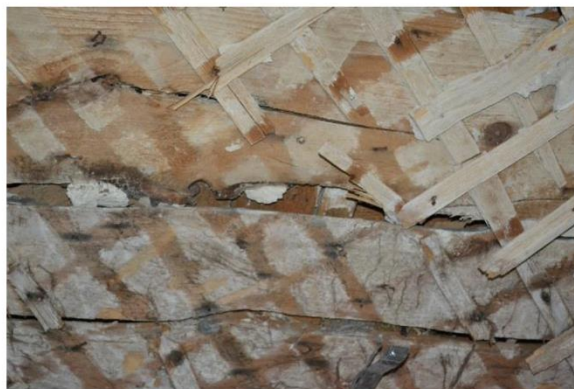
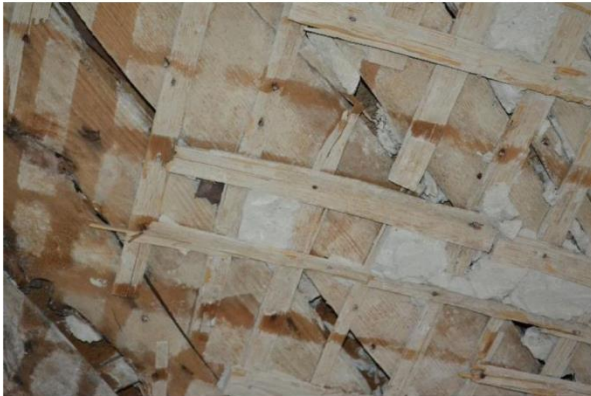
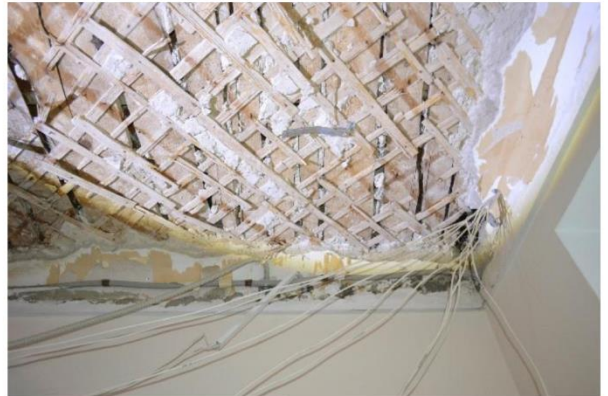
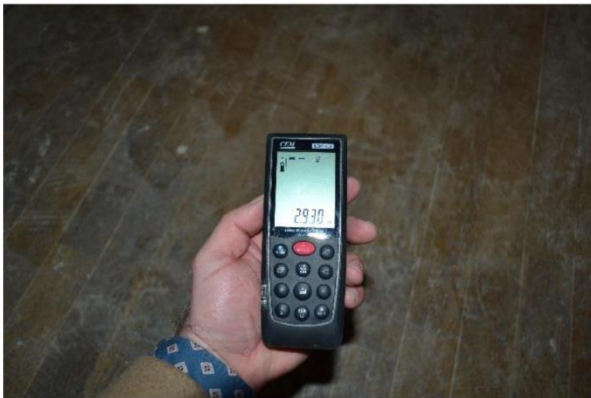
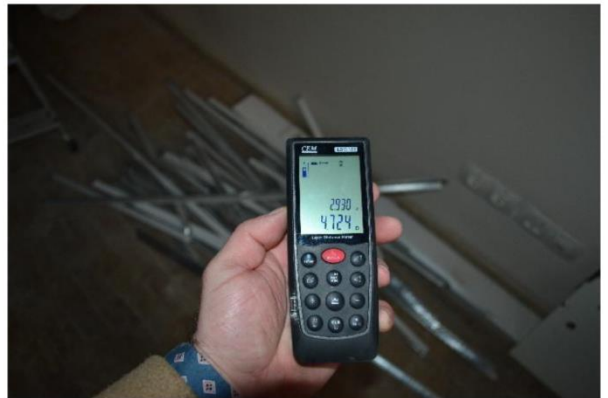
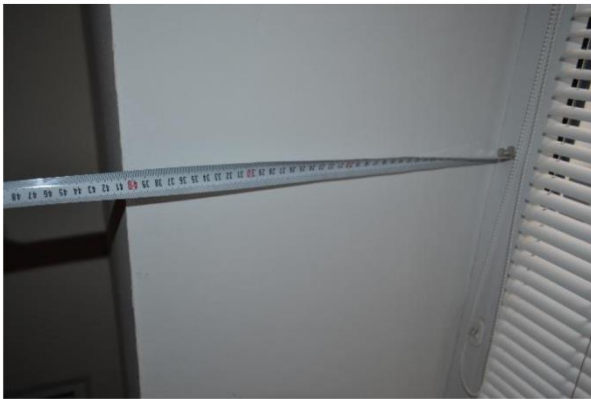
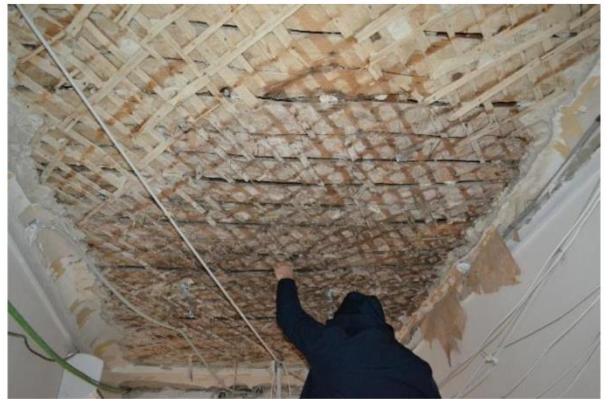
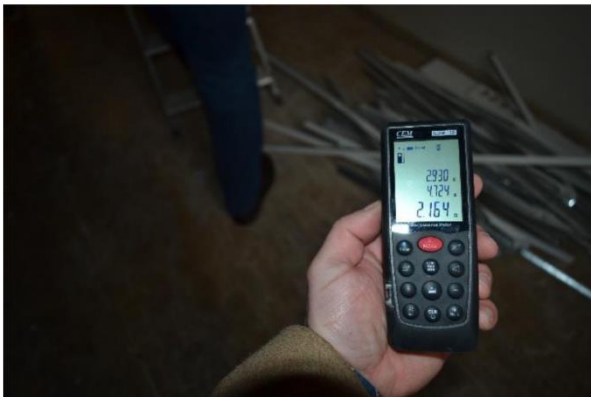
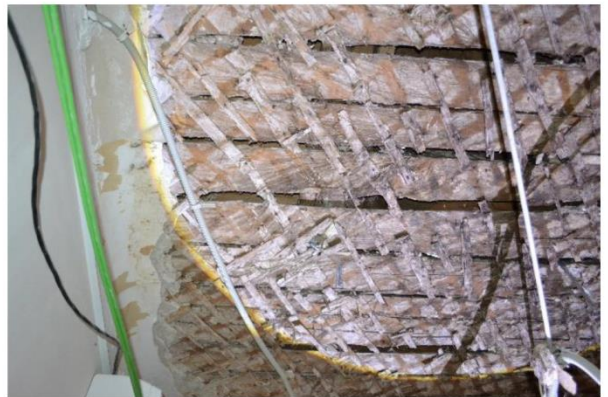
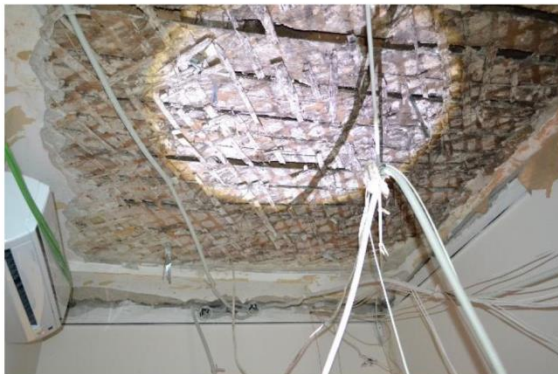
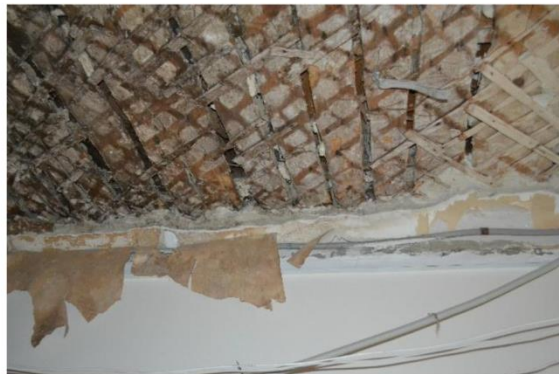
3. The intermediate floor (above the ground floor) of the examined part is in an ***unsatisfactory technical condition***. In March, a plastered part fell from the plastered ceiling on wooden shingles, covering an area of approx. 5.0m<sup>2</sup>. Additionally, noticeable vibrations are observed due to dynamic actions from the upper floor level of the building.

The plastered part on wooden shingles of the attic floor with an area of approx. 2.2x2.2m fell from the ground floor of the building due to rotten floor wooden structure and wooden beams as a result of rotting of the part concerned of the floor wooden structure (moistening before major repairs), due to worsening features of the load-bearing elements of the floor wooden structure and vibrations on the floor level of the building.

Foto.nr.1-16. Tavanul prăbușit. Alcătuirea planșeului între nivele. Elementele din lemn afectate de putrefacție:

- removal of the intermediate and attic floors (by well-established technological phases) and laying a new floor according to the technical requirements of the composition and the regulations in force for buildings located in areas with a seismic intensity of 8 (eight). The expert examination recommends building the attic floor with metal load-bearing beams and a monolithic reinforced concrete slab on corrugated sheet metal ('lost' formwork) or a monolithic reinforced concrete floor, with subsequent placement of a new thermal insulation layer above the attic floor made of efficient modern materials. The need for thermal insulation of the exterior walls will be determined based on the thermo-technical design. The thermal insulation works of the building will be performed in accordance with the requirements of the normative documents NCM E.04.01-2017, NCM E.03.02-2014 and CP E.04.02-2013;

6. Works of demolition (dismantling) of the elements of the attic floor shall be carried out subject to the occupational safety rules, using effective tools without damaging the structural elements, ensuring their further harmless operation. The demolition works shall be carried out by sectors. It is prohibited to throw concrete pieces from a height onto the surface of the lower intermediate floor. The work area shall be marked accordingly, limiting people's access to the building.

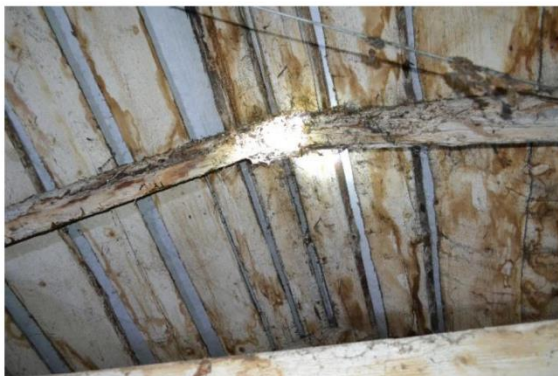
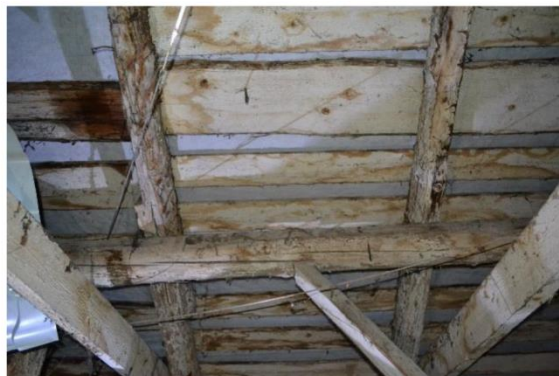
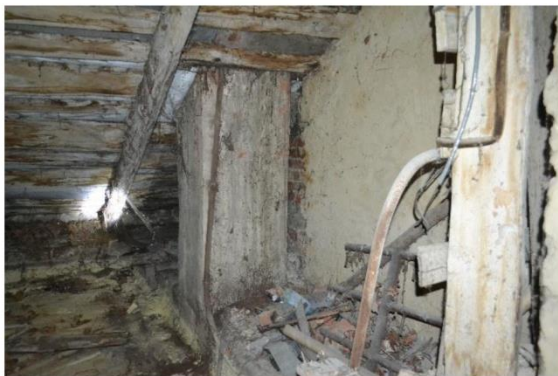
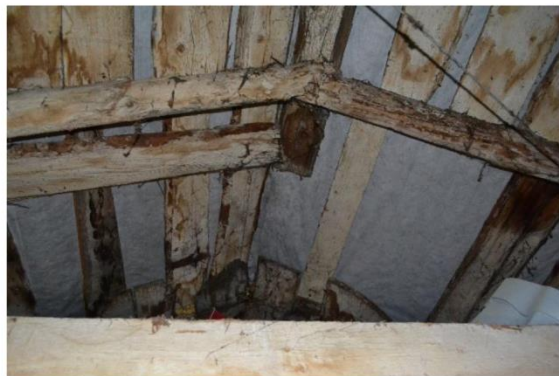
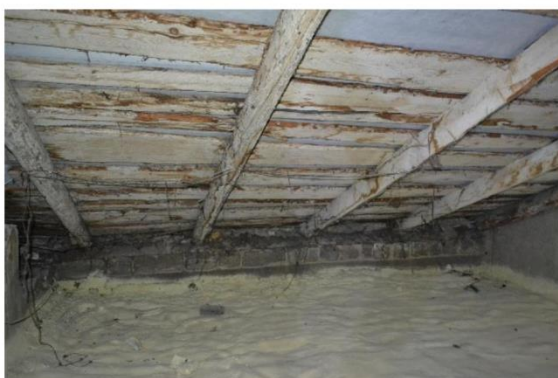
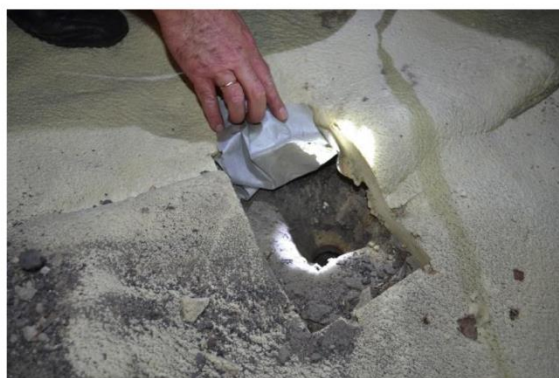
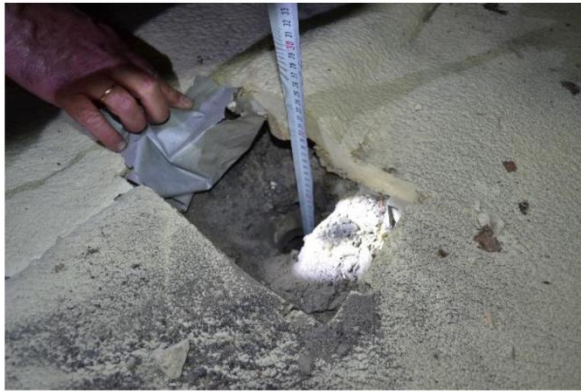
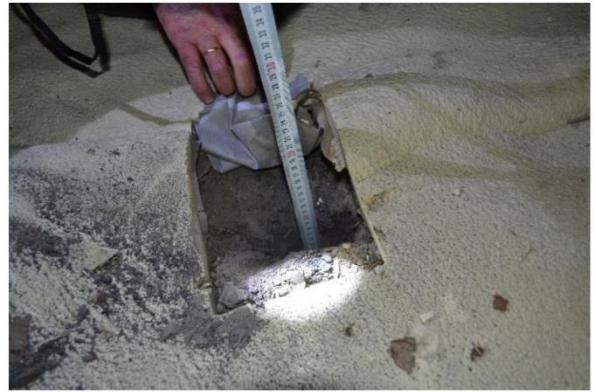
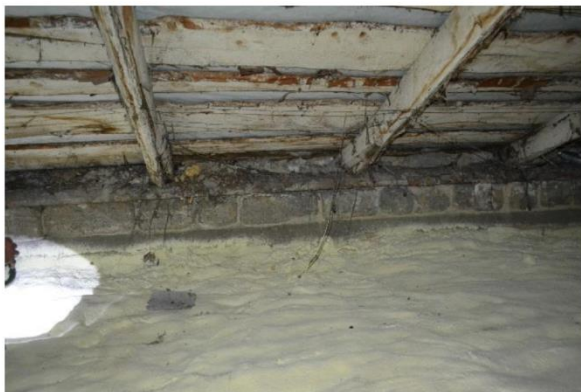
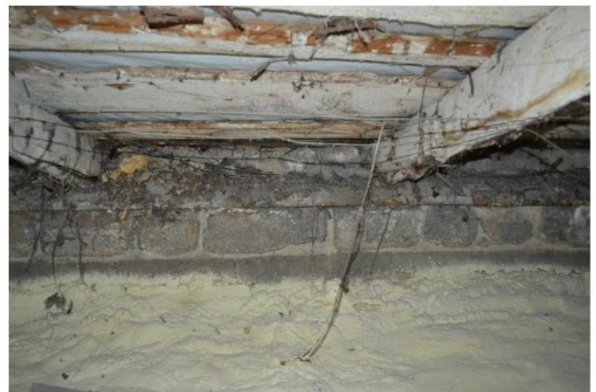
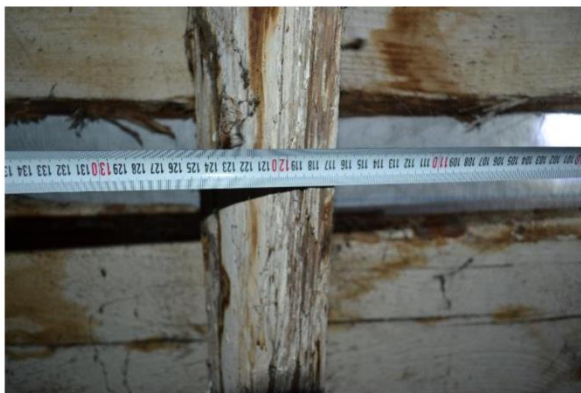
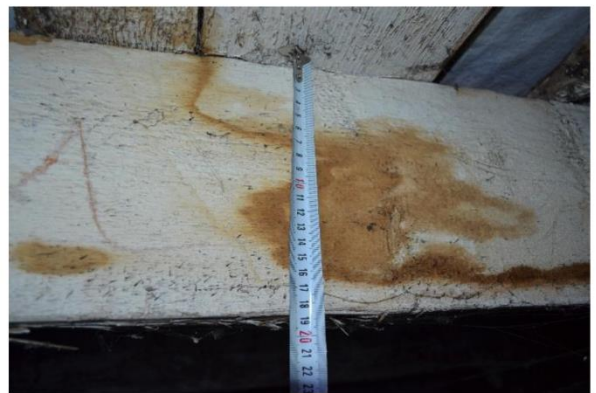
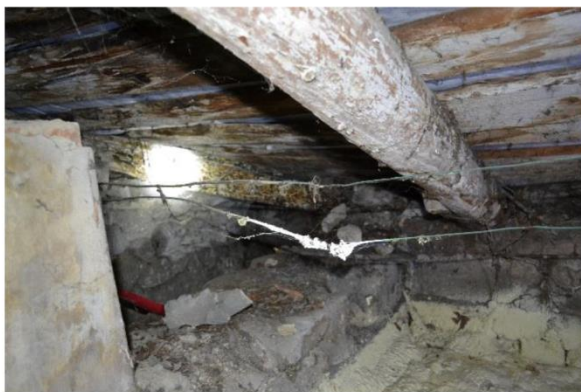
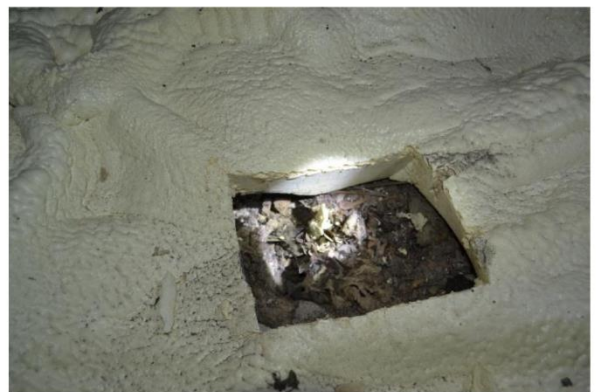
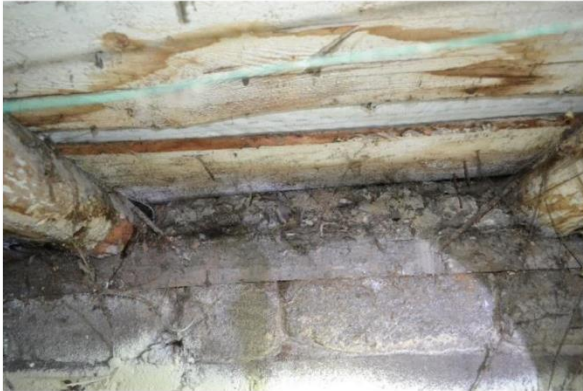
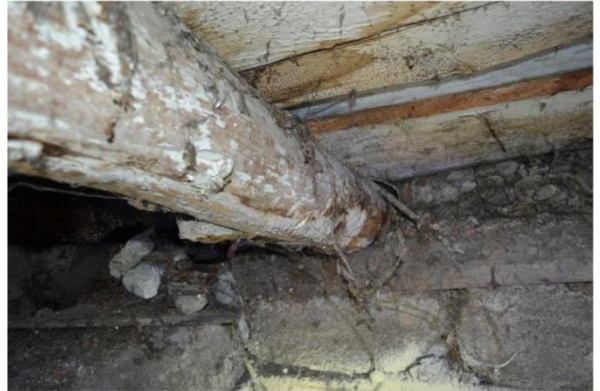
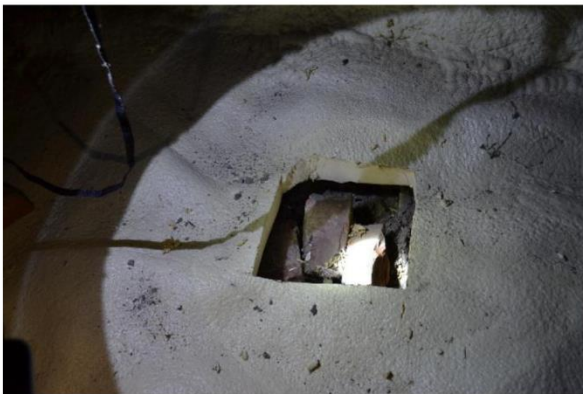
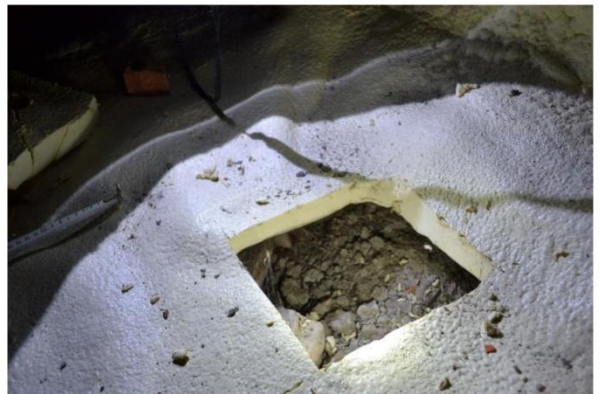
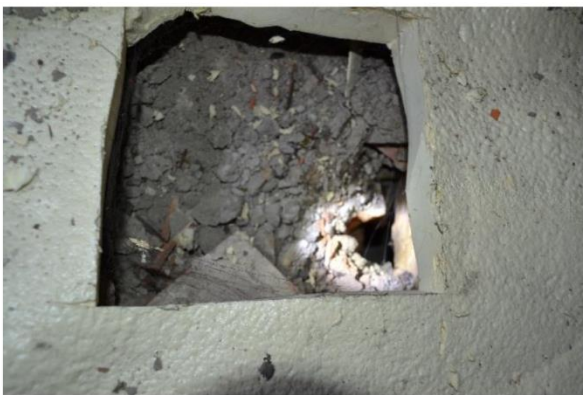
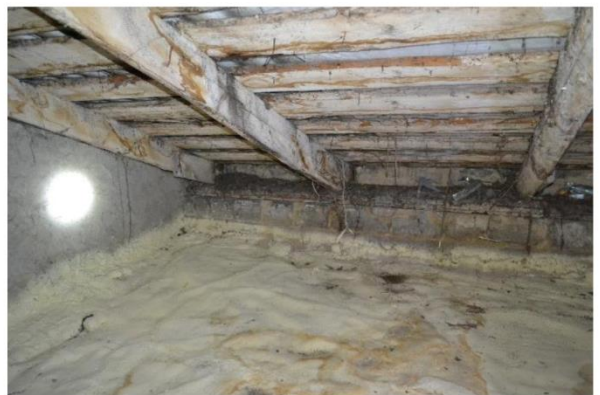
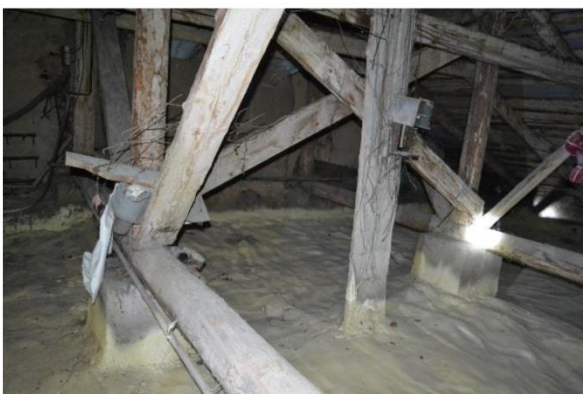
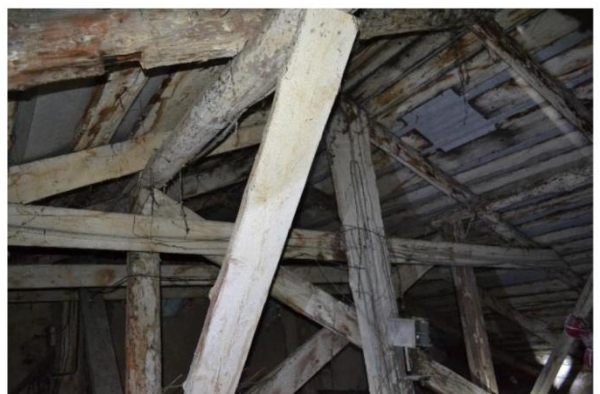
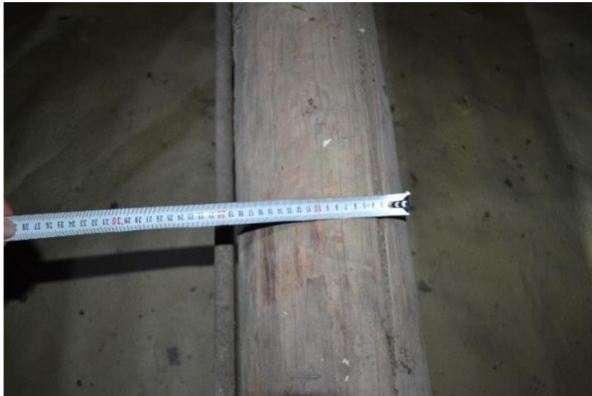
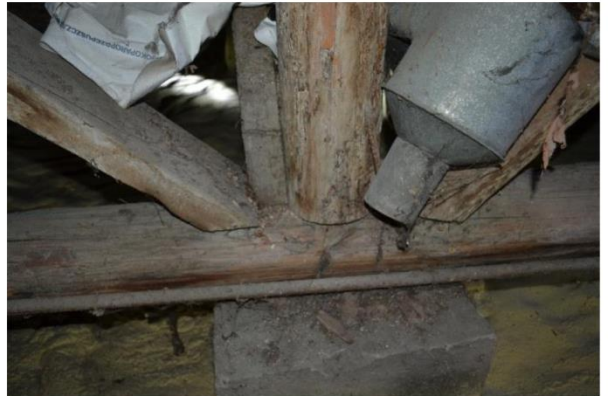
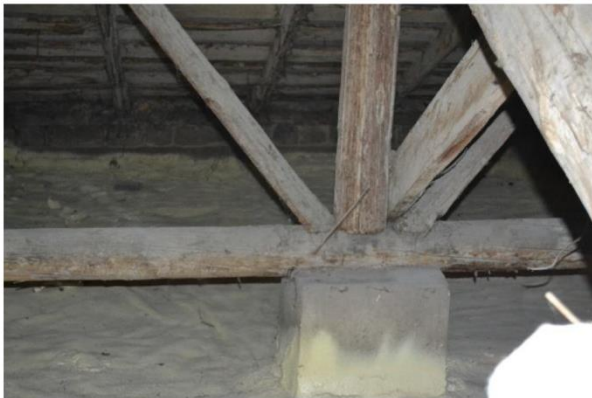
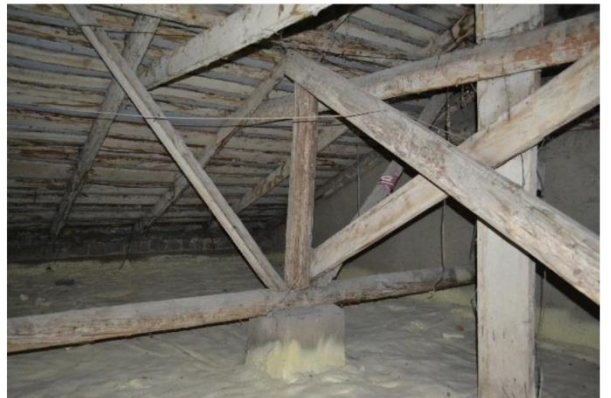
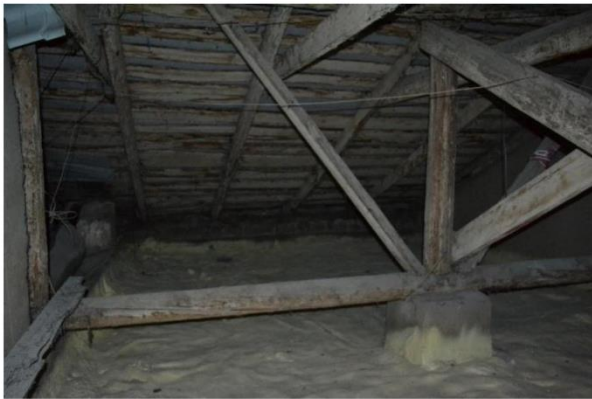
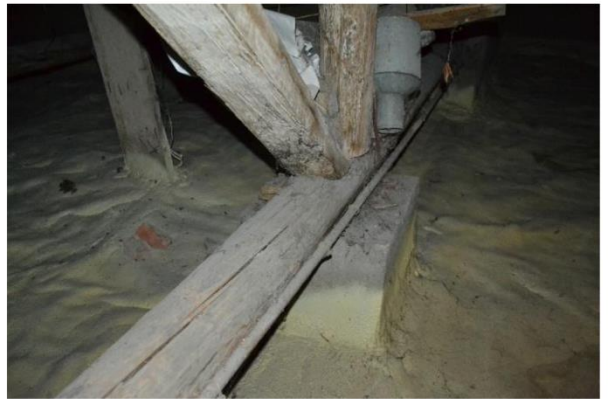
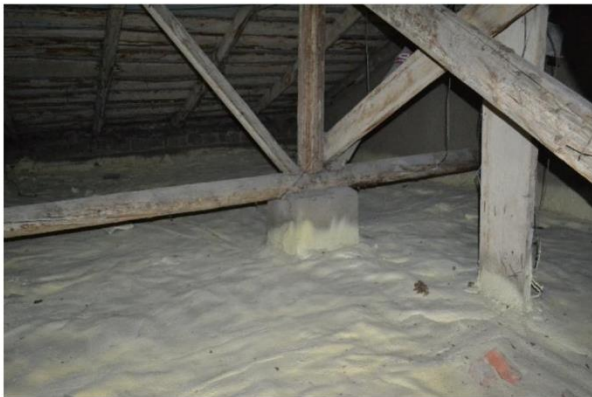
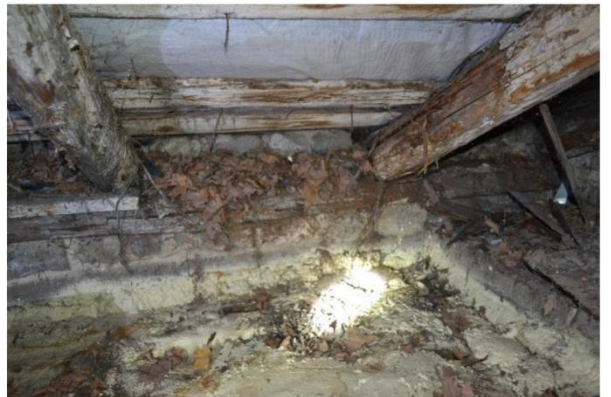
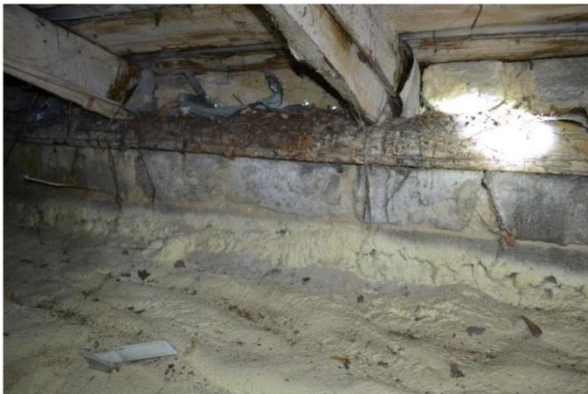
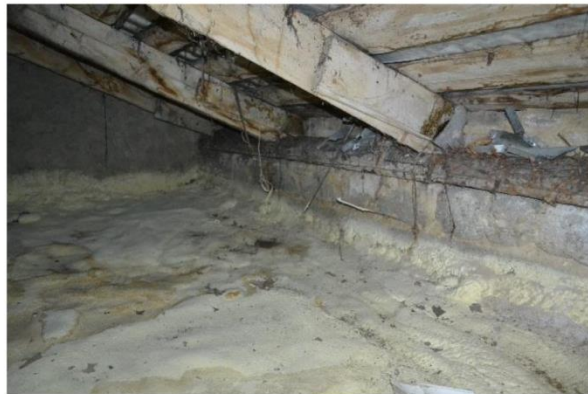
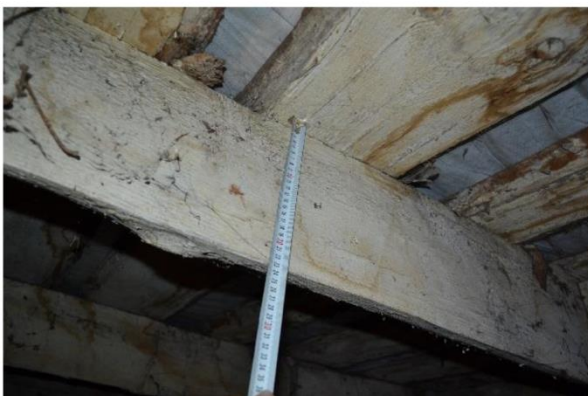
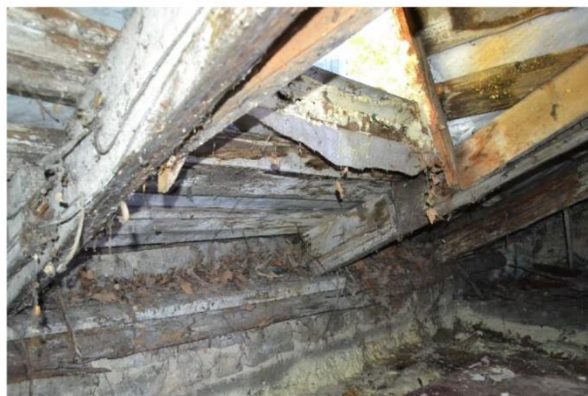
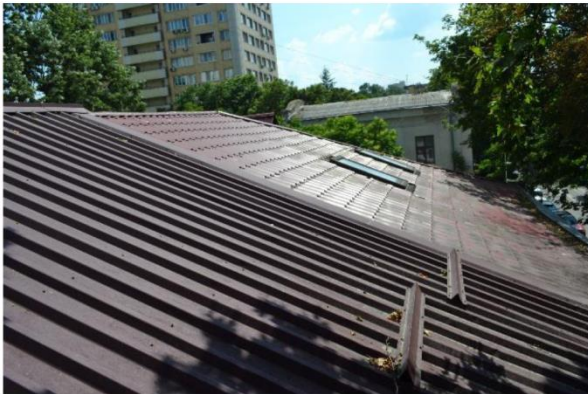
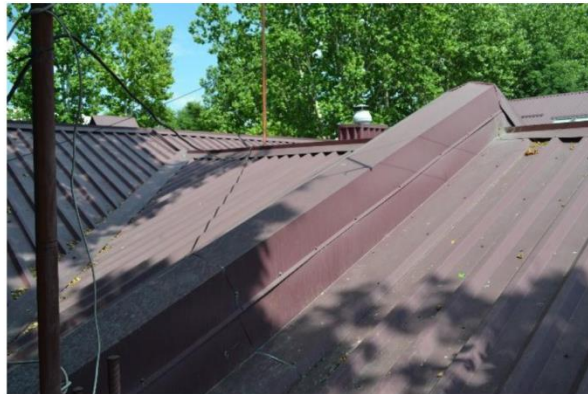
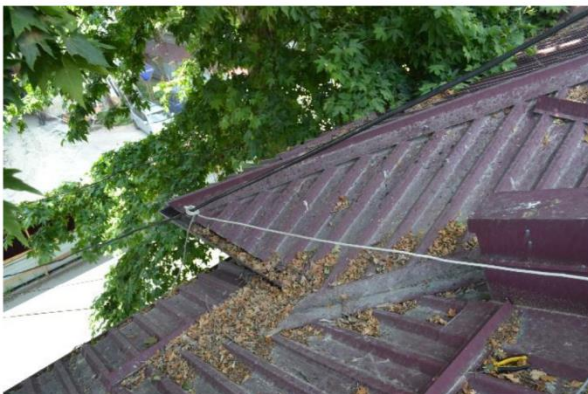
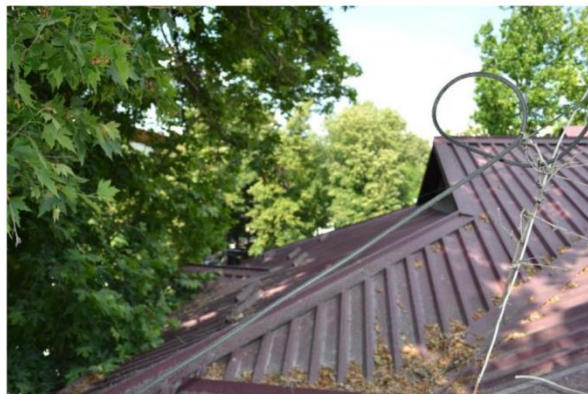
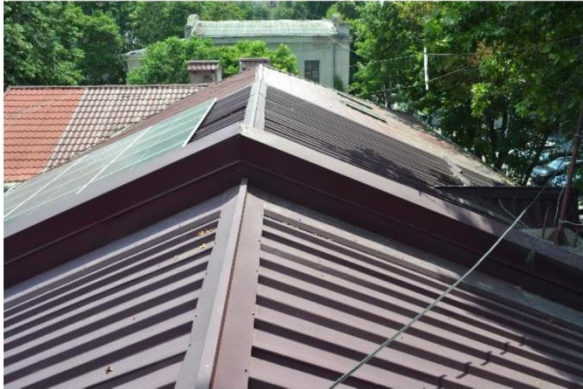
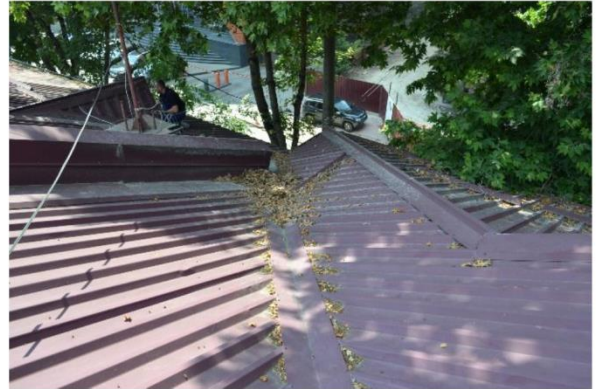
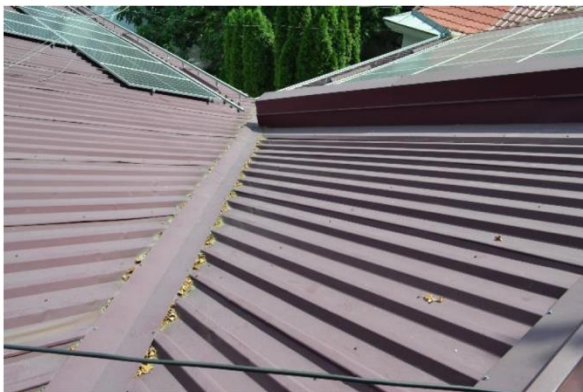
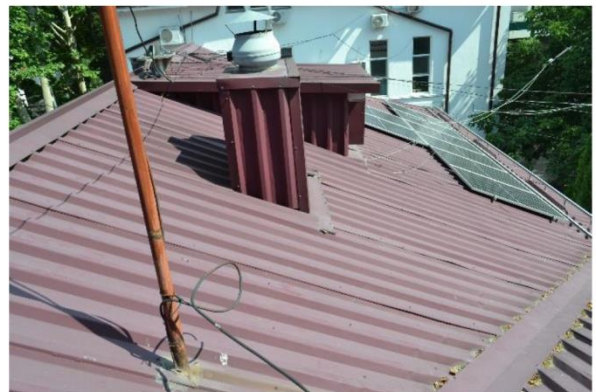
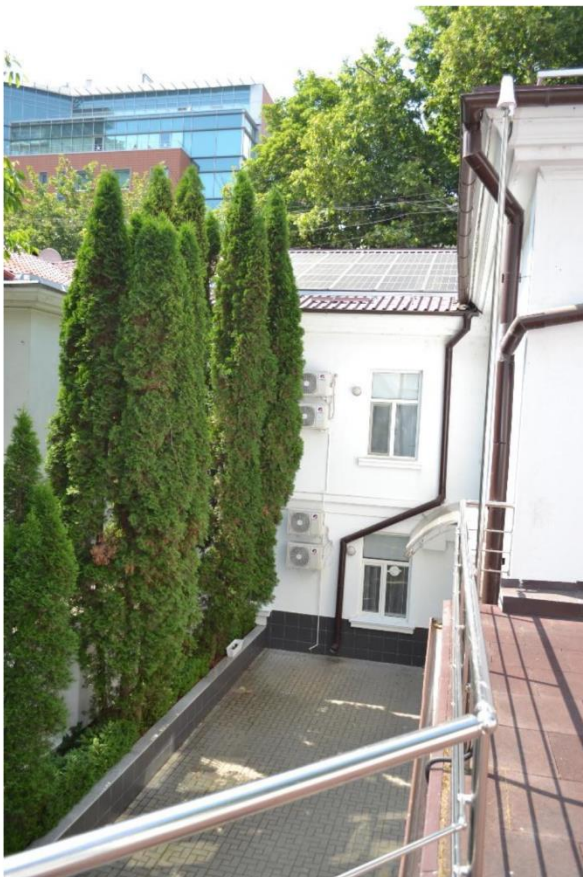
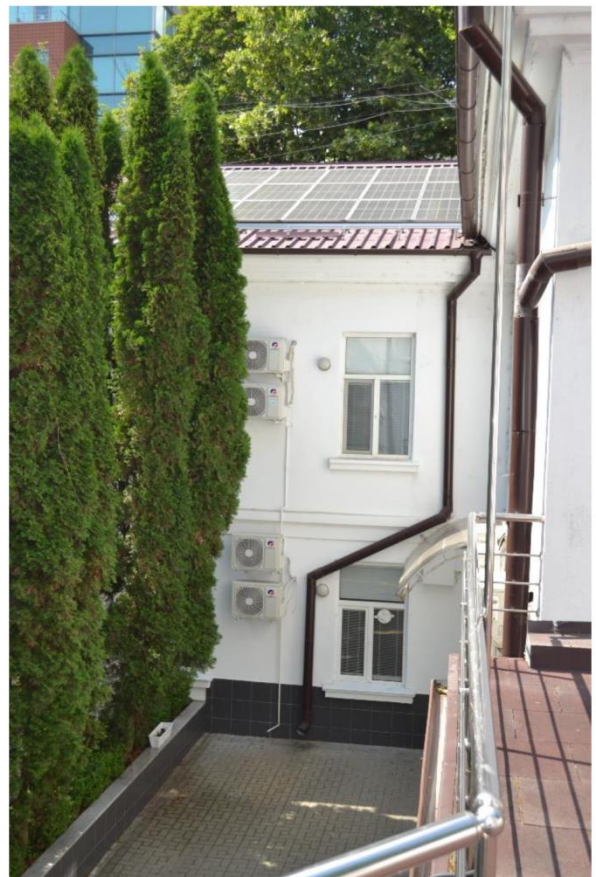
4. In addition to the area mentioned above, during the inspection of the intermediate and attic floors, curve deformations of the floor elements were observed. Additionally, many cracks on the lower part of the ceiling surface (under the ceiling cladding), local damage and falling plaster (see Schedule A4, photo materials) were noticed.

8. The multi-slope truss-type roof of the building is in partially satisfactory technical condition, the structural elements do not show obvious deformations such as inadmissible deflections and/or displacements from the design position. The load-bearing structure of the roof is made of solid wood elements and timber elements (plates, beams, rafters with battens, and vertical and diagonal posts), with roofing made of tiles and corrugated sheets laid on wooden sheathing (see Schedule A4, photo materials). The joints between the elements of the load-bearing structure of the roof are made by means of twisted wire ties, nails and metal clamps, while some elements (plates and posts) are freely supported on the load-bearing elements (walls, attic beams). The expert examination reports that the joints of the load-bearing structure elements of the roof partially comply with the requirements of the current regulations of the Republic of Moldova. During the works of changing the roof covering, no joints were reinforced, and the wooden material from the old roof structure was not treated with antiseptic and fire retardant solutions, in accordance with the requirements of NCM E.03.02-2014.

It should be noted that the characteristics of the wooden material of the roof changed as a result of sectoral rotting, sawn wood, decay, etc. and it is recommended to reconstruct the roof in accordance with the regulatory requirements in force.

Foto.nr.17-60. Alcătuirea planșeului de pod și șarpantei acoperișului.

- reconstruction of the existing roof in accordance with the requirements and technical regulations in force – *recommended in the future*;
- revision of the roof load-bearing structure, with strengthening (if necessary, replacement) of the elements destroyed by rainwater (recommended);

- connection (bringing) of the roof load-bearing structure to the minimum composition requirements, including earthquake- and fire-resistant ones (recommended);

- processing of the wooden material of the roof structure with antiseptic and fire-retardant solutions, in accordance with NCM E 03.02.2014 (recommended);
