CLIENT: European Union Delegation to Moldova through its operational contractor UNDP

Technical Expertise and develop Detailed Technical Design for CONSERVATION AND RESTORATION WORKS OF BENDER FORTRESS (Phase I)

DETAILED TECHNICAL DESIGN

TITLE:
EXPLANATION NOTE

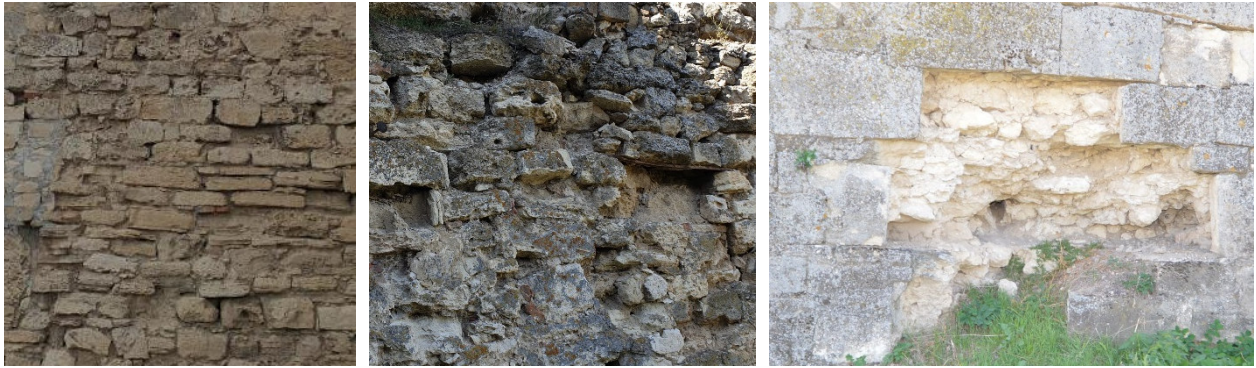
The first stage of decay is the **loss of mortar joints**, usually caused by the washing away of rainwater, freeze-thaw cycles and erosion of atmospheric agents.

The infiltrations and the progress of the decay phenomena of the mortars often cause the **loss of single stones** or even the **swelling and the collapse of portions of the walls**. Even the presence of shrubby vegetation, especially when very rooted, can cause the detachment of stones.

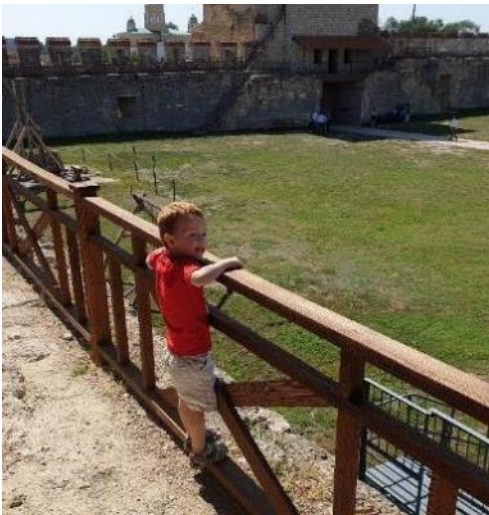
New railings will be installed to ensure the safe use of visitors (avoiding dangerous situations such as the one in the photo).

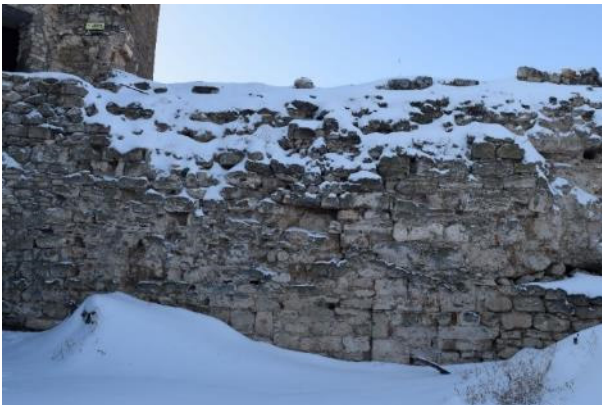
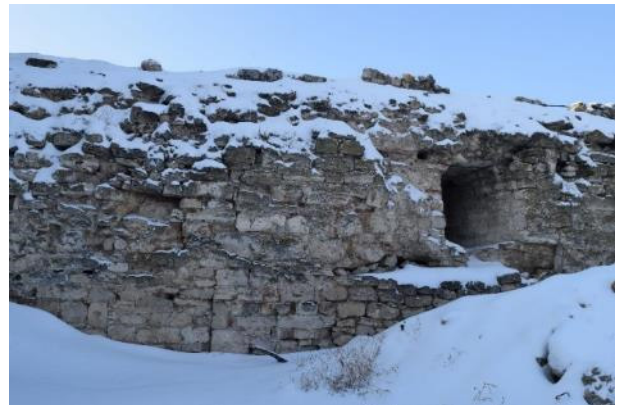
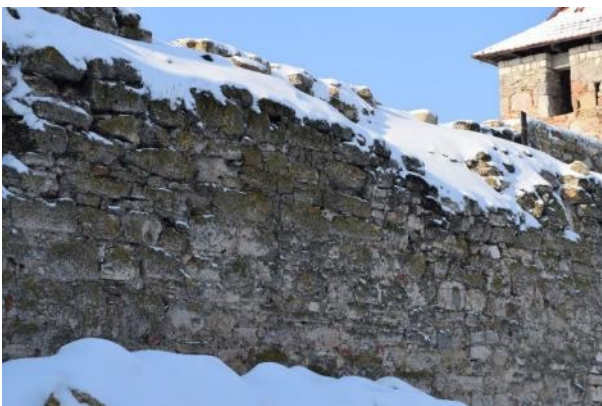
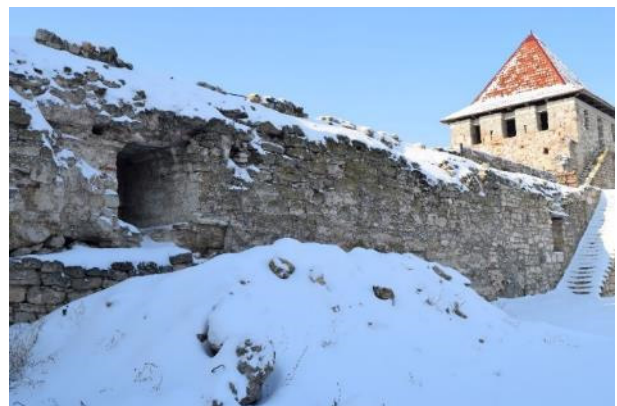
The images below refer to the state of conservation of masonry between towers A2 and A3 internal side. They show well the masonry collapses, the weed vegetation, the partial absence of wall facing and the extensive deterioration of the patrol path.

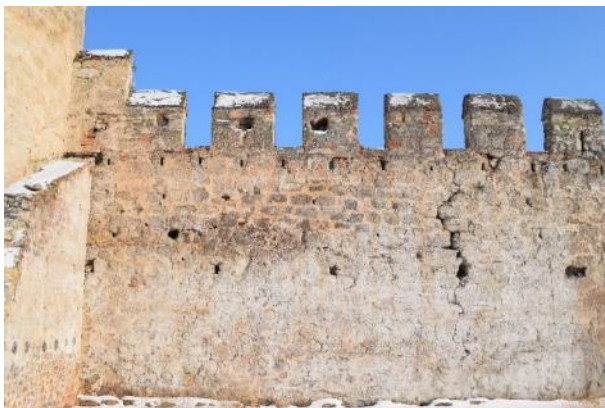
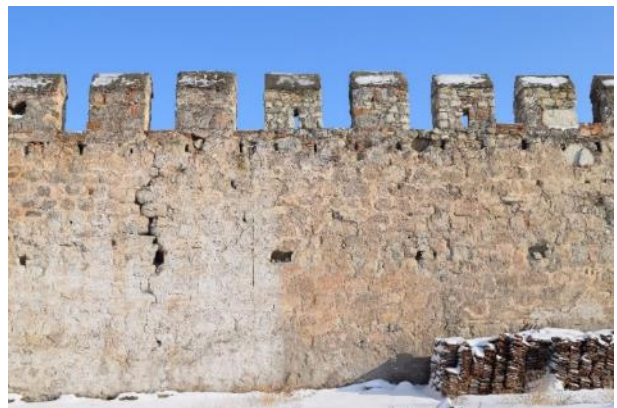
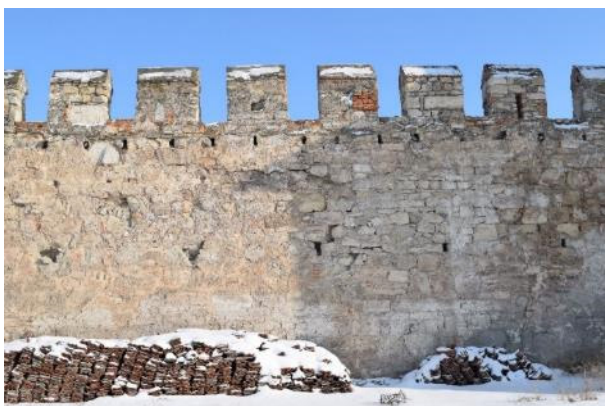
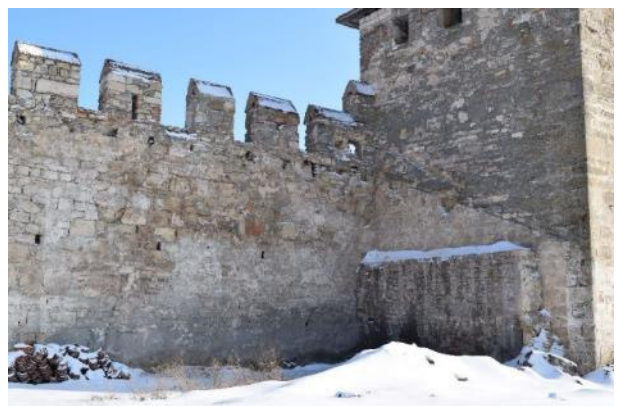
The images below refers to state of conservation of masonry between towers A3 and A4 external side.

All surface deposits and weeds must be cleaned, taking care that the top of the historical masonry still preserved is not damaged. The restoration of the stone surfaces must follow the indications of the specific chapter below. The reconstruction of the patrol route propose the same shapes of the adjacent portions remained intact and guarantees the aesthetic continuity of walkways, and it must be distinguishable from the historical masonry on which it rests. This may occur, for example, using stones of different sizes from the original, or using natural hydraulic mortars (without cement) of a slightly different color than the original ones.

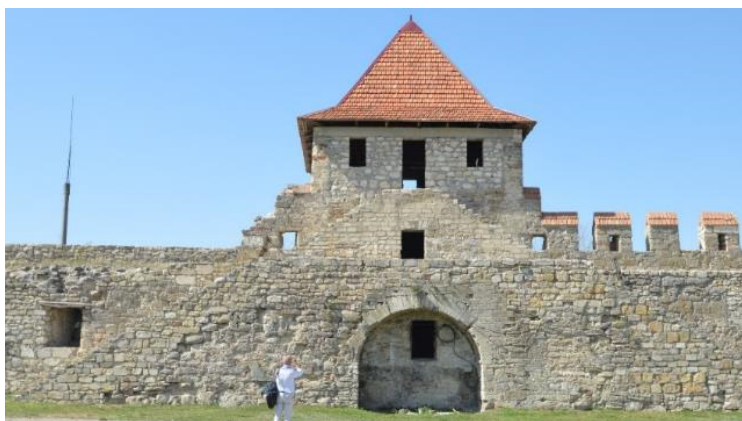
Tower A3: current situation

In the case of the **built elements that were added in more recent phases**, we particularly include the closure of the inner side of the middle towers, such as the A3 tower, with new masonry in the 19th century. In addition, it is impossible to remove this element without risk of damage to the historic walls; therefore, we have decided to mitigate the visual impact of this recent transformation through the disposition of a layer of plaster, composed by natural hydraulic mortar filled with local sand and small pebbles, as shown in the following images. **It is important to underline that the interventions in this chapter aim to solve critical issues caused by recent incompatible works. This type of works should never again be performed on the fortress, we refer in particular to the construction of elements that never existed and to the use of incompatible materials such as reinforced concrete.**

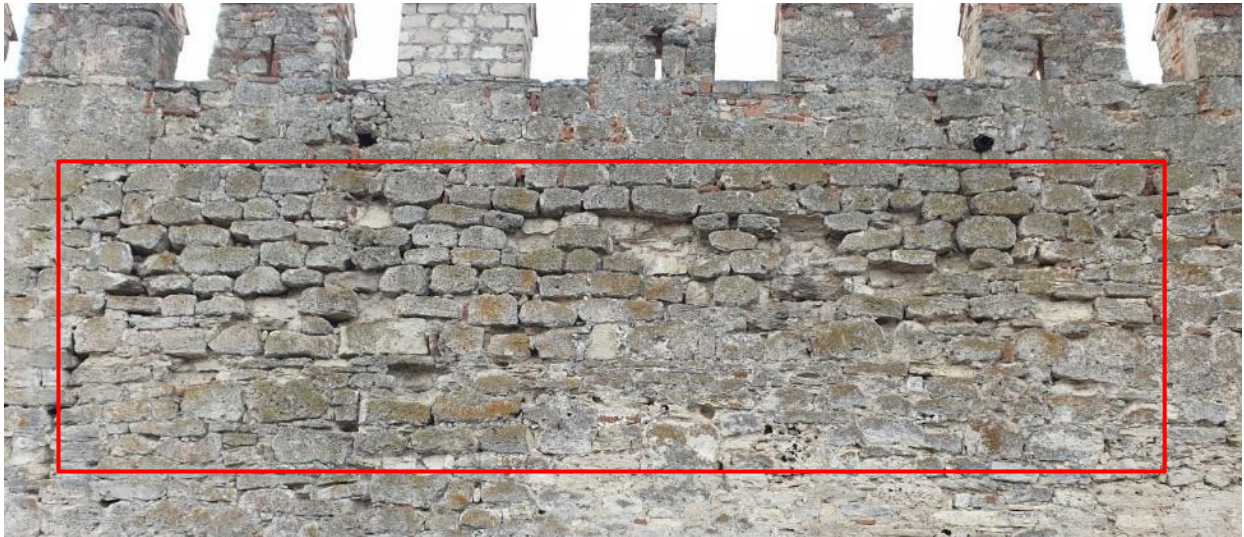
In this case, there could be a further motivation: the loss of the timber frame inside the walls and the presence of these large voids has probably weakened the core of the masonry facilitating the degradation and the detachment of the facing stone.

Local loss of mortar joints and loss of some stones

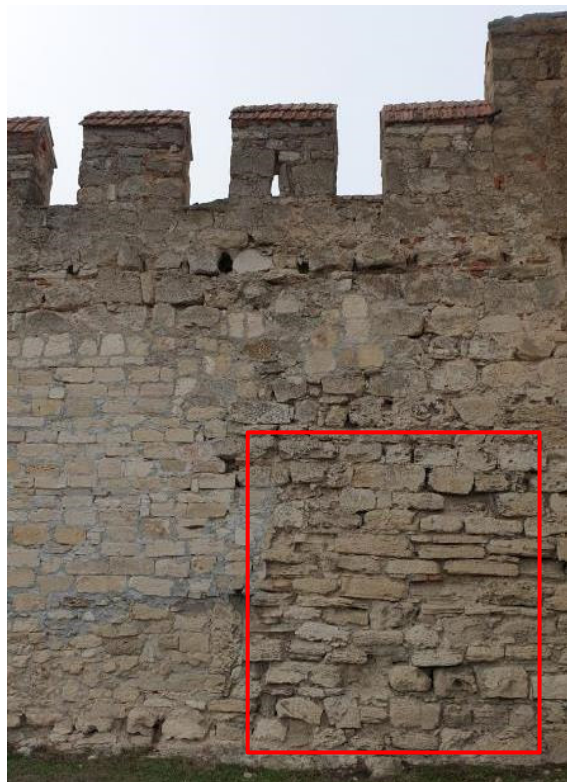
Loss of joints, degradation of stone facing, loss of stones

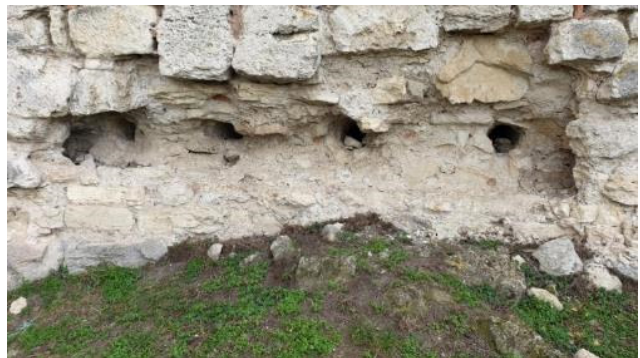
Collapse and local loss of the stone face at the voids left by the lost wooden net

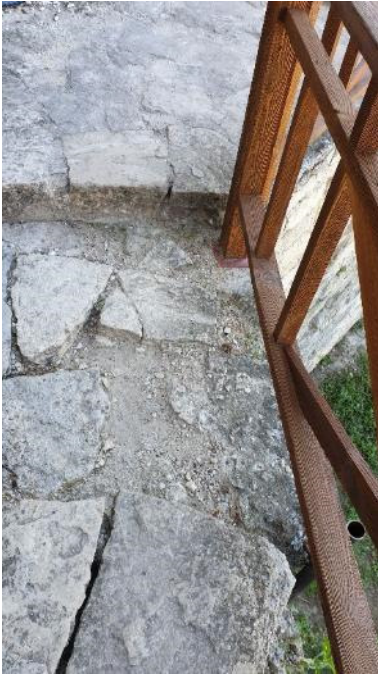
Actual situation of walkways

The intervention described in previous paragraph 6.1.1 must be extended to the entire patrol walkway.

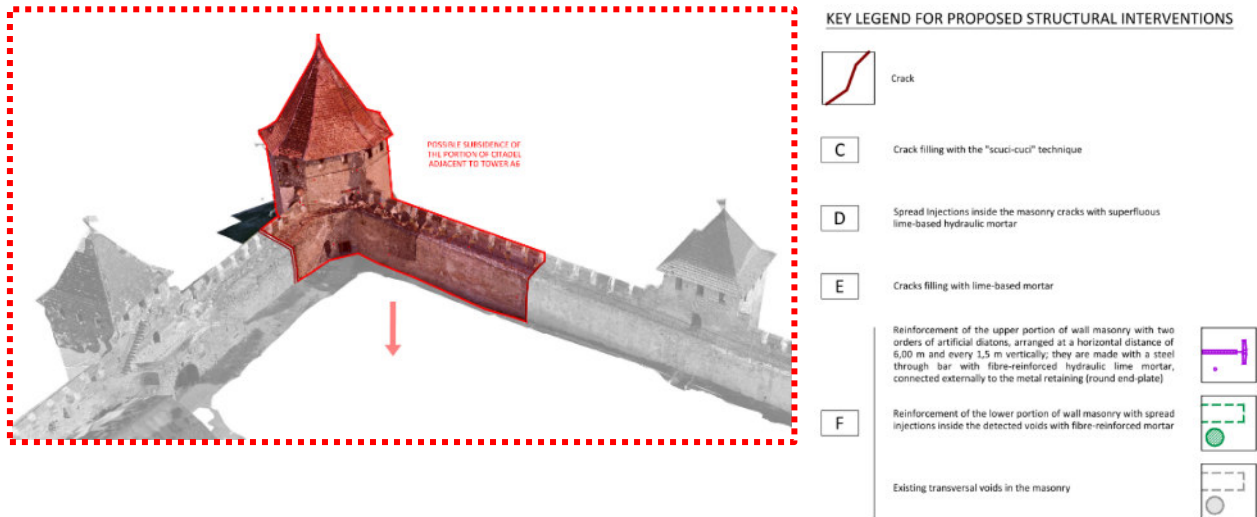
Interpretation of the damage mechanism of the portion of the citadel adjacent to Tower A6, probably consisting of a ground subsidence.

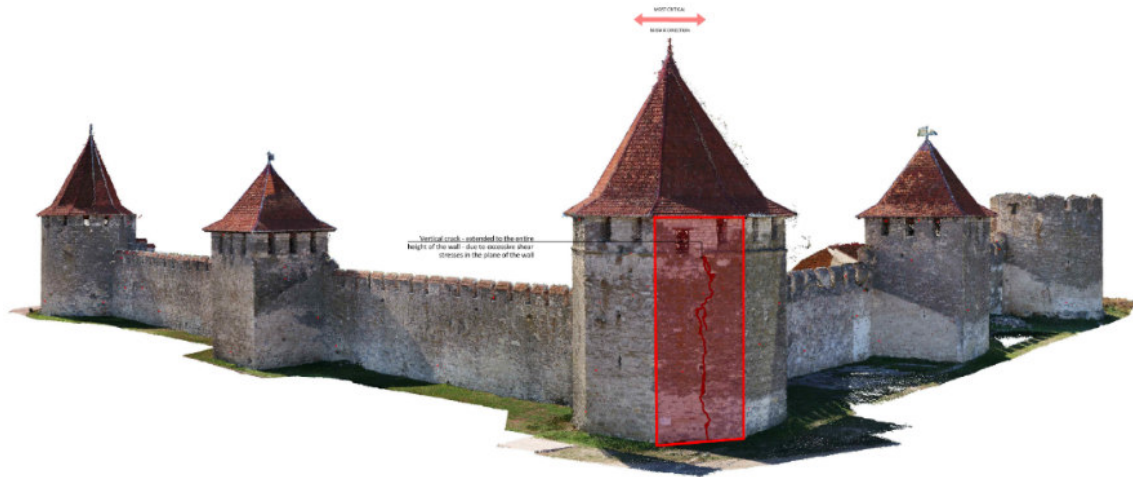
Reinforcement interventions are necessary to statically consolidate the tower after the manifestation of very large vertical cracks in the center of some walls of the tower, due to the typical lesions affecting lean structures such as towers and bell towers.

Vertical crack - extended to the entire height of the wall - due to excessive shear stresses in the plane of the wall in the most critical direction of the earthquake

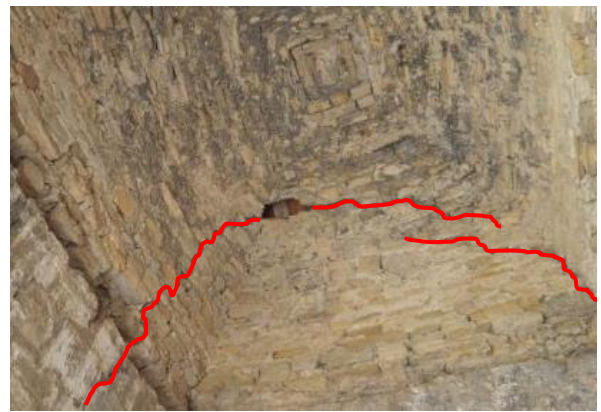
Masonry cracks show the activation of a kinematic mechanisms due to the thrust of the vaults combined with a ground subsidence.

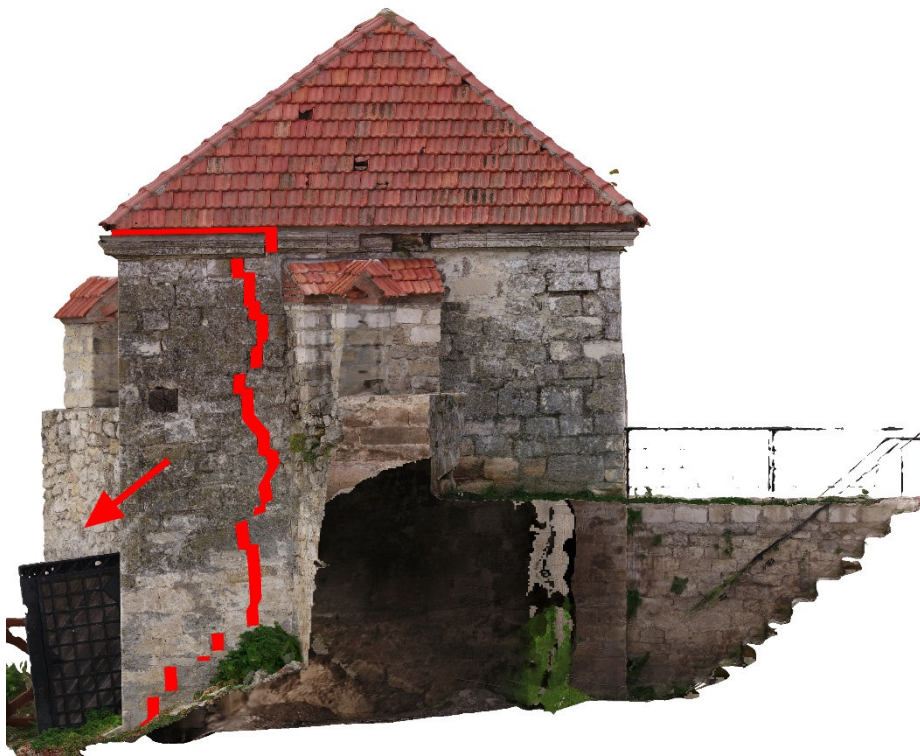
Masonry cracks could be linked to a combination of two main structural failures: the rotation of the façade due to the thrust of the vault (1) and a ground subsidence (2). The result is a shift of the wall in the direction of the ground slope (3).
