Technical Expertise and develop Detailed Technical Design for CONSERVATION AND RESTORATION WORKS OF BENDER FORTRESS (Phase I)

DETAILED TECHNICAL DESIGN

ARCHITECTURAL INTERVENTIONS

DETAILS

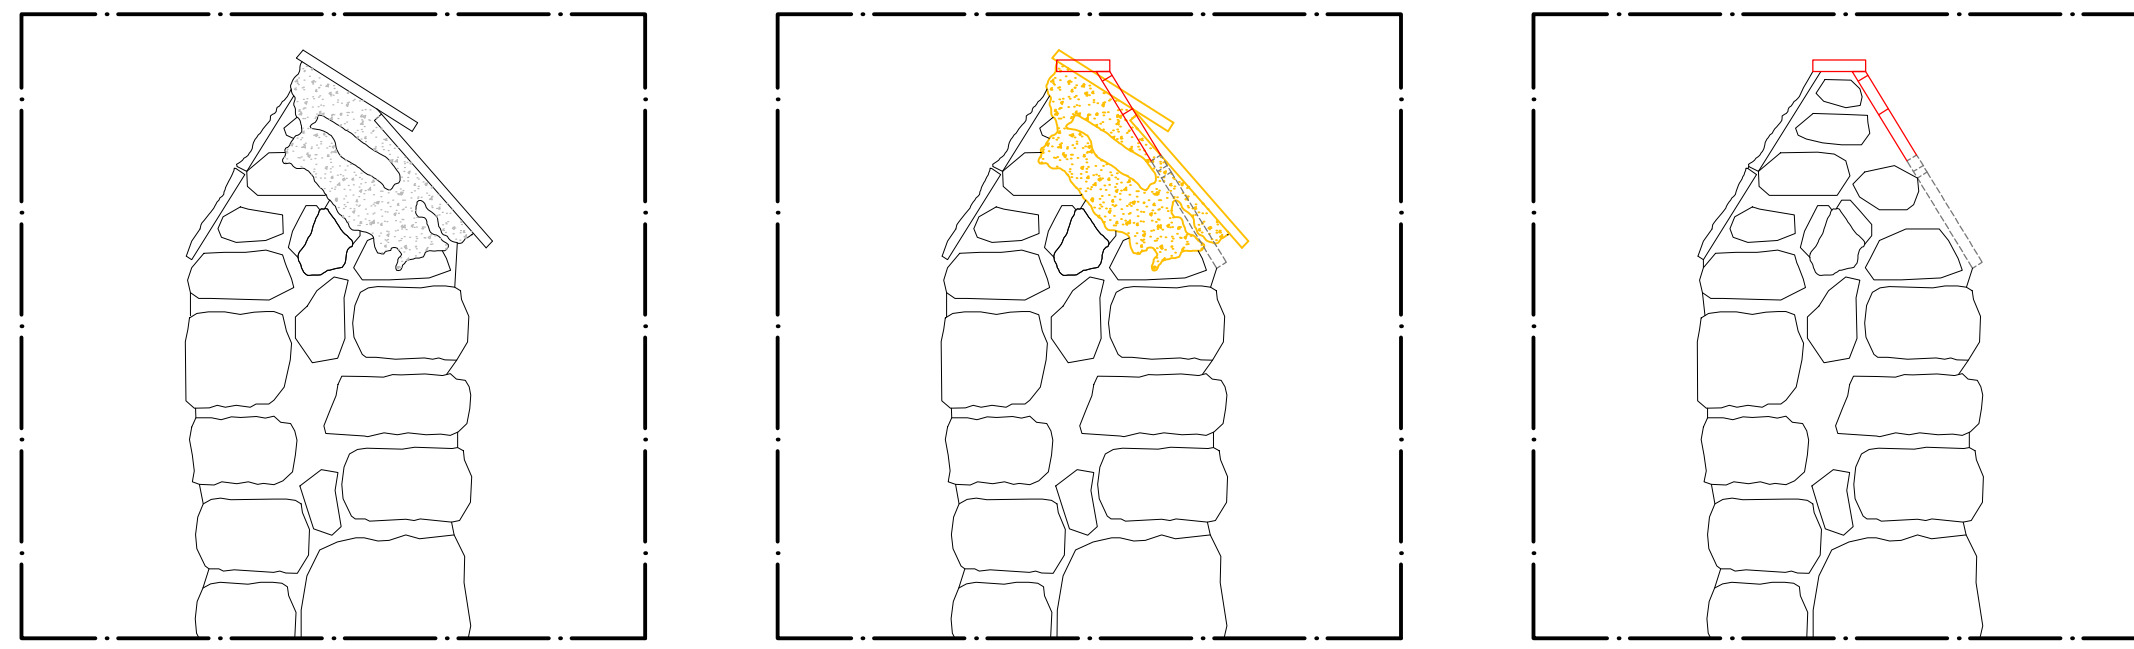
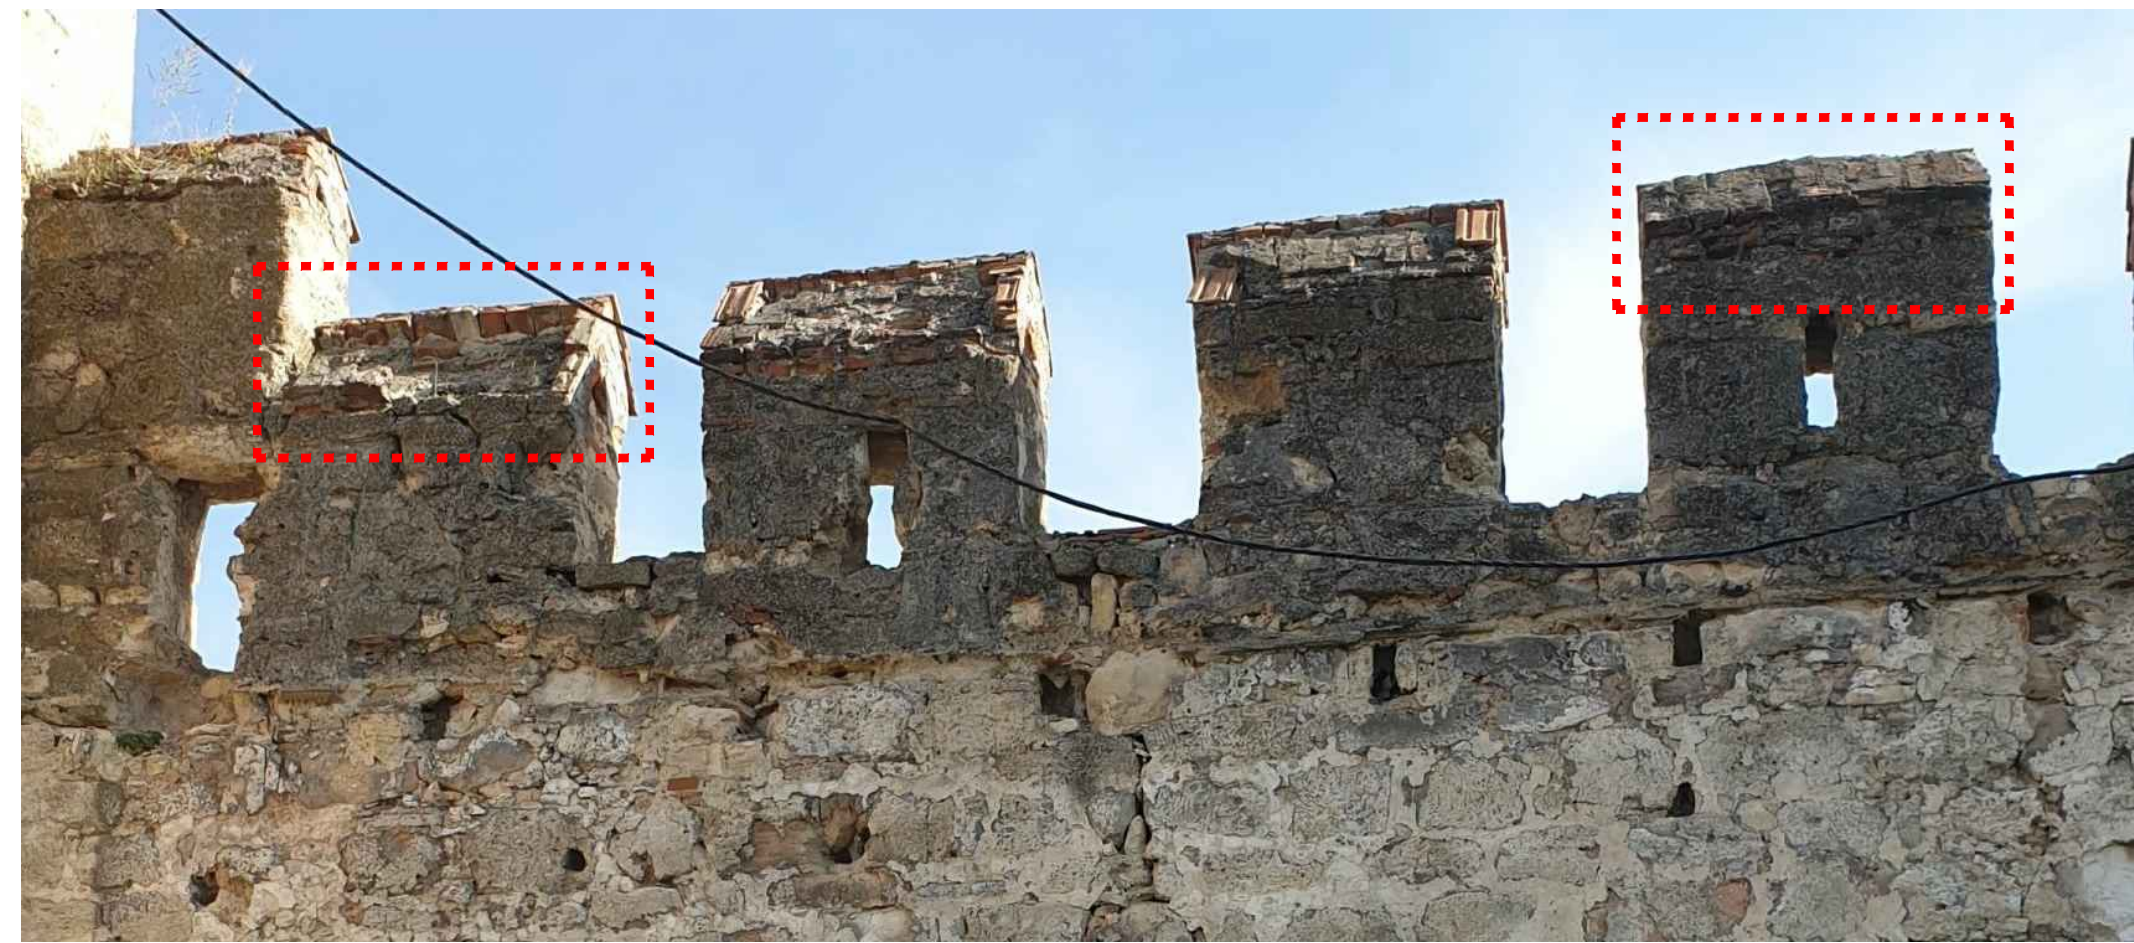
DETAIL 04. REPAIR OF SERIOUS INJURIES WITH THE "SCUCI-CUCI" TECHNIQUE - 1:10

RESTORATION OF THE WALL CONTINUITY IN DEGRADED AREAS OR FOT THE CLOSURE OF LARGE CRACK

DESCRIPTION
The intervention consists in restoring limited areas of damaged or degraded walls through the removal of degraded elements (stone or brick) and the creation of a new wall texture with healthy elements without interrupting the static function of the masonry during the application. Sound elements must have characteristics similar to the original ones, both geometric (shape and size) and mechanical. The use of non-shrinkage or slightly expansive mortars is necessary.

- PERFORMANCE**
- Cleaning and brining of the wall facing.
 - Shoring up the wall
 - Removal of the damaged part astride the crack.
 - Preparation of surfaces and stones
 - Reconstitution of the masonry with mortar and elements compatible with the original ones.
 - Compensation for degraded joints.

FEATURES
It is only applicable for masonry that has good quality and certain regularity and in the case of limited damage. The intervention can be applied to both walls and connection areas. The intervention is effective in the presence of elements with good resistance and if materials with similar characteristics in shape and size are used in the restoration. The connection with the existing masonry is decisive.
