Technical Expertise and develop Detailed Technical Design for CONSERVATION AND RESTORATION WORKS OF BENDER FORTRESS (Phase I)

DETAILED TECHNICAL DESIGN

TITLE: EXPLANATION NOTE	ASSIGN. CODE	DOCUMENT CODE				
		PRATICA	PARTE	DISC. PROG.	NUMERO	REV.
	C226	-	P	PE	r02	-
REPRESENTATION SCALE:		INTERNAL CODE:

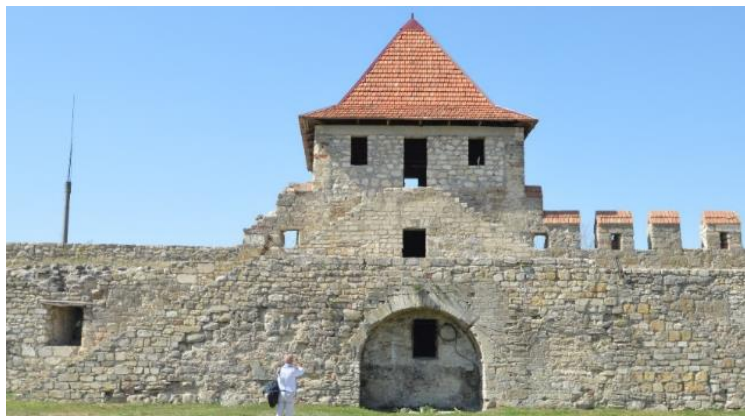
Tower A3: current situation

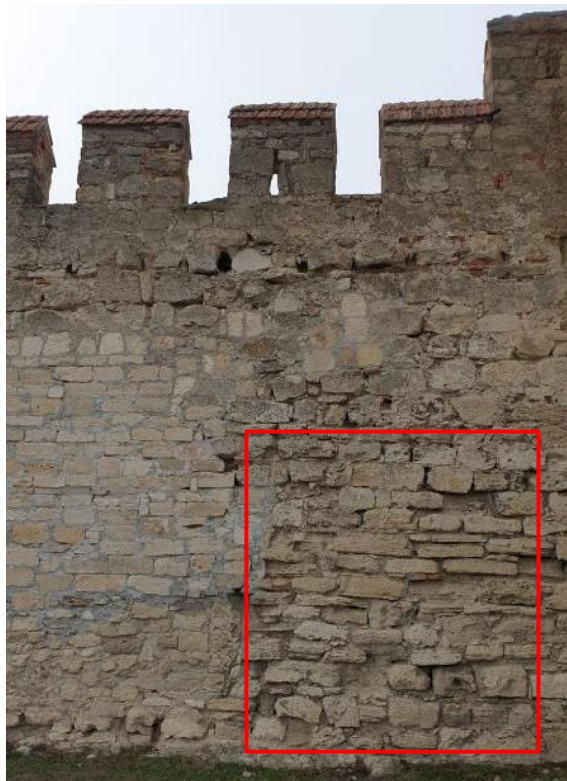
Loss of joints, degradation of stone facing, loss of stones

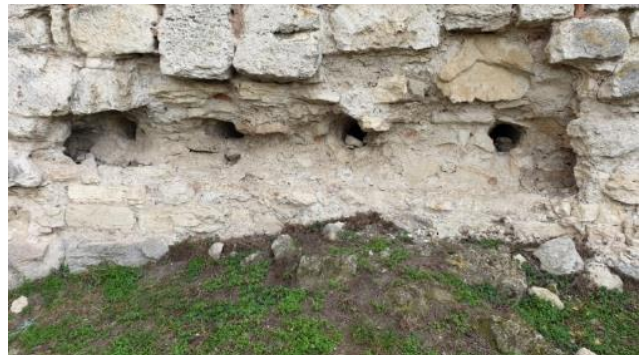
Collapse and local loss of the stone face at the voids left by the lost wooden net

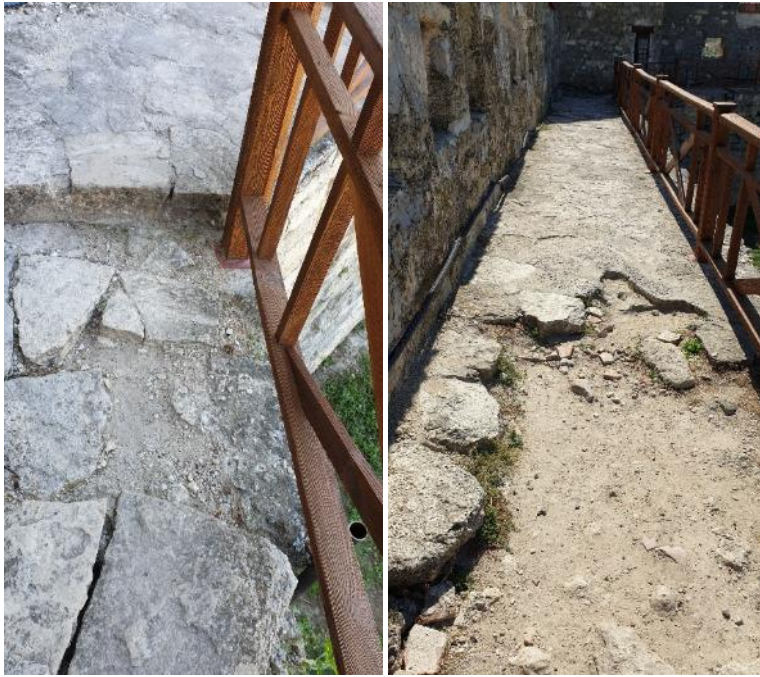
Actual situation of walkways

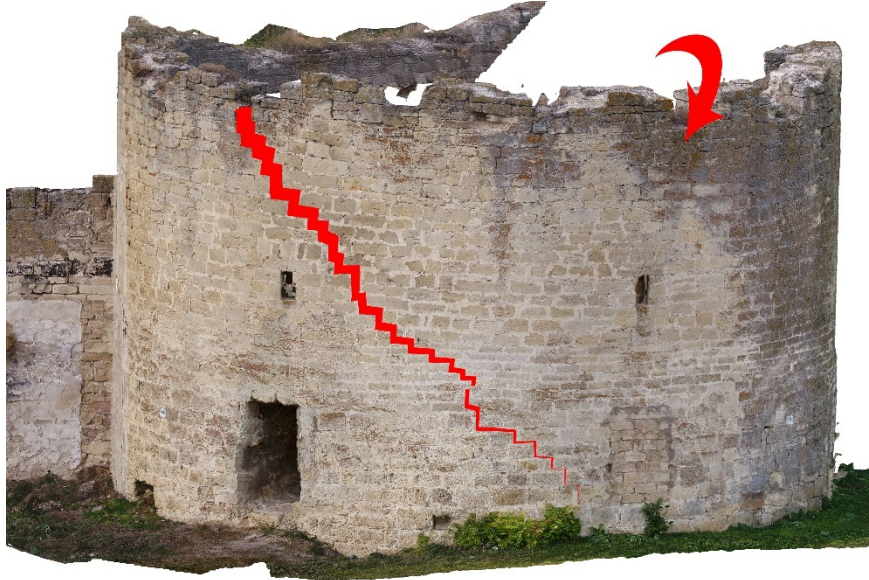
Typical kinematical motion of a portion of masonry in case of circular buildings such as Tower B3
