CLIENT: European Union Delegation to Moldova through its operational contractor UNDP

Technical Expertise and develop Detailed Technical Design for CONSERVATION AND RESTORATION WORKS OF BENDER FORTRESS (Phase I)

DETAILED TECHNICAL DESIGN

TITLE:
EXPLANATION NOTE

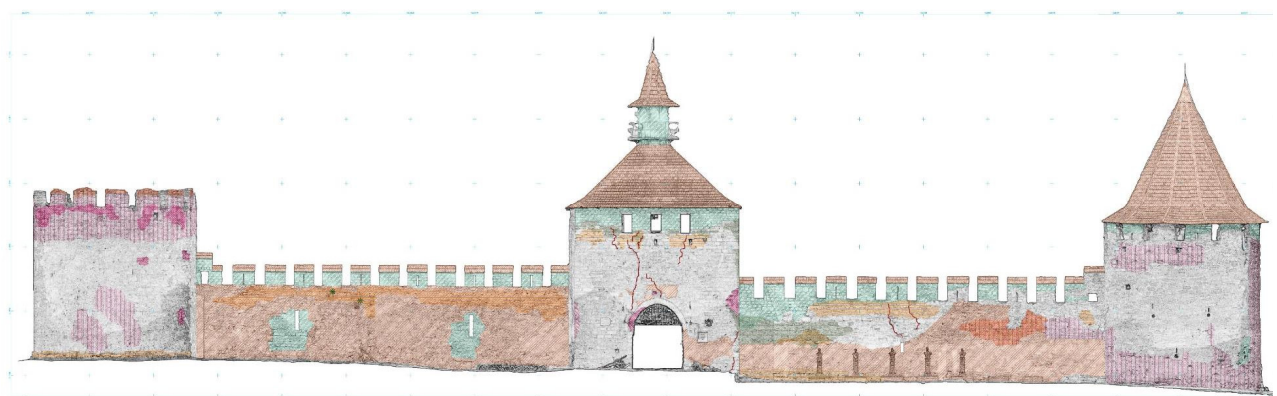
Stone surface mapping

The presence of these voids and sometime the different building phases of the two wall facing of the same wall combined with the harsh climatic conditions of the Bender area, have favoured some **decay phenomena** currently visible on the masonries at different stages of progression (and properly mapped into the drawings named "Decay phenomena and cracks mapping").

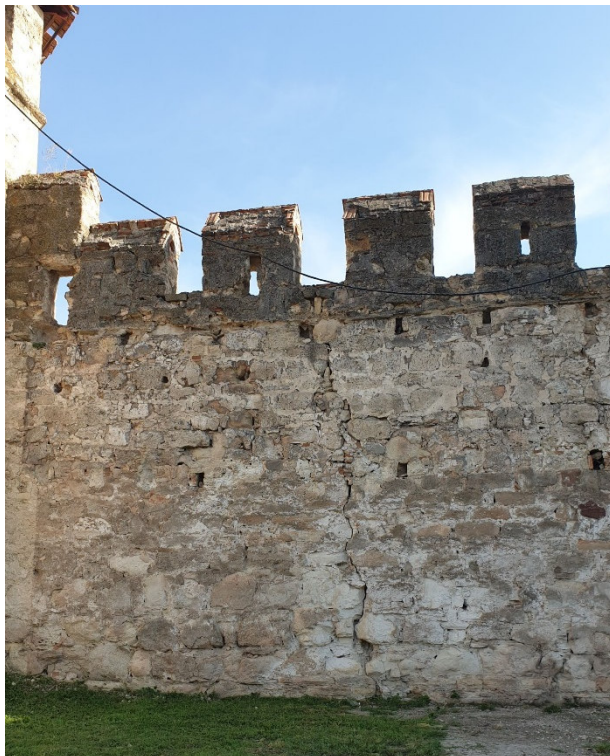
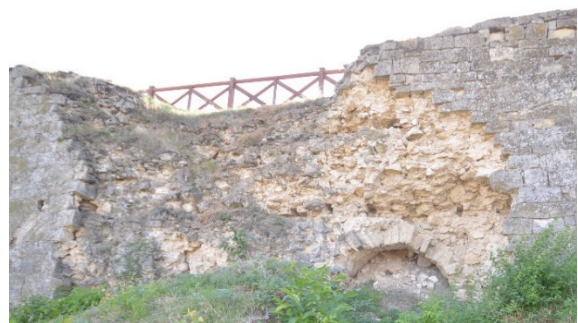
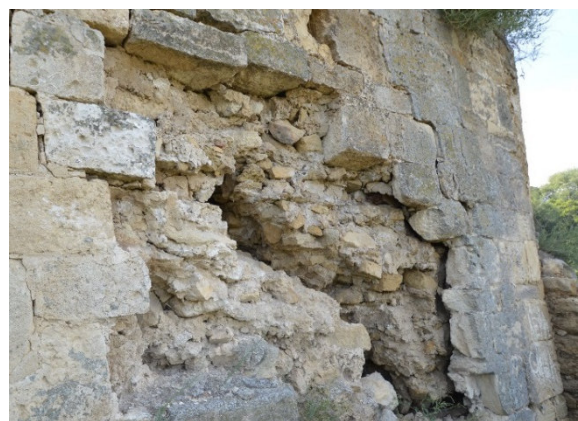
The first stage of decay is the **loss of mortar joints**, usually caused by the washing away of rainwater, freeze-thaw cycles and erosion of atmospheric agents.

The infiltrations and the progress of the decay phenomena of the mortars often cause the **loss of single stones** or even the **swelling and the collapse of portions of the walls**. Even the presence of shrubby vegetation, especially when very rooted, can cause the detachment of stones.

These decay phenomena combined with the effects of the subsidence of the soil, increase the structural weaknesses which are revealed in the form of cracks (more or less deep) up to considerable detachments and collapses of the wall facing.

Therefore, the priority must be to secure, from a structural point of view, the citadel and the lower fortress, in order to allow visitor's safe use. In this phase the structural works will be concentrated on Tower A6, Tower B3 and Water Tower (please see Structural chapters and Structural Project drawings). Securing works will involve also the masonries of the Citadel.

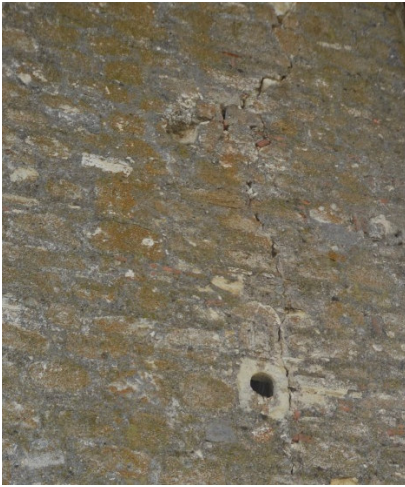
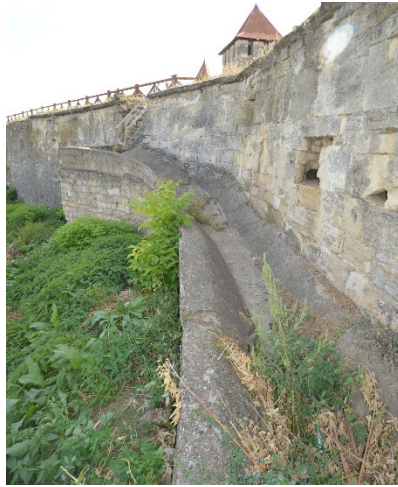
Another very frequent decay phenomenon in monuments that, like the fortress of Bender, "live" substantially outdoors and in symbiosis with the surrounding context is the **biological patina** and **shrubby vegetation**.

The biological patina present on the walls of the fortress of Bender does not appear particularly aggressive. Surely, it will be necessary to remove it and to clean very well at least the surfaces where other works will be carried out in order to provide suitable supports to receive consolidation, grouting, reintegrations, etc.

The weed vegetation seems to be concentrated in the areas less frequented by visitors and at the collapses of the low fortress, as well as along the existing drainage channel.

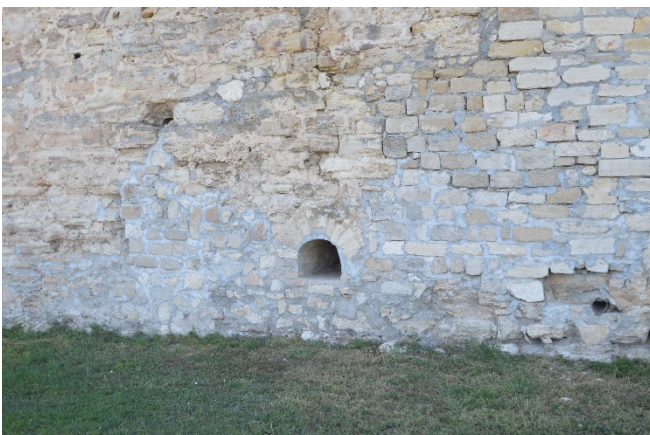
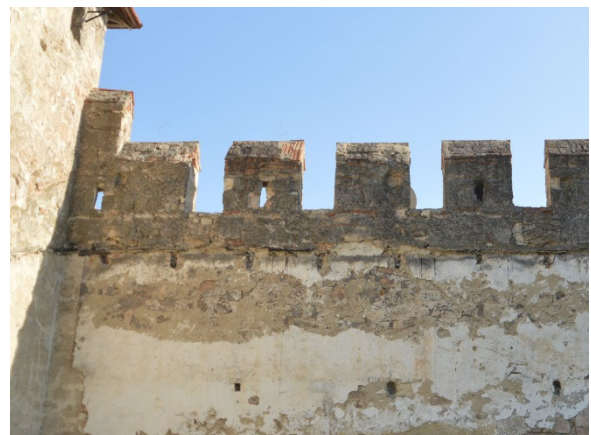
The first two issues refer to the **incompatibility of the material used in the repairs** from a **chemical-physical point of view**.

It is important to underline that the use of cement in plasters and mortars can be very harmful to original stones in geographical areas subject to freeze-thaw cycles such as Bender, because of its high saline component and its different thermal expansion compared to the existing stone and mortar. This can cause fragmentation, detachments and collapses of stones. It is also important to underline that these phenomena often occur in combination with each other and their evolution is faster where the decay has already started.

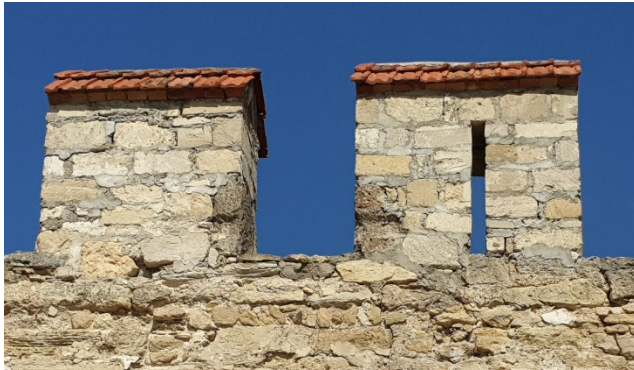
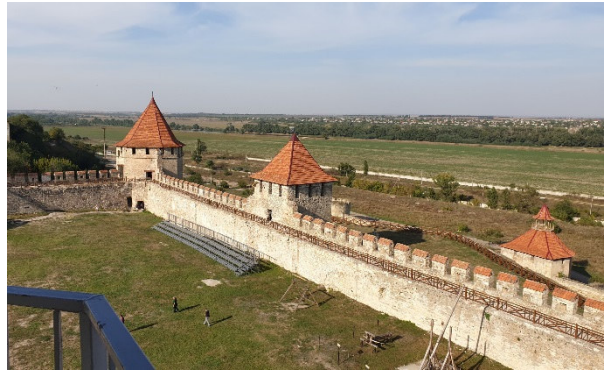
The third issue refers to the **incompatibility of restoration solutions from the historical and cultural point of view**.

Marseillais-type tiles are not a local or traditional material. It is an industrial product that has no history in the Bender fortress. The use of this material returns an image of the fortress that never existed.

In this phase this issue will be addressed on Tower A6, Tower A3, Tower A2 and Tower A4 (please see also Architecture chapters, Structural chapters and Project drawings). Restoration works will involve also all battlements of the Citadel.

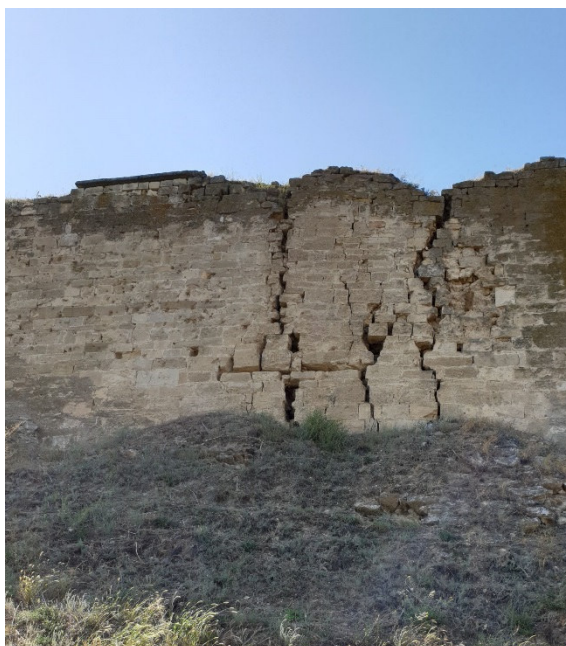
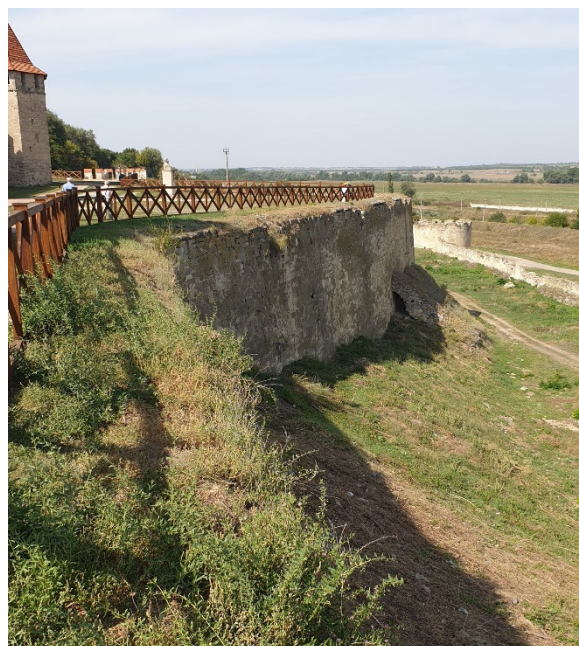
- the **deviation of the visitors' path** away from the Rampart B7 (seriously compromised from a structural point of view), for which no interventions are foreseen in this lot of works because structural monitoring of at least one year is currently underway

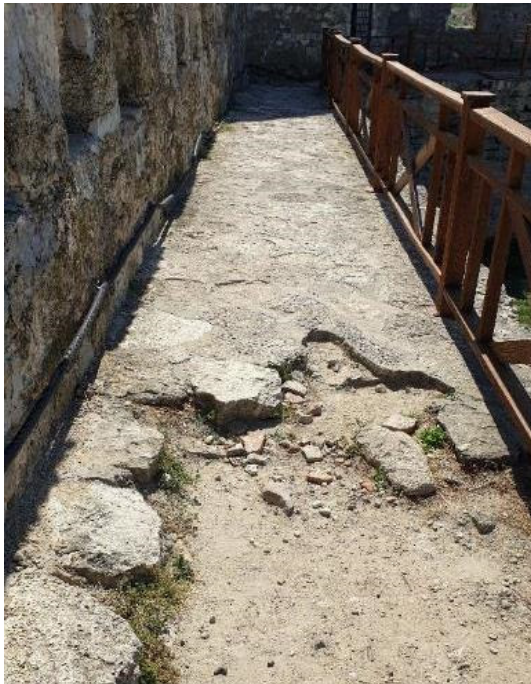
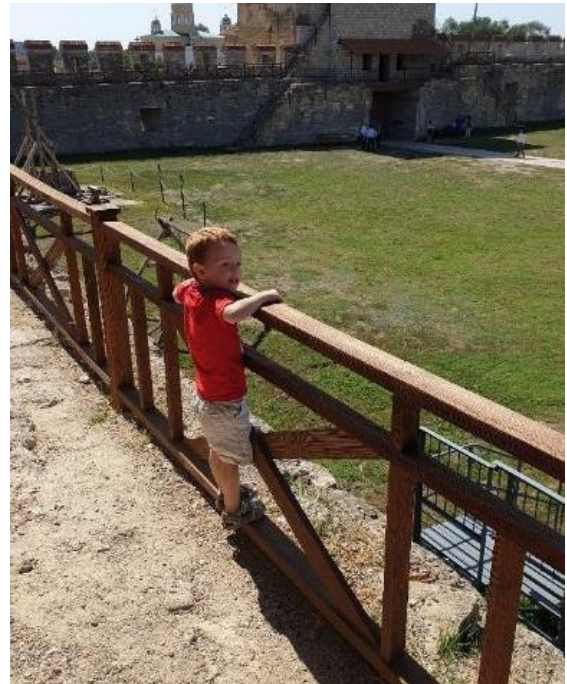
- The **arrangement of the patrol path** and all the parapets to avoid falls from a height

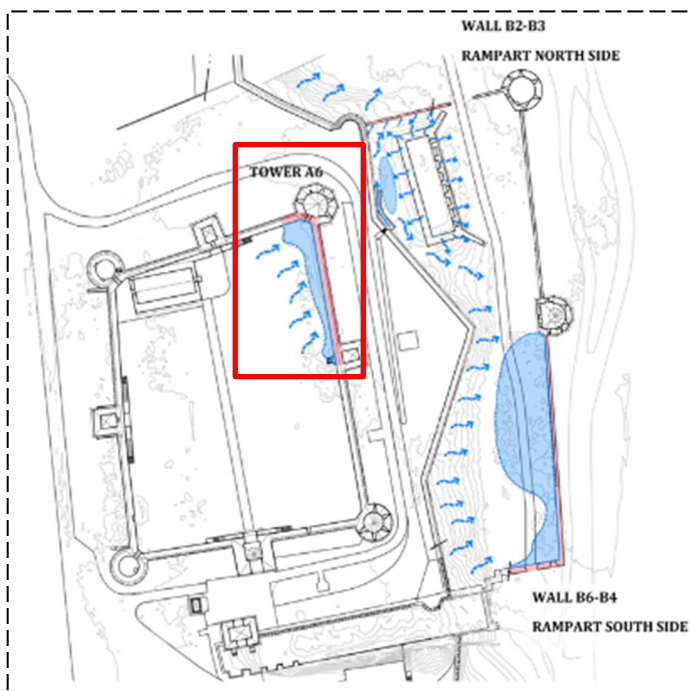
4.6 Problems in the drainage of rainwater

The drainage of water in the citadel is the main critical issue regarding the drainage of surface water.

The studies on the slopes of the land have shown a stagnation at the A6 tower.

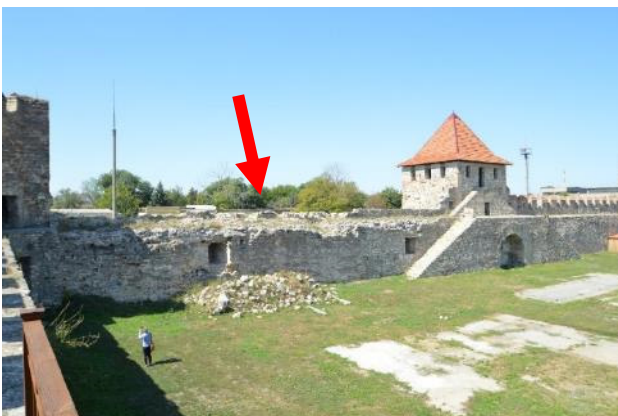
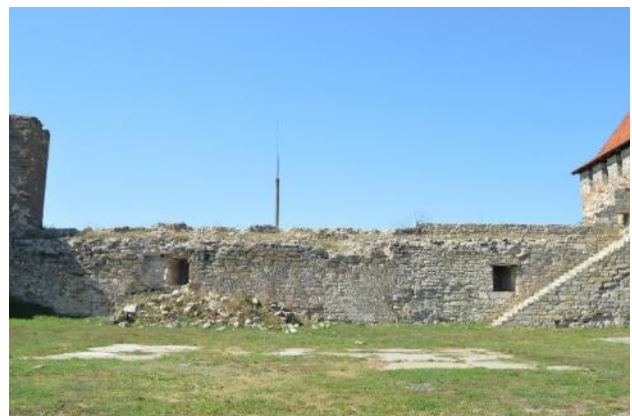
On walls between towers A2 and A3 the patrol path is now ruined, with lacks at the upper part of the masonry; restoration and rearrangement are here particularly necessary. This intervention must **follow the contemporary architectonical restoration principles, in particular: distinguishability, reversibility (at least potential) of the intervention and material compatibility.**

All surface deposits and weeds must be cleaned, **taking care that the top of the historical masonry still preserved is not damaged during the intervention.** Therefore, it might be necessary to stabilise moving

stones with preliminary application of mortar. The restoration of the stone surfaces must follow the indications of the specific chapter below. **The reconstruction of the patrol route resumes the shapes of the adjacent portions remained intact and guarantees the aesthetic continuity of walkways, and it must be distinguishable from the historical masonry on which it rests.** This may occur, for example, using stones of different sizes from the original, or using natural hydraulic mortars (without cement) of a slightly different colour than the original ones.

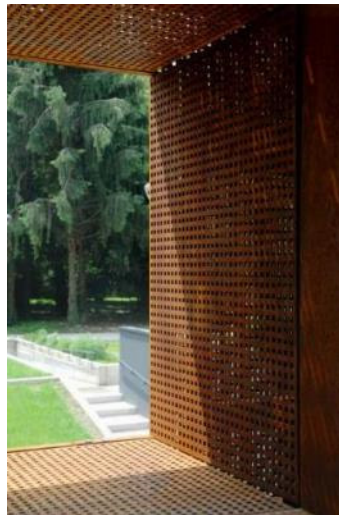
New railings will be installed to ensure the safe use of visitors (avoiding dangerous situations such as the one in the photo).

The railings will be installed directly on the patrol path. It will consist of vertical supports in Cor-ten iron with a top rail with a rectangular section and perforated Cor-ten panels according to the detailed drawings. The insertion of the metal mesh is important to guarantee the safety standards for visitors.

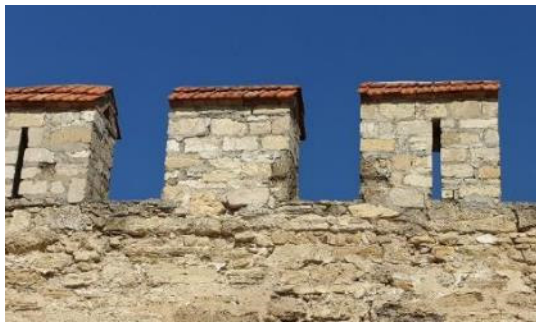
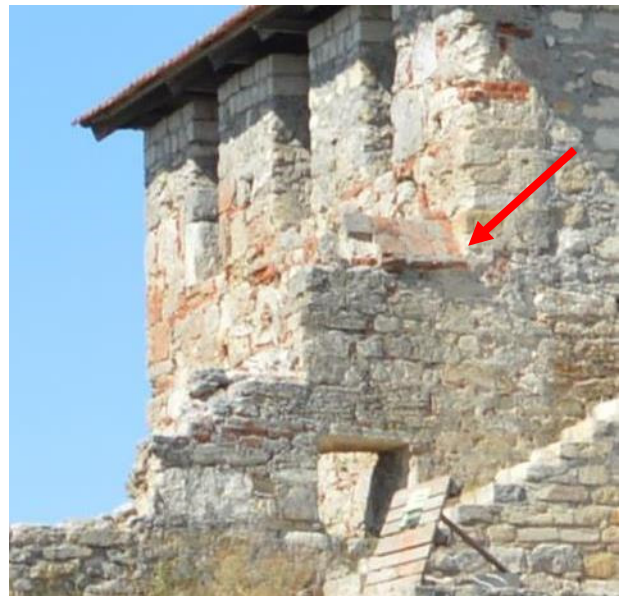
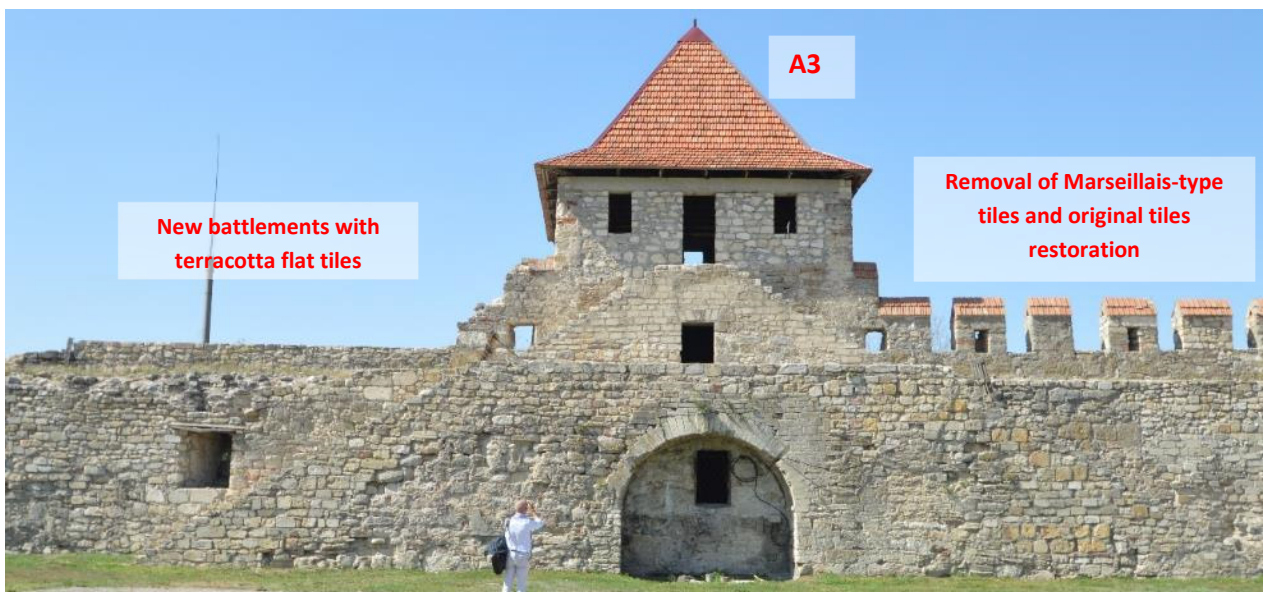
The guidelines for the re-integration of the battlements are based on the observation of the few historical portions preserved. As can be seen in the following images, the battlements historically did not culminate with Marseillais-type tiles (a late 19th century industrial material) but with terracotta flat tiles. Recent reconstructions have provided an image of these elements (and of the fortress) which is not reflected in history. We therefore believe that **the approach to restoration must take into consideration the historical materials with which the fortress was built and the image that the use of these materials generated.**

As summarized in the previous image, the battlements recently rebuilt between the A3 and A4 towers will be modified by

- replacing the “Marseillais”-type tiles with terracotta flat tiles, if there are no original tiles under the industrial one
- removing of the “Marseillais”-type tiles and restoring terracotta flat tiles, if original tiles are preserved under the industrial one.

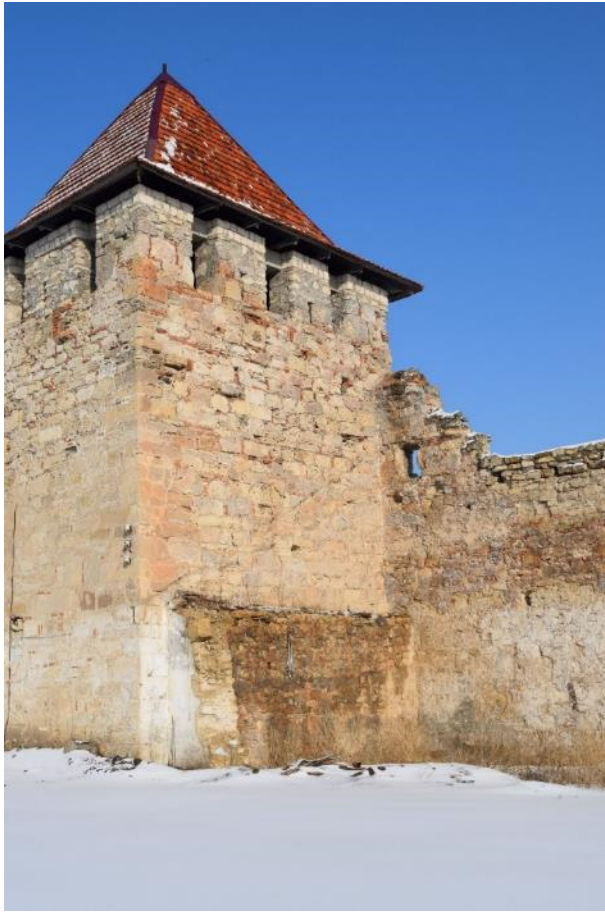
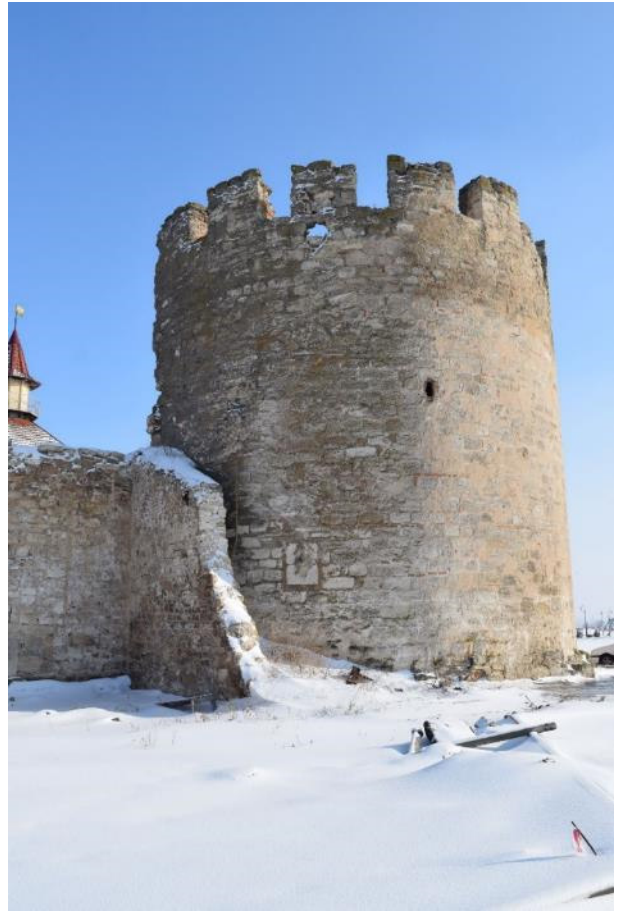
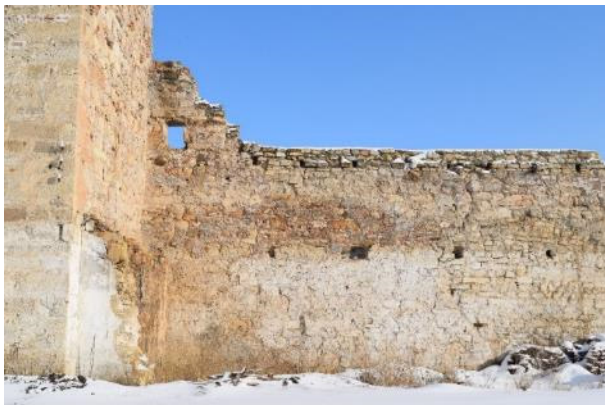
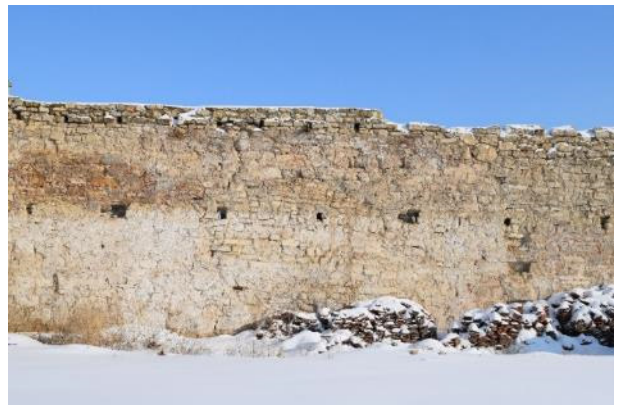
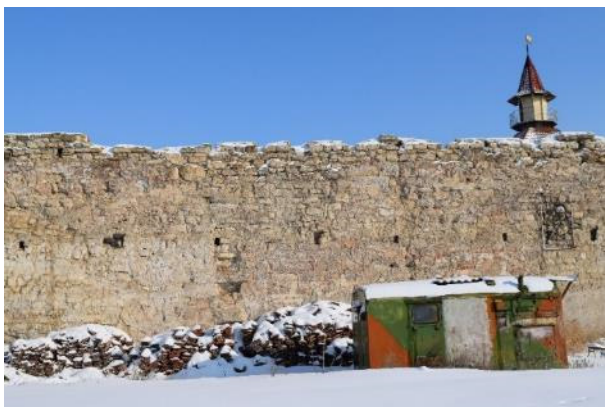
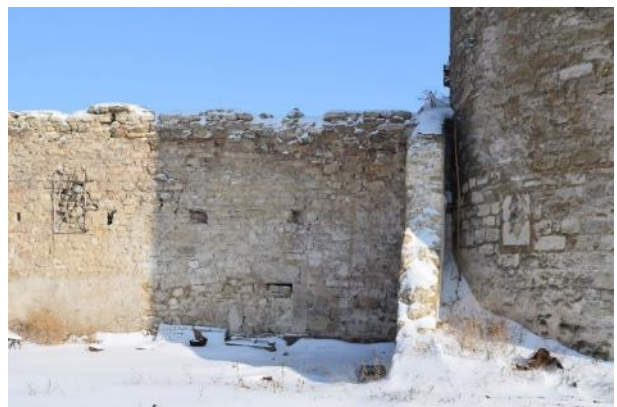
The images below refers to state of conservation of masonry between towers A2 and A3 external side.

All surface deposits and weeds must be cleaned, taking care that the top of the historical masonry still preserved is not damaged. The restoration of the stone surfaces must follow the indications of the specific chapter below. The reconstruction of the patrol route propose the same shapes of the adjacent portions remained intact and guarantees the aesthetic continuity of walkways, and it must be distinguishable from the historical masonry on which it rests. This may occur, for example, using stones of different sizes from the original, or using natural hydraulic mortars (without cement) of a slightly different color than the original ones.

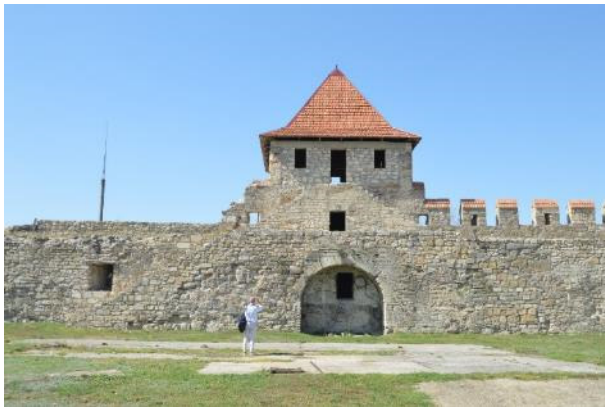
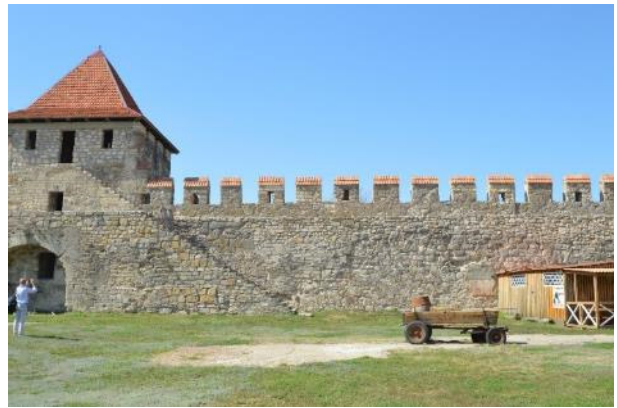
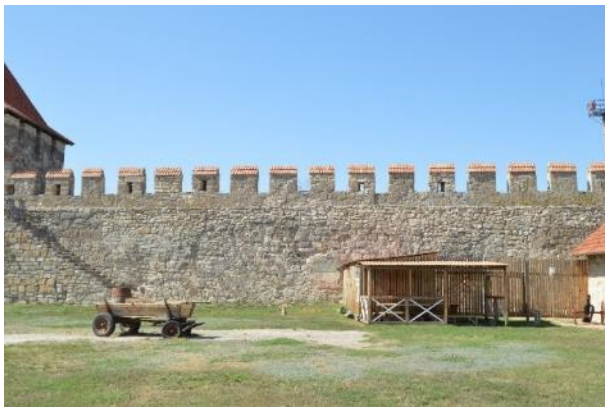
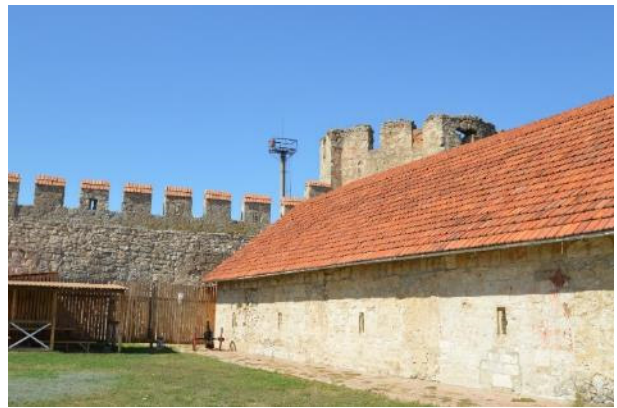
The images below refers to state of conservation of masonry between towers A3 and A4 internal side.

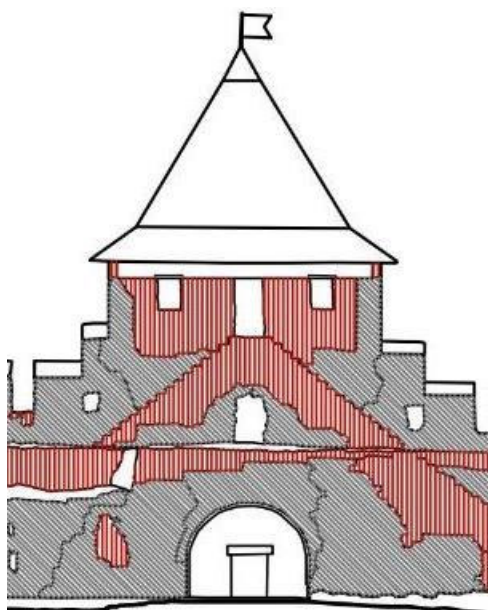
Tower A3: current situation

The roof of the A3 tower will be replaced as already described above in this report, the “Marseillais”-type tiles of the battlements will be removed, the new battlements will be built with compatible mortars. Recent interventions made with cement mortars that cannot be removed without damaging the structure, such as the new battlements and the new stairs, can be visually mitigated by applying thin layers with highly diluted natural hydraulic lime mortars.

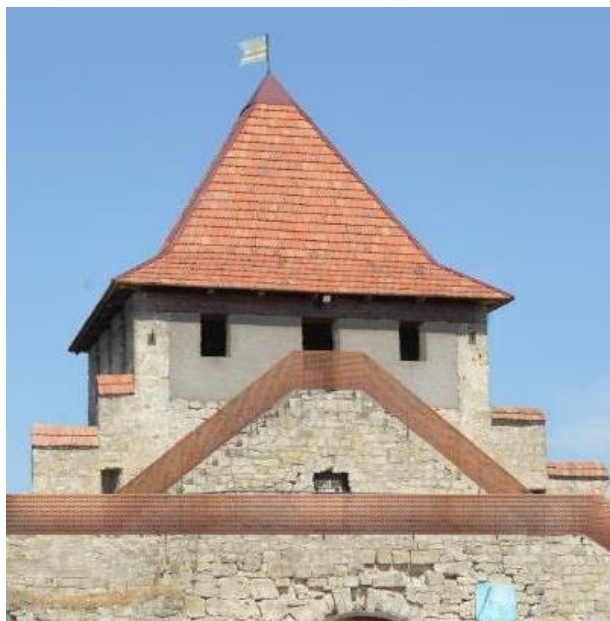
Recent interventions in red

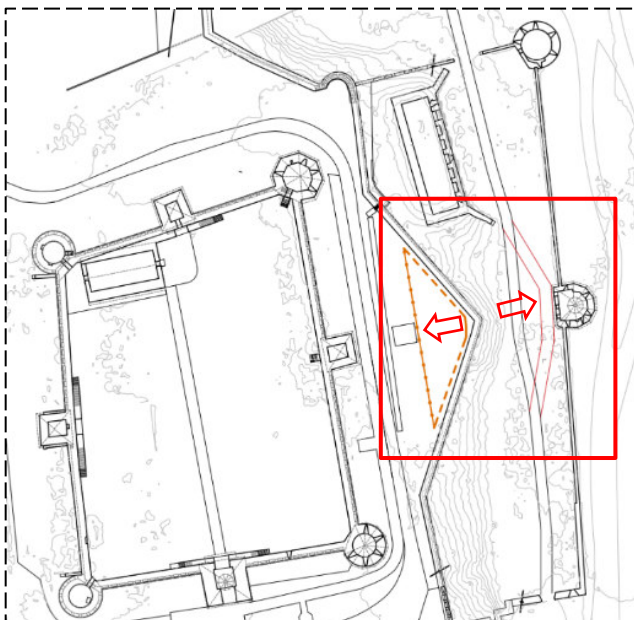
In Rampart B7, the situation appears rather serious and structural monitoring of at least 13 months is required to understand the behavior over time of the deep lesions and lack of facing present on the masonry, before defining the correct interventions.

Structural reinforcement for the rampart B7 is a priority, but it will be necessary at least 13 months of structural topographic monitoring on it to properly define the appropriate interventions.

The aim of the proposed intervention in the present works-lot is to secure the visit routes pending evaluation for a more decisive intervention on the Rampart B7.

Once the monitoring campaign will be finished, we recommend reinforcement interventions on masonry. For this reason, the visit routes will need to be temporarily further distanced from the bastion.

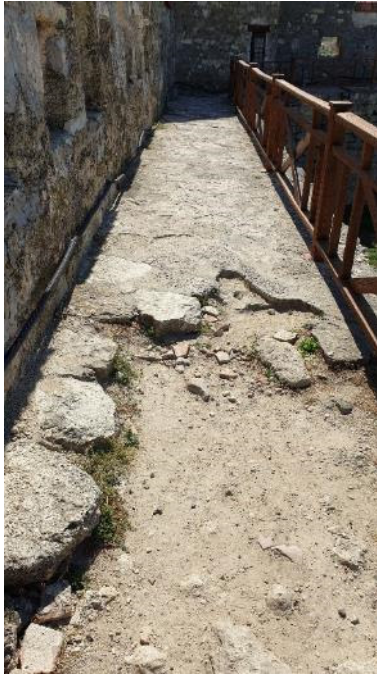
Actual situation of walkways

As visible from the photos, the whole walkway requires general maintenance: removing vegetation and deposits, fixing of moving stones, replacement of missing stones, refill of missing joints.

The intervention described in previous paragraph 6.1.1 must be extended to the entire patrol walkway.

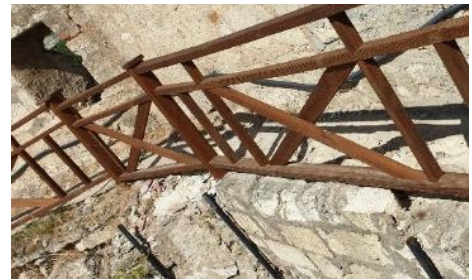
A child can fall through the mesh of the railing

- railings of different types, all unsuitable for guaranteeing safety at altitude
- the absence of railings

All routes at height must be equipped with a railing that protects against falls.

The mesh must therefore be composed of elements close enough to prevent the passage of people, that can fall and injure themselves, and the passage of objects, that can fall and injure any passersby.

Where they already exist, all railings will be replaced, where they are absent, they will be added.

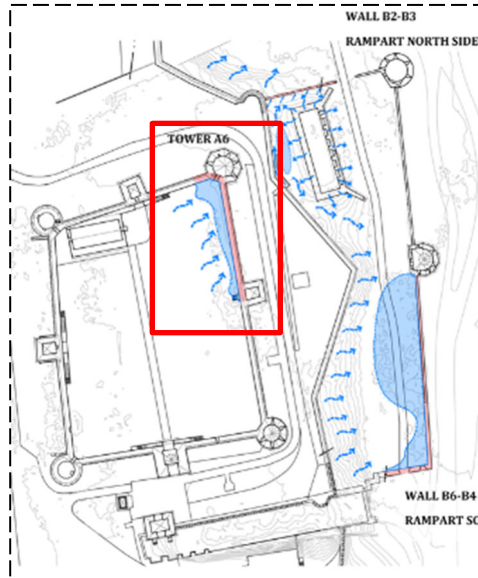
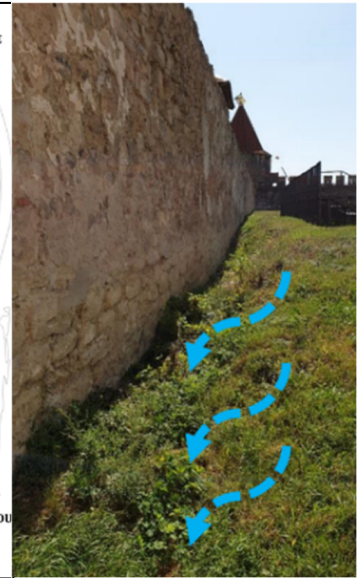
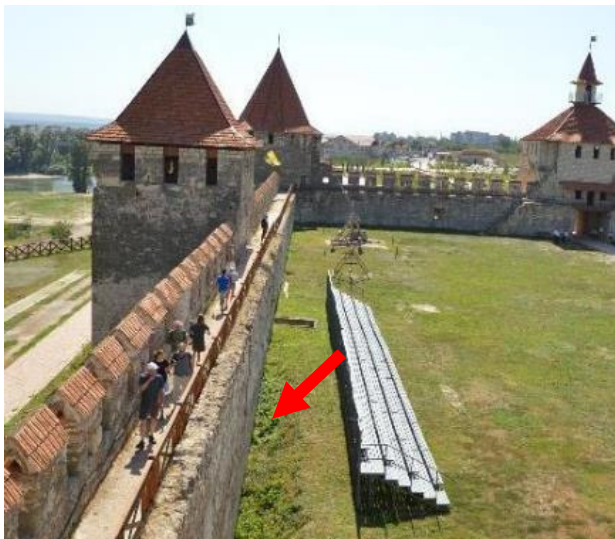
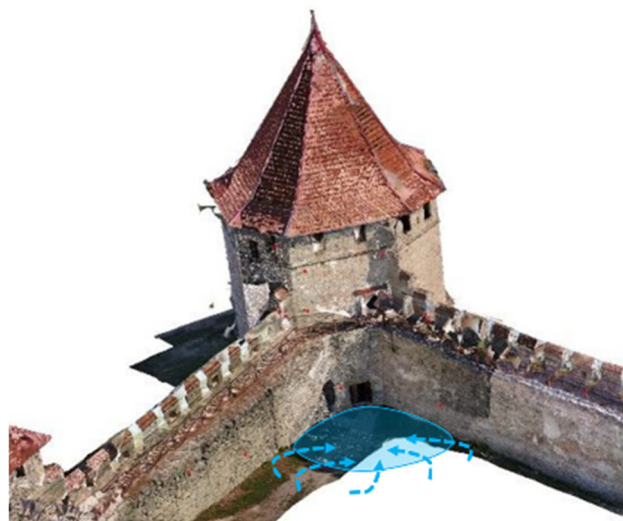
The studies on the slopes of the land have shown a stagnation at the A6 tower. This stagnation could be one of the triggering factors and in any case contributes to aggravate the structural problems of subsidence of this portion of the fortress.

Action is required to limit the accumulation of water at the A6 tower.

The ground will be remodeled to drain correctly water by inverting the inclination and it should be inserted, for the entrance to tower A6, a stone staircase similar to that existing for the entrance to tower A7. In this way the stagnation should be avoided.

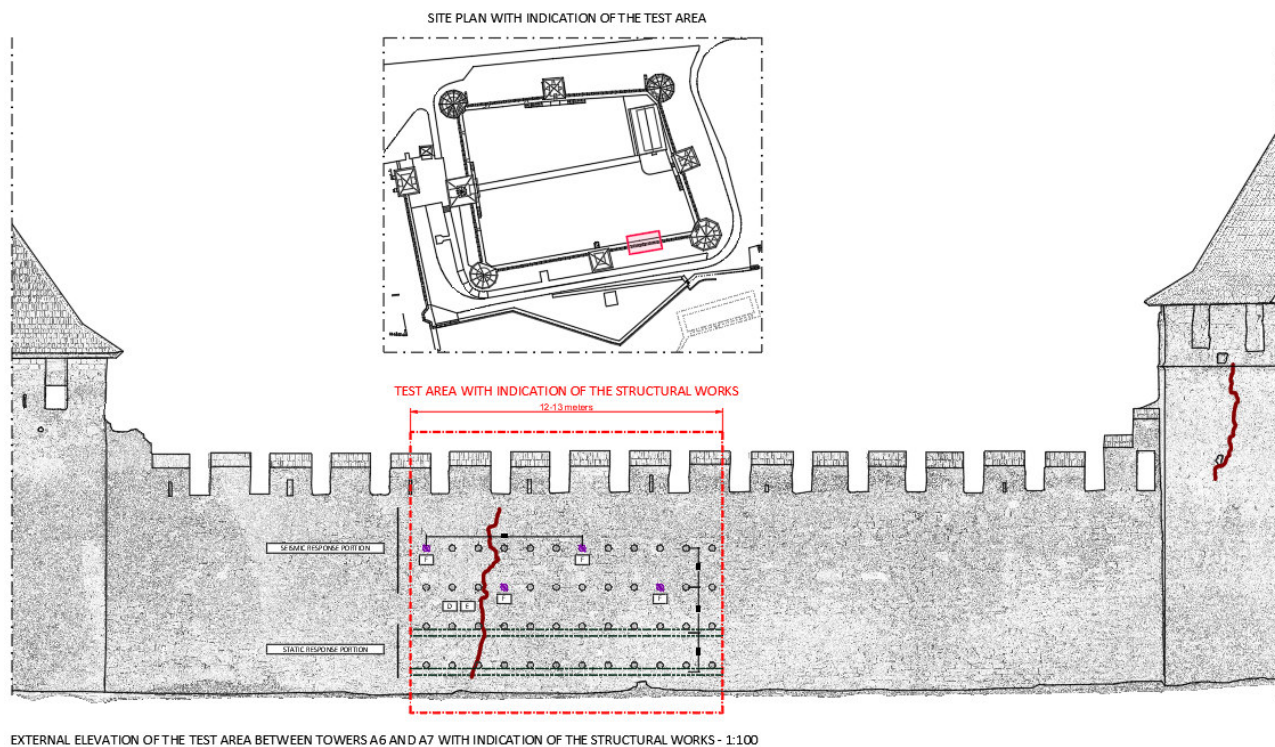
Elevation of the wall between towers A6 and A7 with proposal of the test areas where structural interventions could be done.

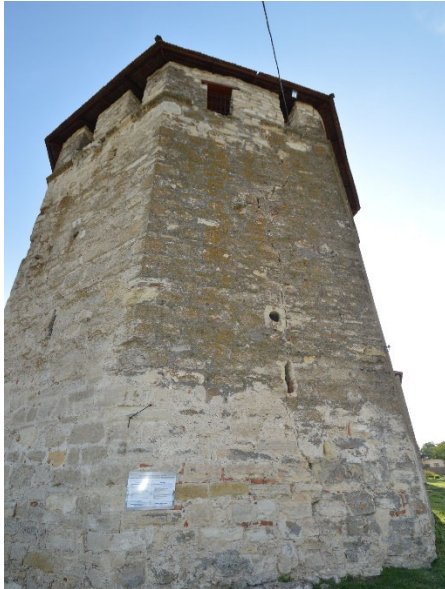
The polygonal Tower B3 is located at the northeast corner of the Citadel and it's characterized by three levels of wooden decks laid on a steel primary structure. The proposed intervention aims to prevent any possible kinematical motion of overturning and shear failure of portions of the perimeter wall due to seismic actions, as shown in the following picture.

Reinforcement interventions are necessary to statically consolidate the tower after the manifestation of very large vertical cracks in the center of some walls of the tower, due to the typical lesions affecting lean structures such as towers and bell towers.

The proposed intervention consists of eight metal tie-rods - four for each level - laid on the existent wooden decks and covered with a new one. These tie-rods consist of a metal plate 40 x 10 mm for what concerns the surface in contact with the floors and of a stainless steel through bar with circular section for what concerns the masonry section; each tie-rod ends with a metal retaining, in direct contact with the wall. Every executive indication is reported in the structural design drawing.

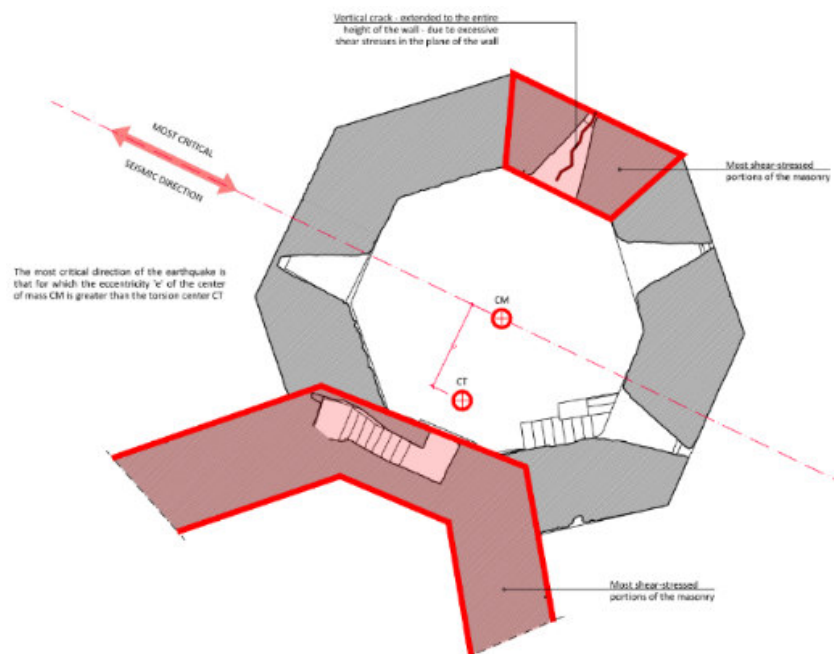
Vertical crack - extended to the entire height of the wall - due to excessive shear stresses in the plane of the wall in the most critical direction of the earthquake

This kind of seismic instability is typical of tall buildings such as bell towers. In the case of Tower A6, the intervention will be carried out at the level of the last two decks to ensure that they are able to strengthen the box behaviour of the structure and prevent the reciprocal sliding of the portions of masonry with shear failure. From a static point of view, however, the tower doesn't show any sign of failure.

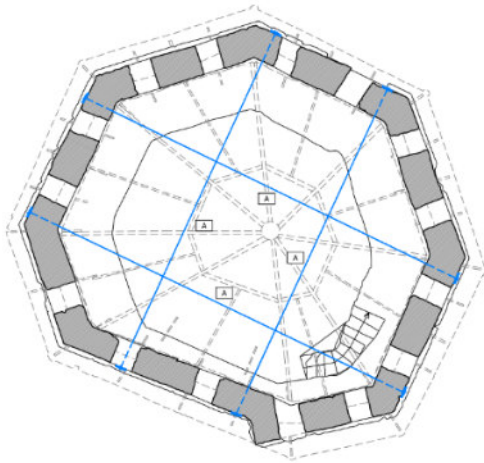
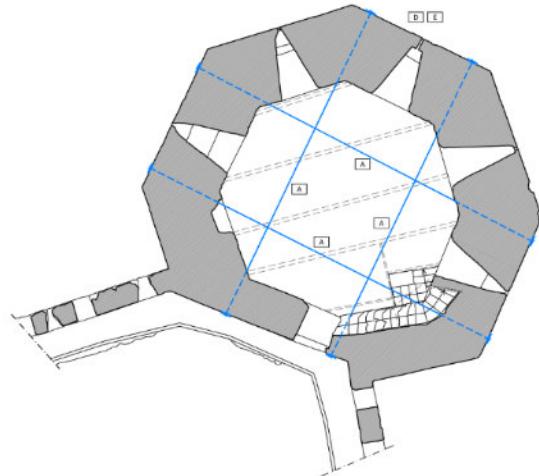
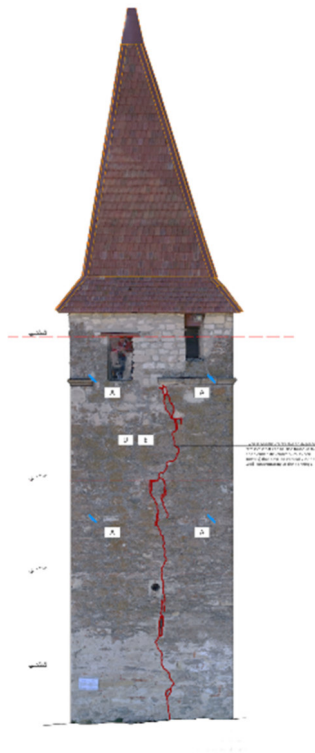
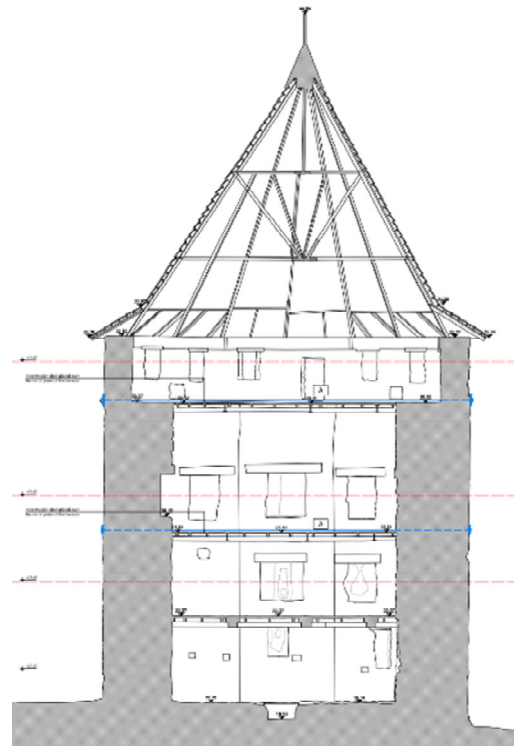
Elevation of the north-eastern facade of the tower with indication of the structural works

Vertical section of the tower with indication of the structural works

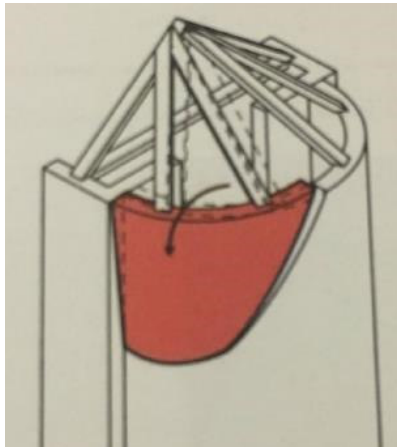
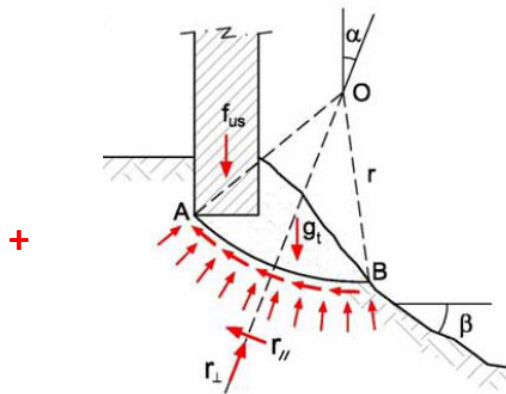
The Water Tower has a serious cracking that involves the inner pavilion vault for all its thickness; this crack extends also to the walls below and in particular involves two orthogonal walls to the eastern facade.

It has been assumed that such disruptions are caused by a combined action given by an excessive thrust of the vault at its bottom level and by a failure of the foundation of the prospectus due to a slip downstream of a portion of ground.

Masonry cracks show the activation of a kinematic mechanisms due to the thrust of the vaults combined with a ground subsidence.

The interventions which have been planned consist of four tie-rods placed at the base of the vault to limit the movement of the wall at the top, and a foundation cordon that limits the lowering of the wall and the sliding downstream.

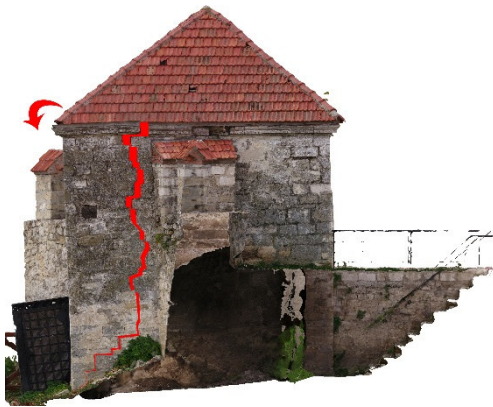
1)

Out-of-plane rotation of the facade due to the thrust of the pavilion vault

Masonry cracks could be linked to a combination of two main structural failures: the rotation of the façade due to the thrust of the vault (1) and a ground subsidence (2). The result is a shift of the wall in the direction of the ground slope (3).

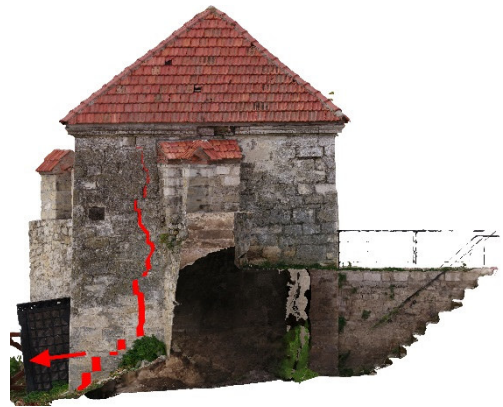
2)

Rotation at the foot of the wall due to ground subsidence

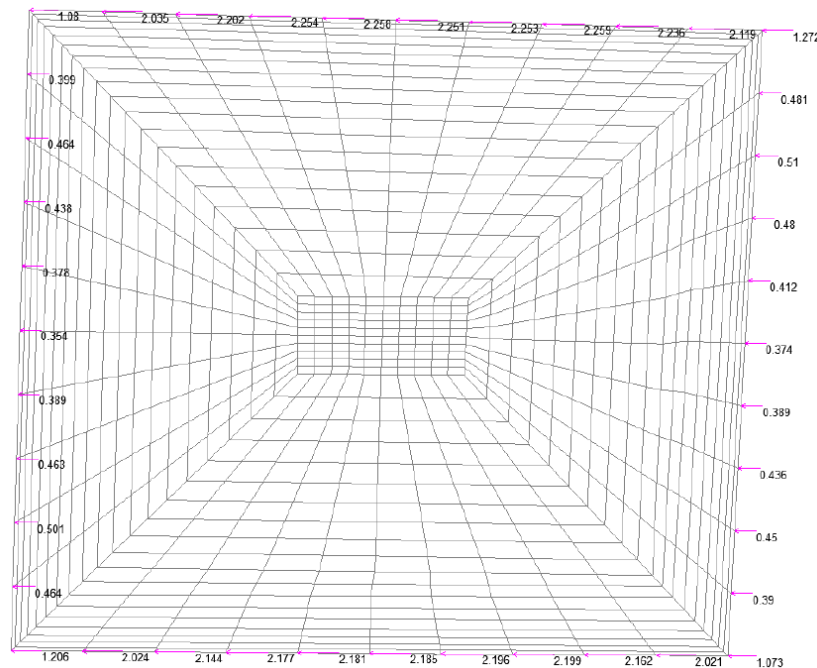
The analysis which has been carried out show that the horizontal component of the thrust of the vault has a maximum value of 2,259 kN per half meter of masonry. Applied on the longest side of the vault (about 5,00 m) the total load on the wall is 22,60 kN.

The horizontal actions on the perimetral walls of the vault

As the vault is fissured and therefore is no longer able to properly transmit its weight on the perimeter walls, some structural interventions have been planned to prevent possible out-of-plane tipping mechanisms in static conditions. The same interventions could achieve the same positive effect in seismic conditions, so they will be dimensioned to provide this additional contribution as well.

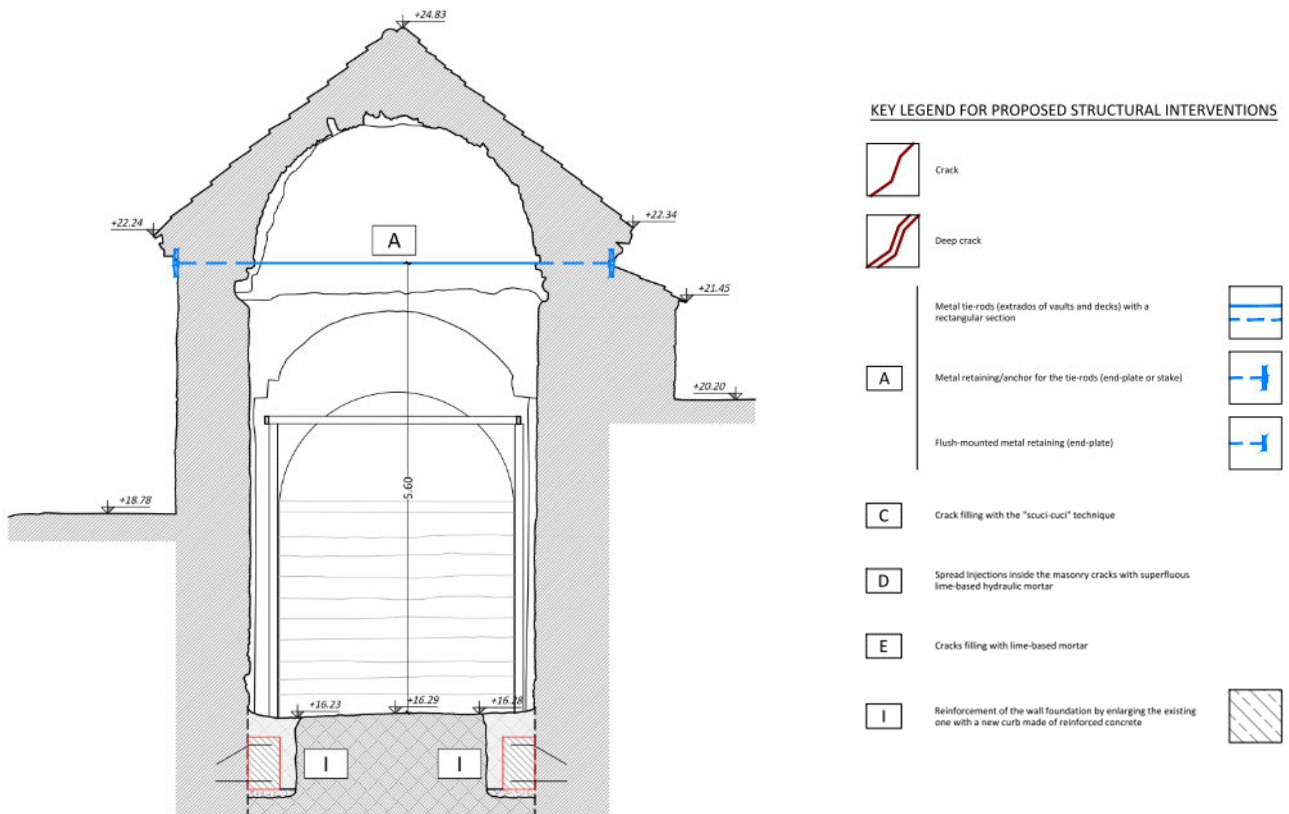
1-1 vertical section of the Water tower with indication of the structural works

For this reason, an extension of the foundation is proposed by casting a reinforced concrete curb realized according to the requirements of structural project drawings. The minimum section will be 50 cm wide and 65 cm high, connected to the existing masonry by means of stainless-steel bars able to transmit the shear stresses between the concrete and the masonry. For what concerns the concrete reinforcing steel, there will be 3+2+3 Ø16 longitudinal bars and the stirrups Ø8 will be put every 25 cm; connectors between the concrete and the existent masonry will have a step of 25 cm as well.

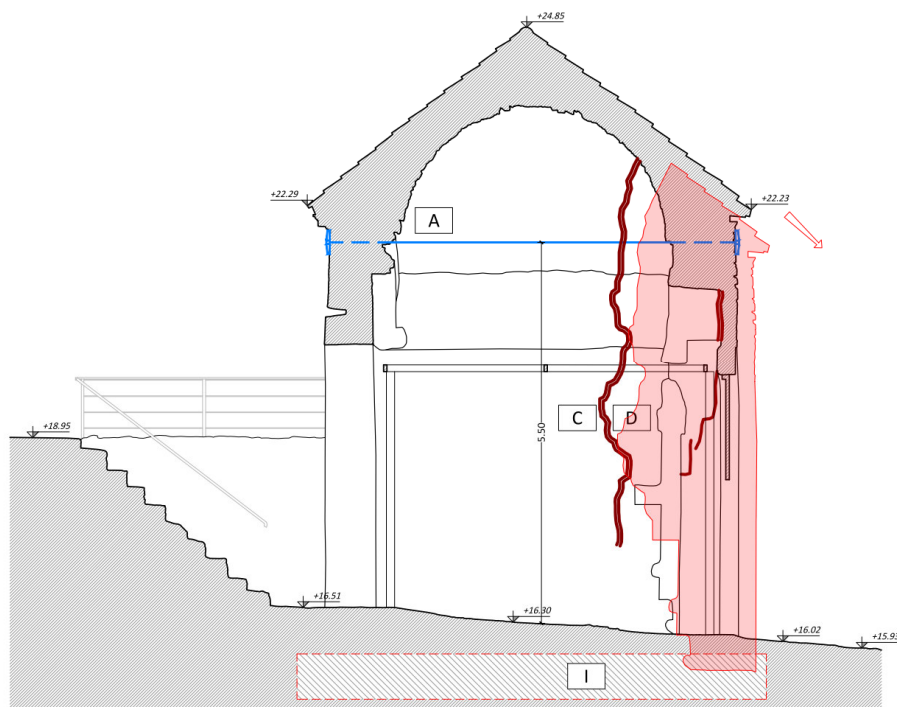
2-2 vertical section of the Water tower with indication of the structural works

Two pairs of tie rods have been designed to contain both the push of the vault and to inhibit any kinematics of seismic nature that could cause the loss of the box behaviour (overturning off the plane of portions of wall). For this reason, the metal profiles of the tie-rods have been chosen in order to be strong enough to absorb both these types of stress.
