CLIENT: European Union Delegation to Moldova through its operational contractor UNDP

Technical Expertise and develop Detailed Technical Design for CONSERVATION AND RESTORATION WORKS OF BENDER FORTRESS (Phase I)

DETAILED TECHNICAL DESIGN

TITLE:
EXPLANATION NOTE

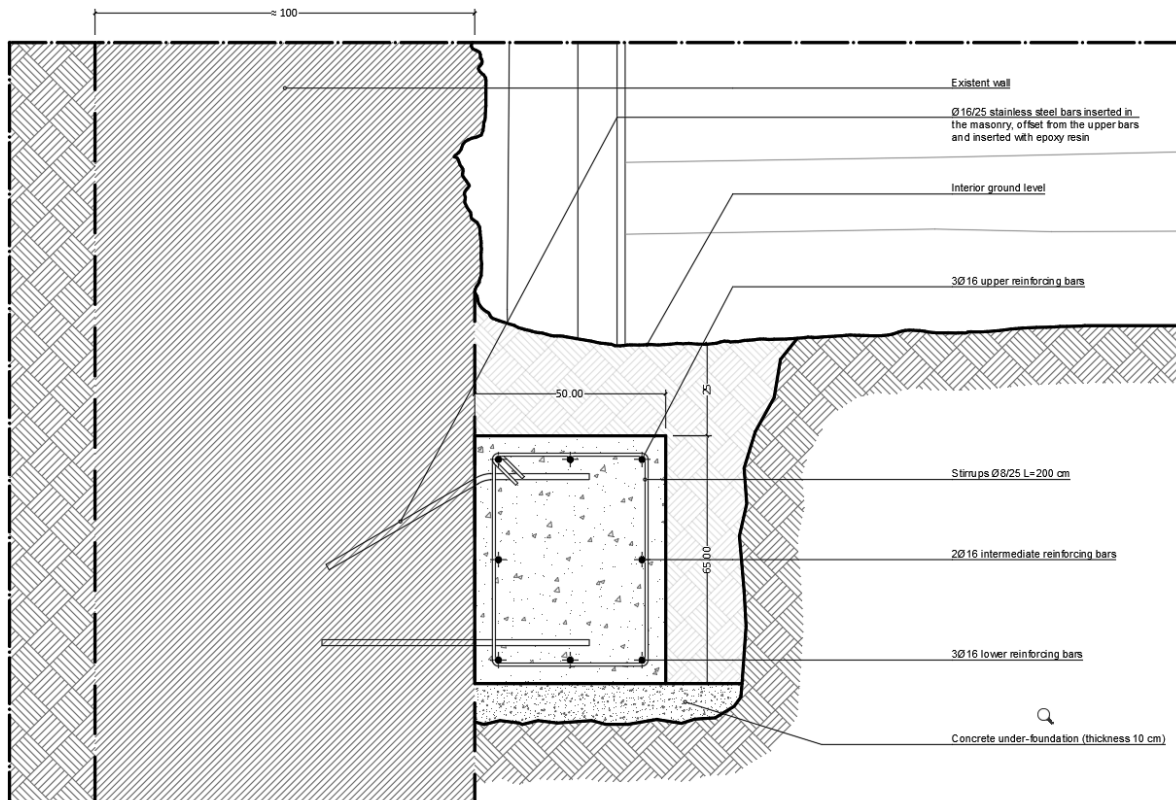
The new curb made in reinforced concrete

For this reason, an extension of the foundation is proposed by casting a reinforced concrete curb realized according to the requirements of structural project drawings. The minimum section will be 50 cm wide and 65 cm high, connected to the existing masonry by means of stainless-steel bars able to transmit the shear stresses between the concrete and the masonry. For what concerns the concrete reinforcing steel, there will be 3+2+3 Ø16 longitudinal bars and the stirrups Ø8 will be put every 25 cm; connectors between the concrete and the existent masonry will have a step of 25 cm as well.

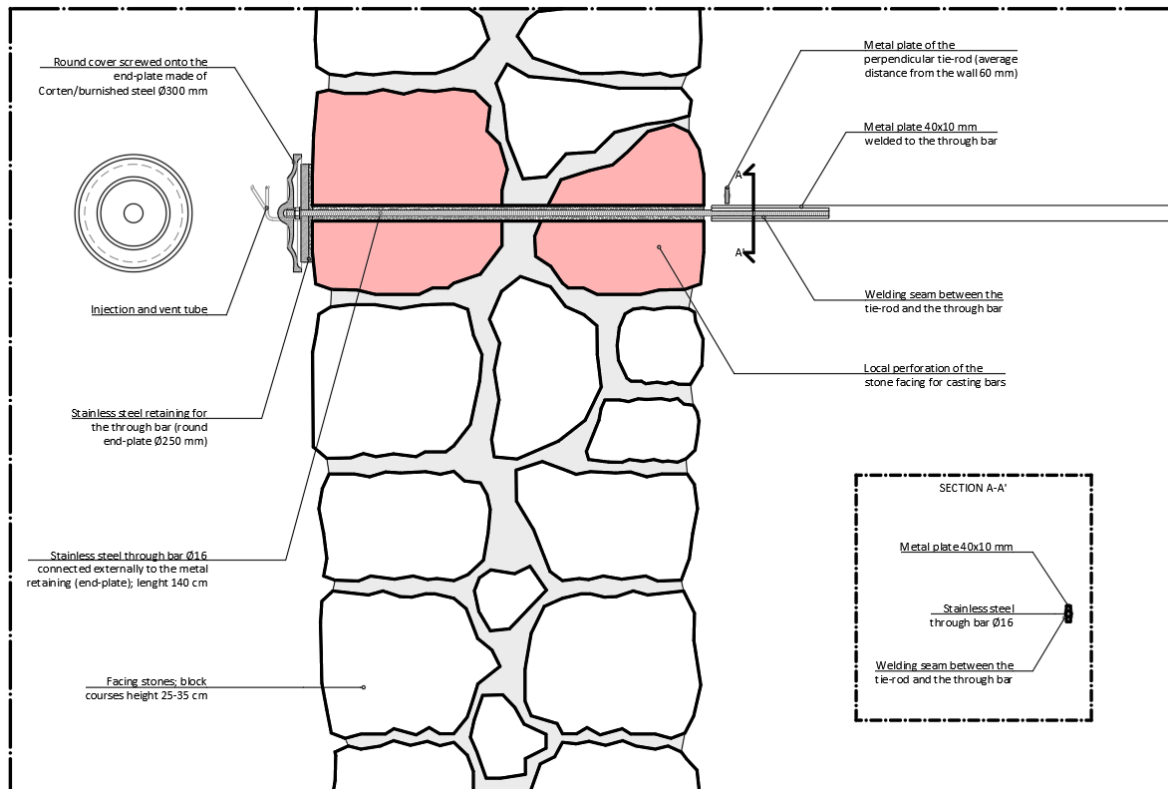
The new metal tie-rod and the round-plate with its cover

They will be bound to the walls with round end-plates with a diameter of 25 cm, made of S275 steel and protected with a round cover made of Corten/burnished steel.
