**Technical Expertise and develop Detailed Technical Design for
CONSERVATION and RESTORATION WORKS OF BENDER FORTRESS (Phase I)**

DETAILED TECHNICAL DESIGN

C B A			
	07-2020	first emission	C226_PER_009.dwg
	DATE	REVISION	FILE NAME

TITLE: RESTORATION INTERVENTIONS
Elevation | Water Tower-A

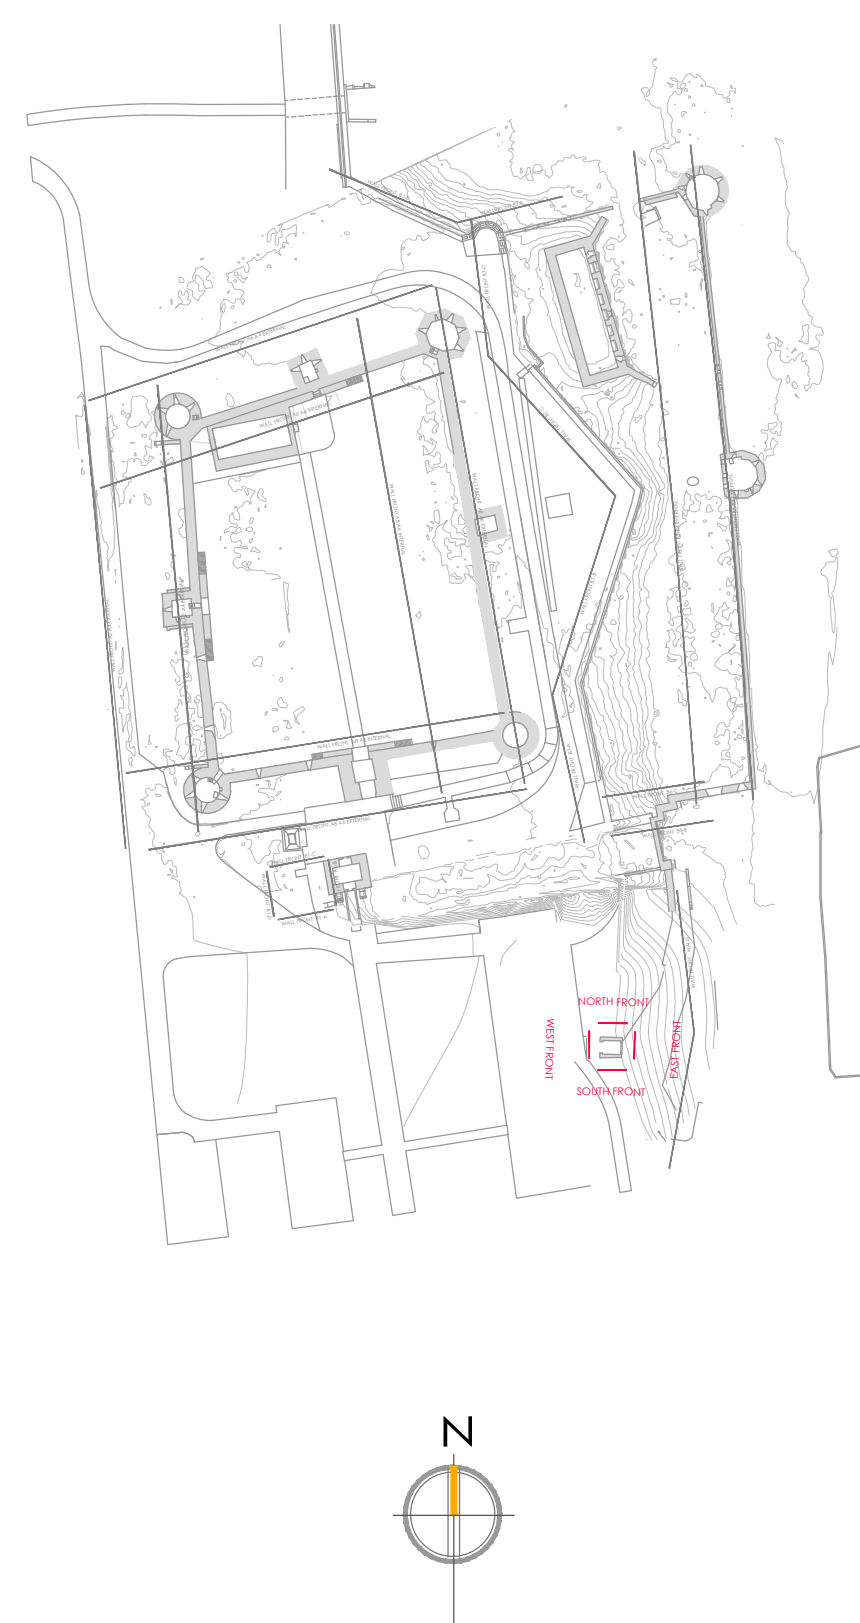
Alteration of stone
this symbol indicates the
presence of loss of original
surface, fragmentation and
mortar joint leakage

STRUCTURAL FAILURES

Crack: Minor crack with a width of about 0.1 mm

Deep crack: Crack that crosses completely the stone piece

Detachment of the facing stones

Swelling
