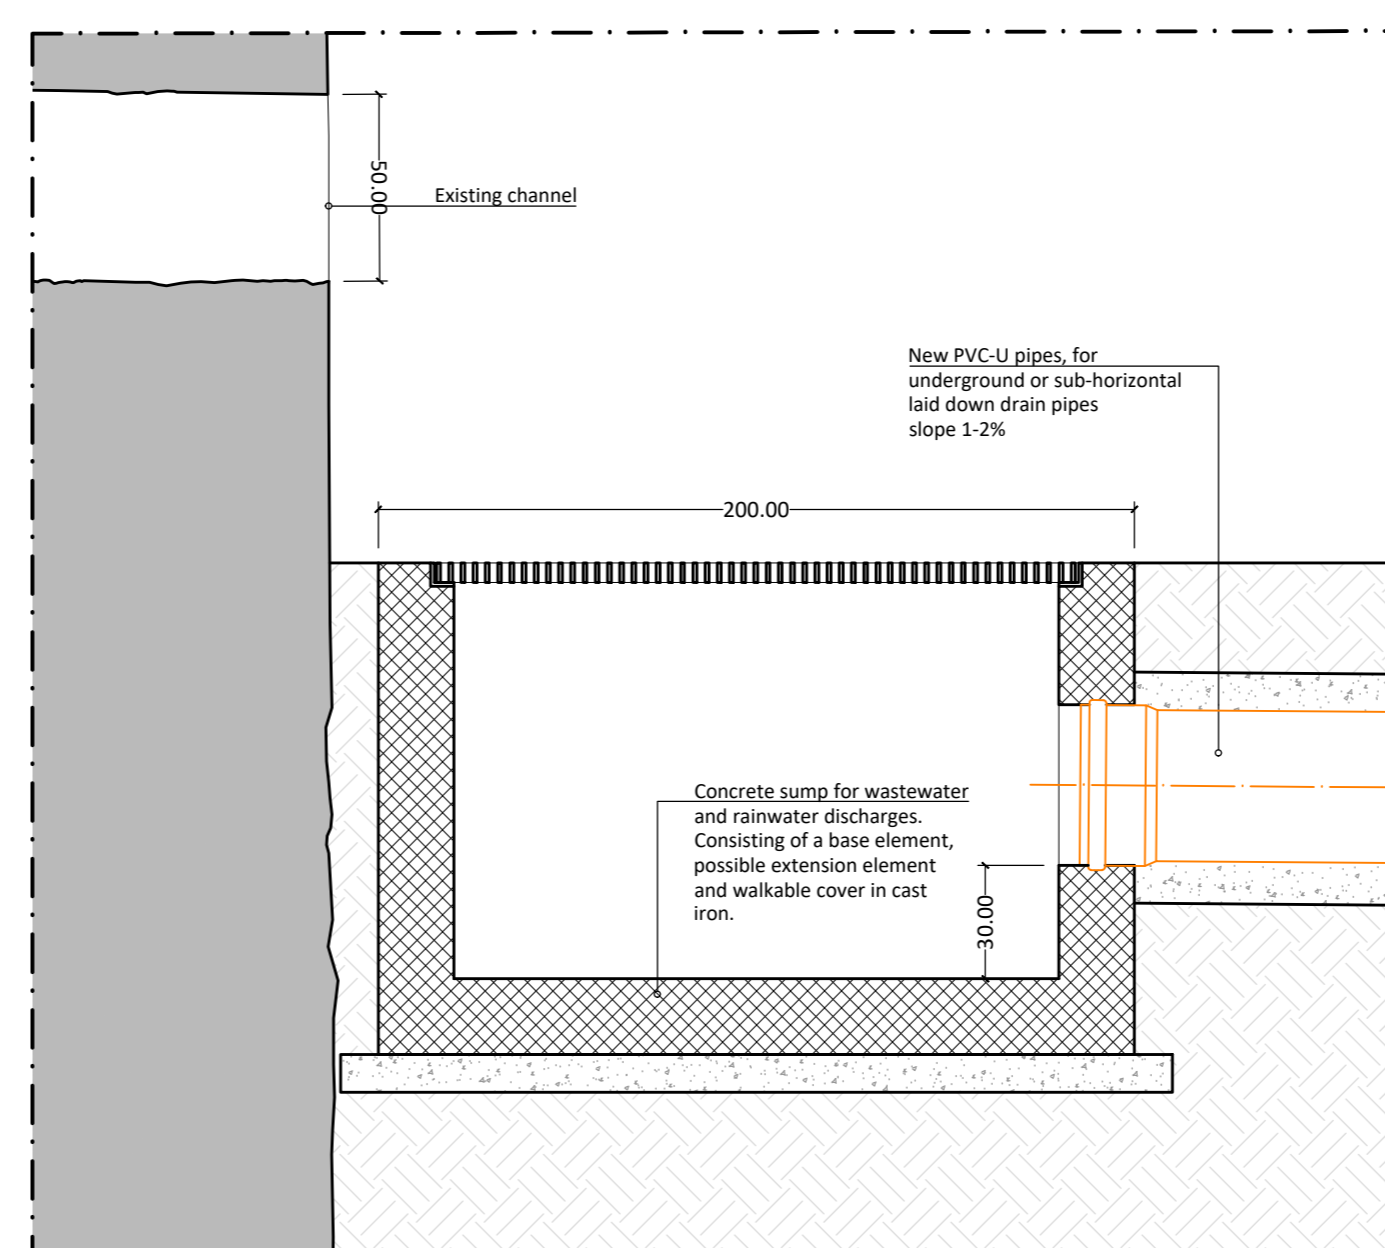
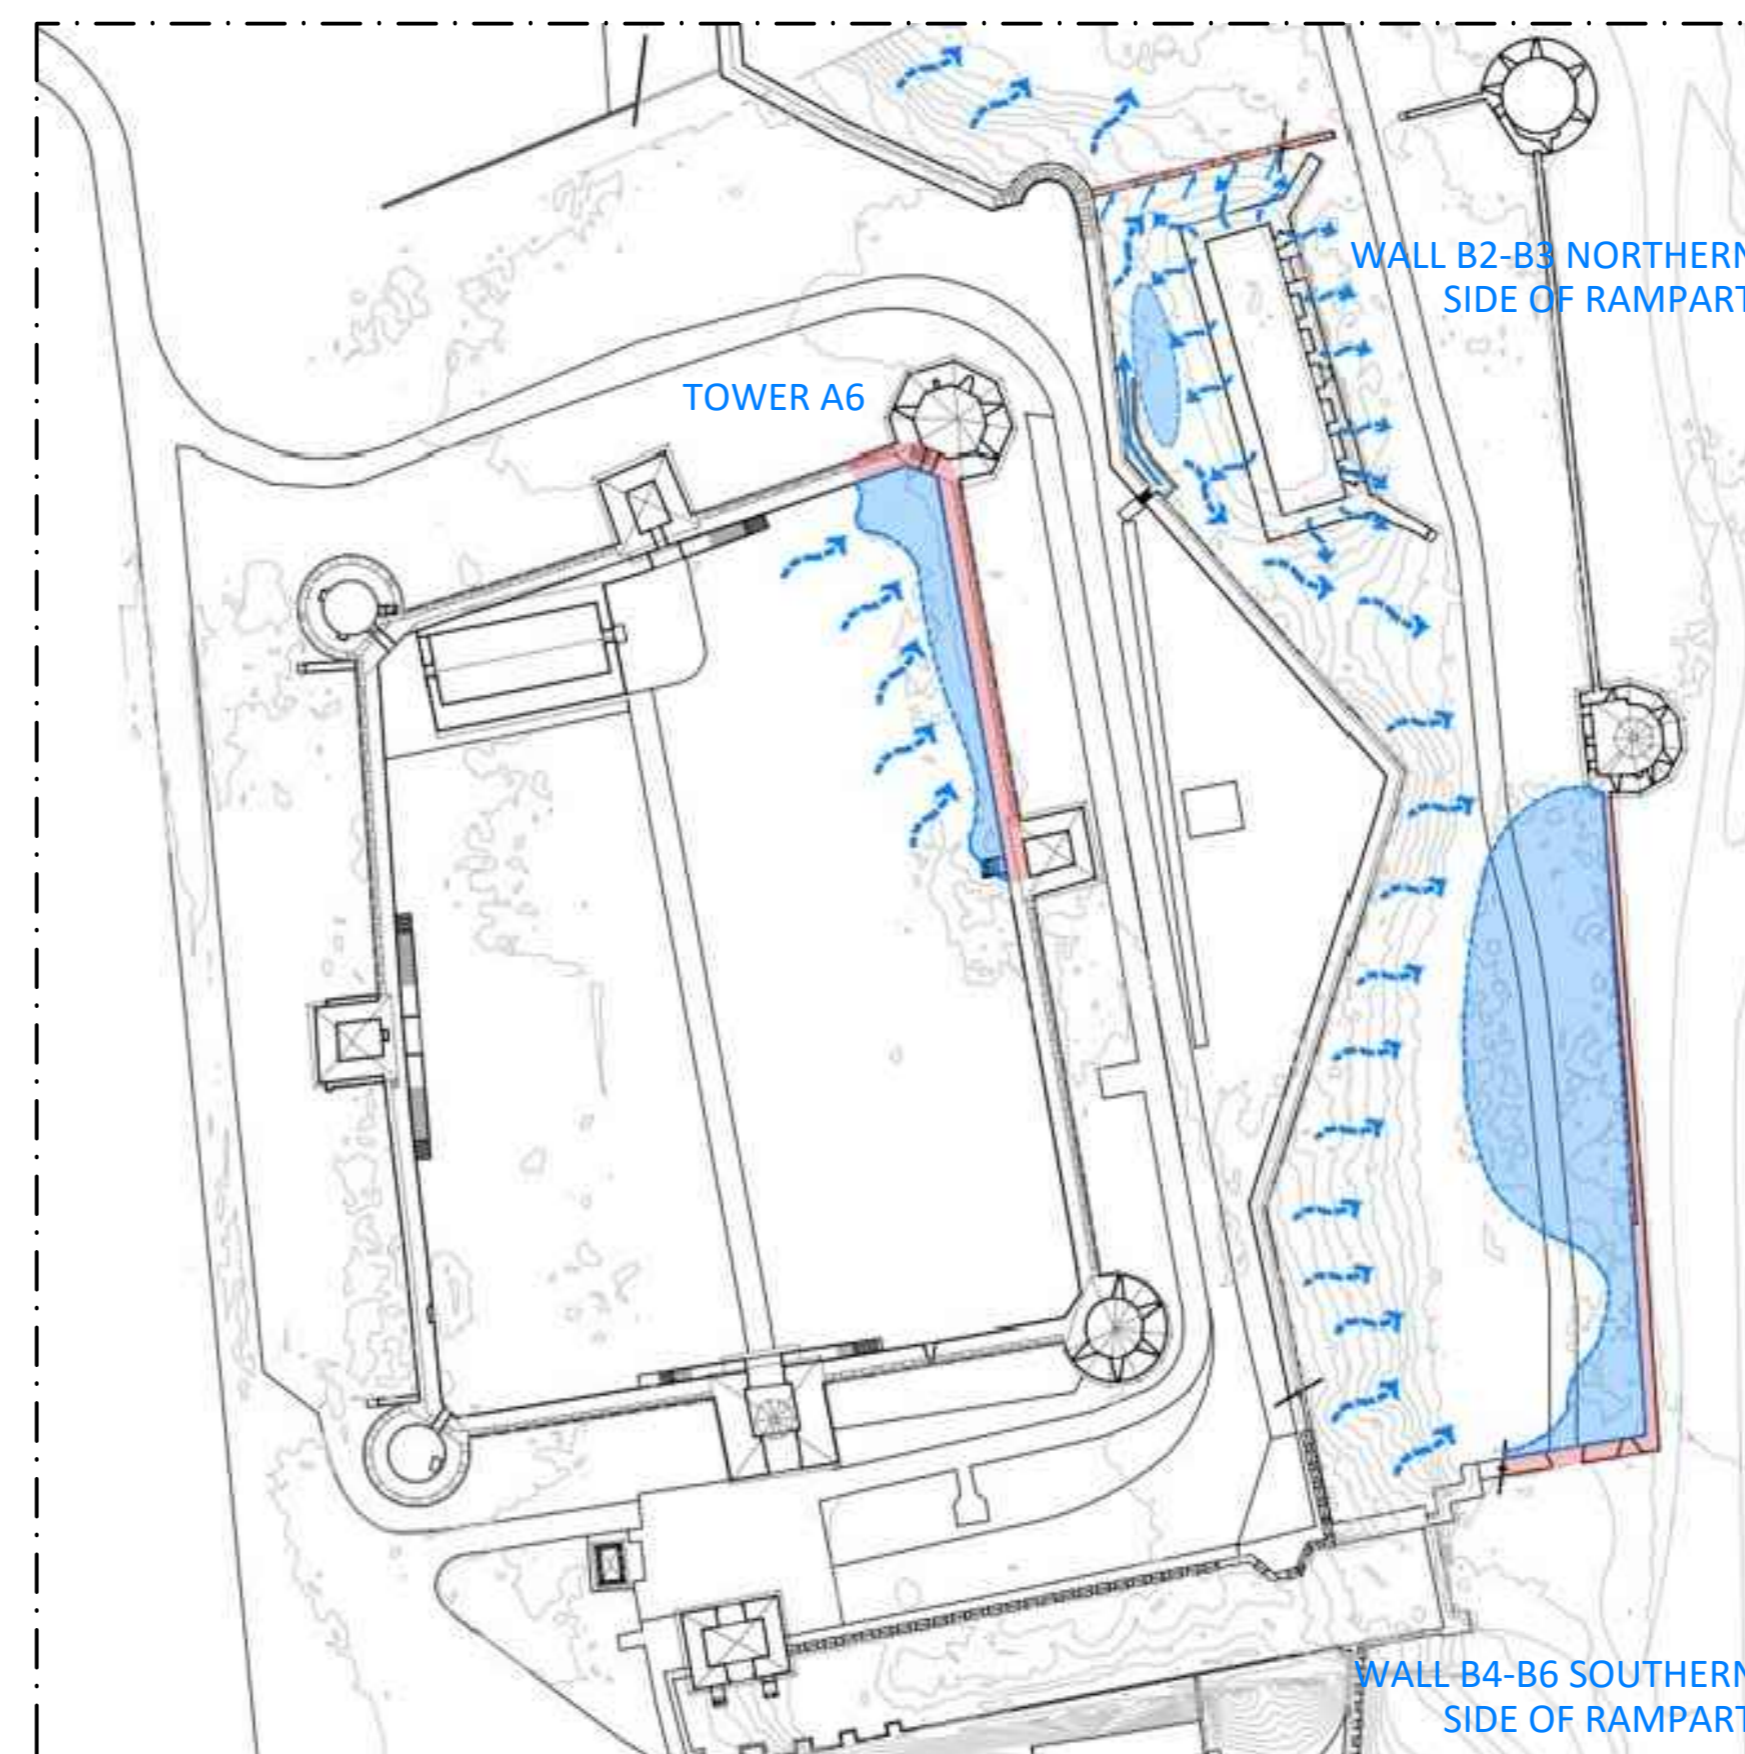
The ground depression at the entrance of the tower could be a probable stagnation area, in a point already subject, moreover, to structural problems.

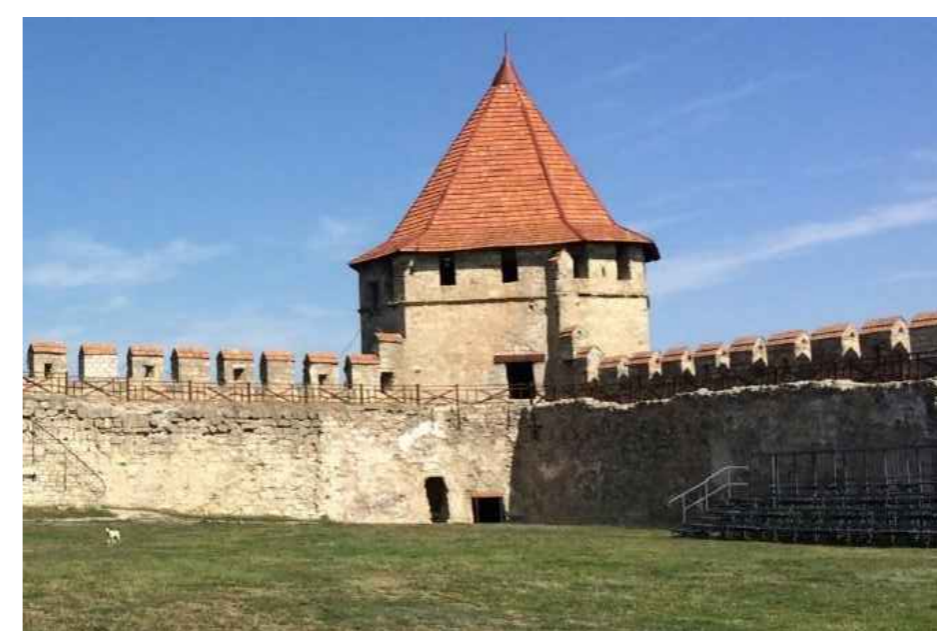
The curves of the elevation indicated a probable stagnation area near the wall, where there is the lowest point of the ground inside the lower fortress.

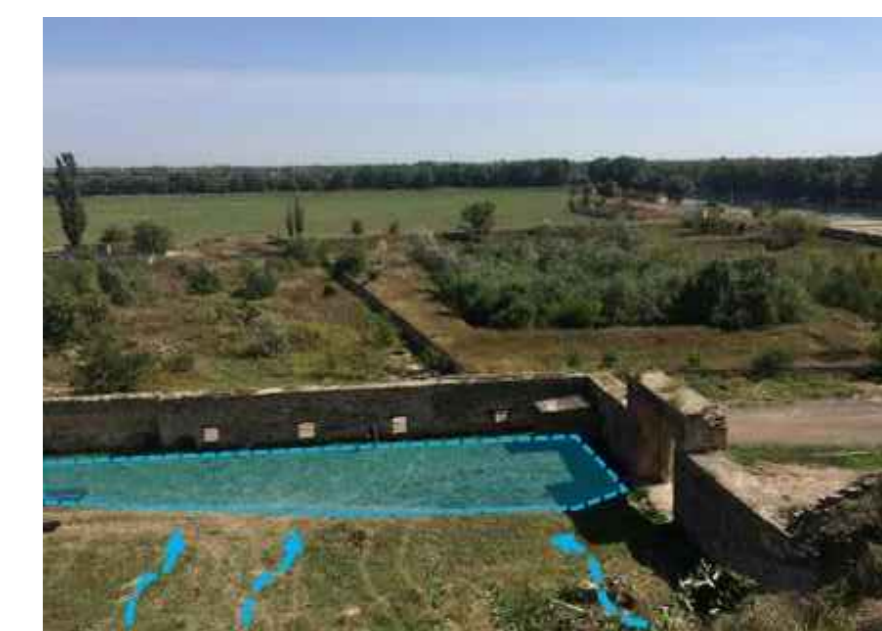
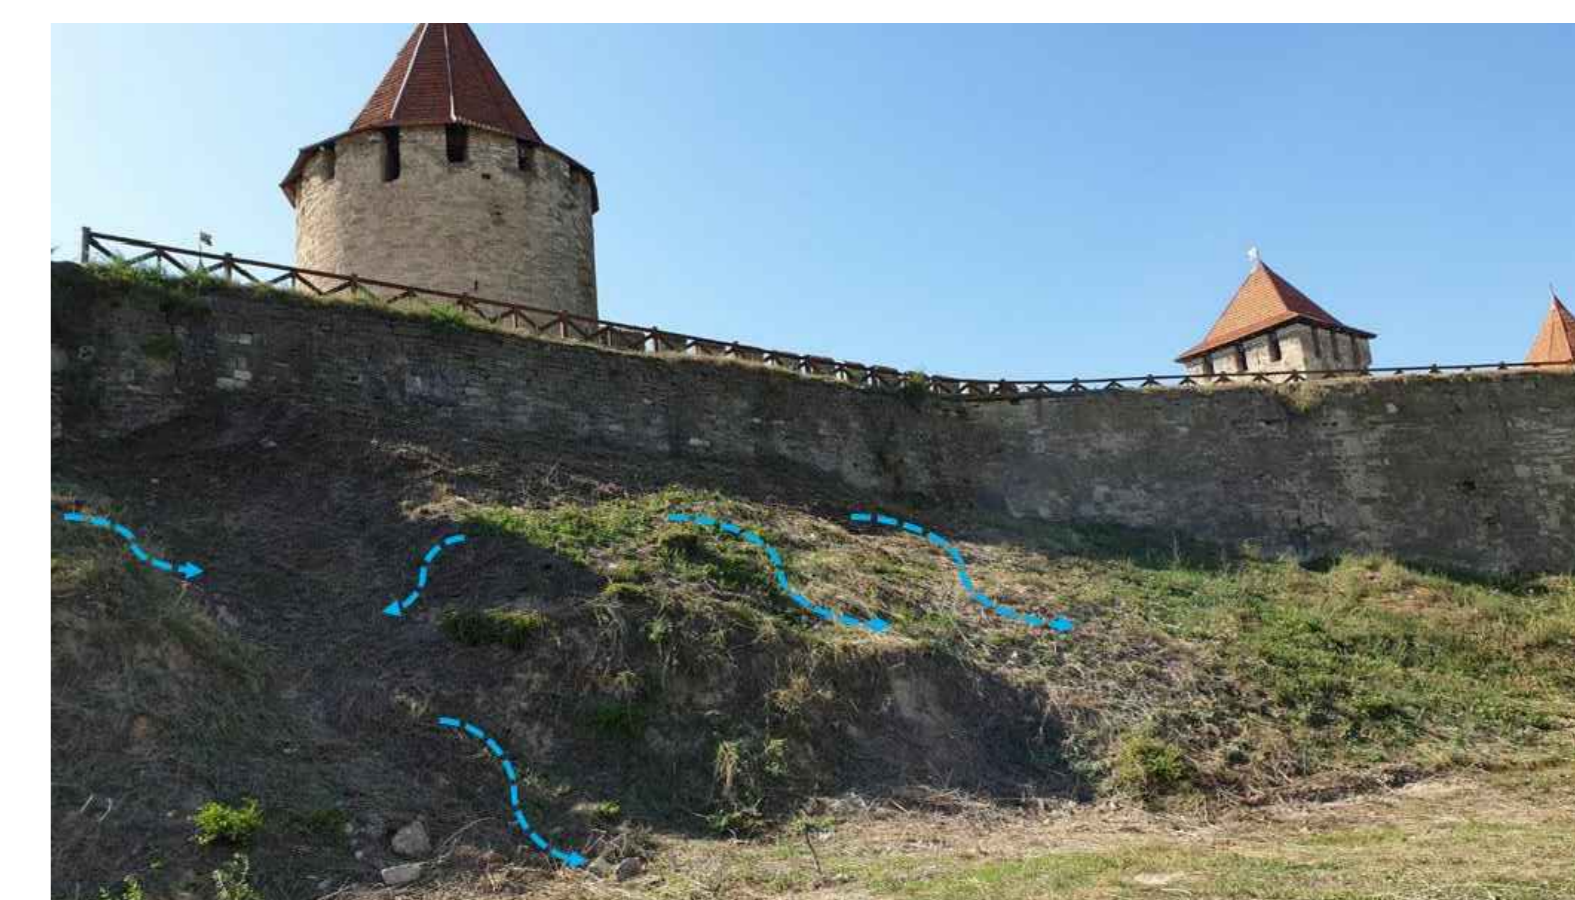
In this area the existent artificial drainage system is still visible, in an area with the confluence of various ground slopes. So, this could be a probable stagnation point, with potentially significant flowing risks in some portions of the walls between between towers B2 and B3.
