REPORT OF EXPERT EXAMINATION No. 9839-08-23/T

**of the 'UN House Moldova' building
with cadastral no. 0100520.040.01 and 0100520.040.02
on 131, 31 August 1989 str., Chisinau municipality**

Prepared based on the request of
UNDP Moldova

Chisinau, 2023

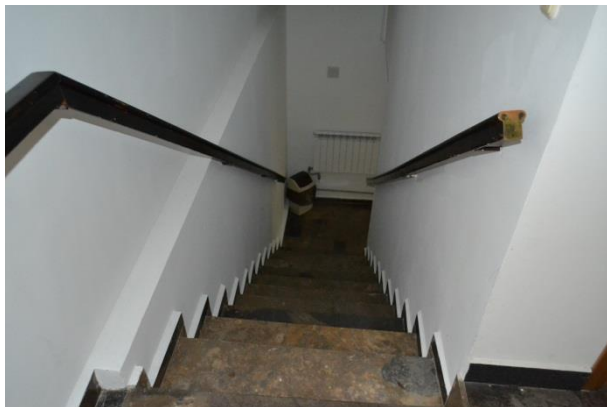
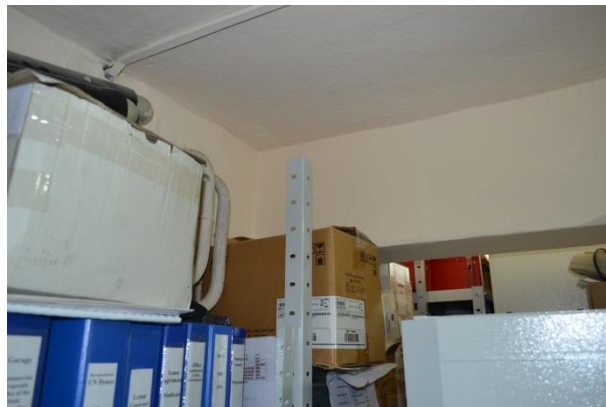
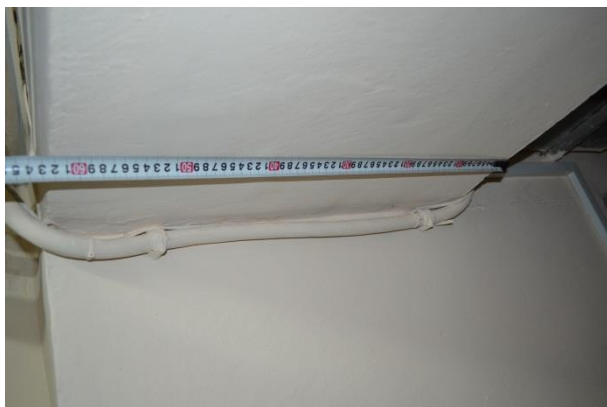
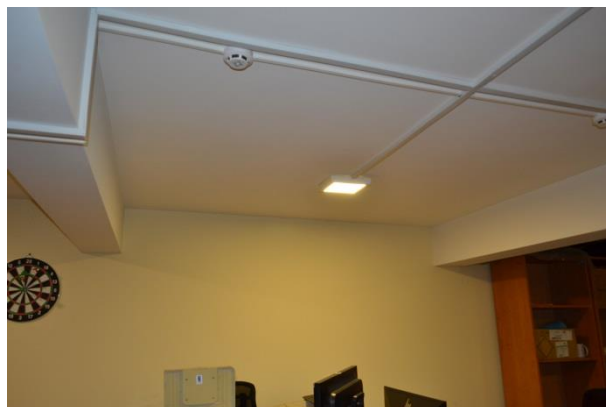
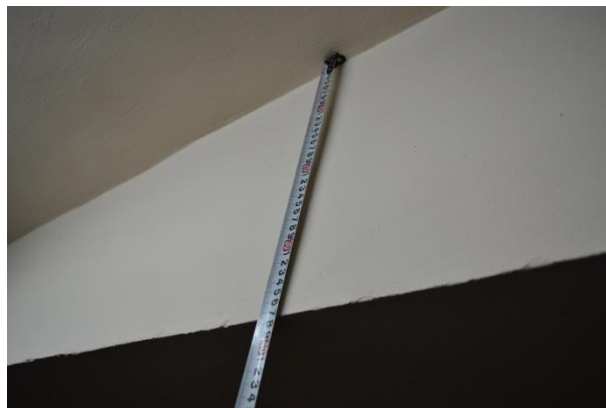
Starea tehnică a elementelor structurale ale subsolului:
